# AIRCRAFT ACCIDENT REPORT

EASTERN AIR LINES, INC  
DOUGLAS DC-8, N8607  
NEW ORLEANS, LOUISIANA  
FEBRUARY 25, 1964

## SYNOPSIS

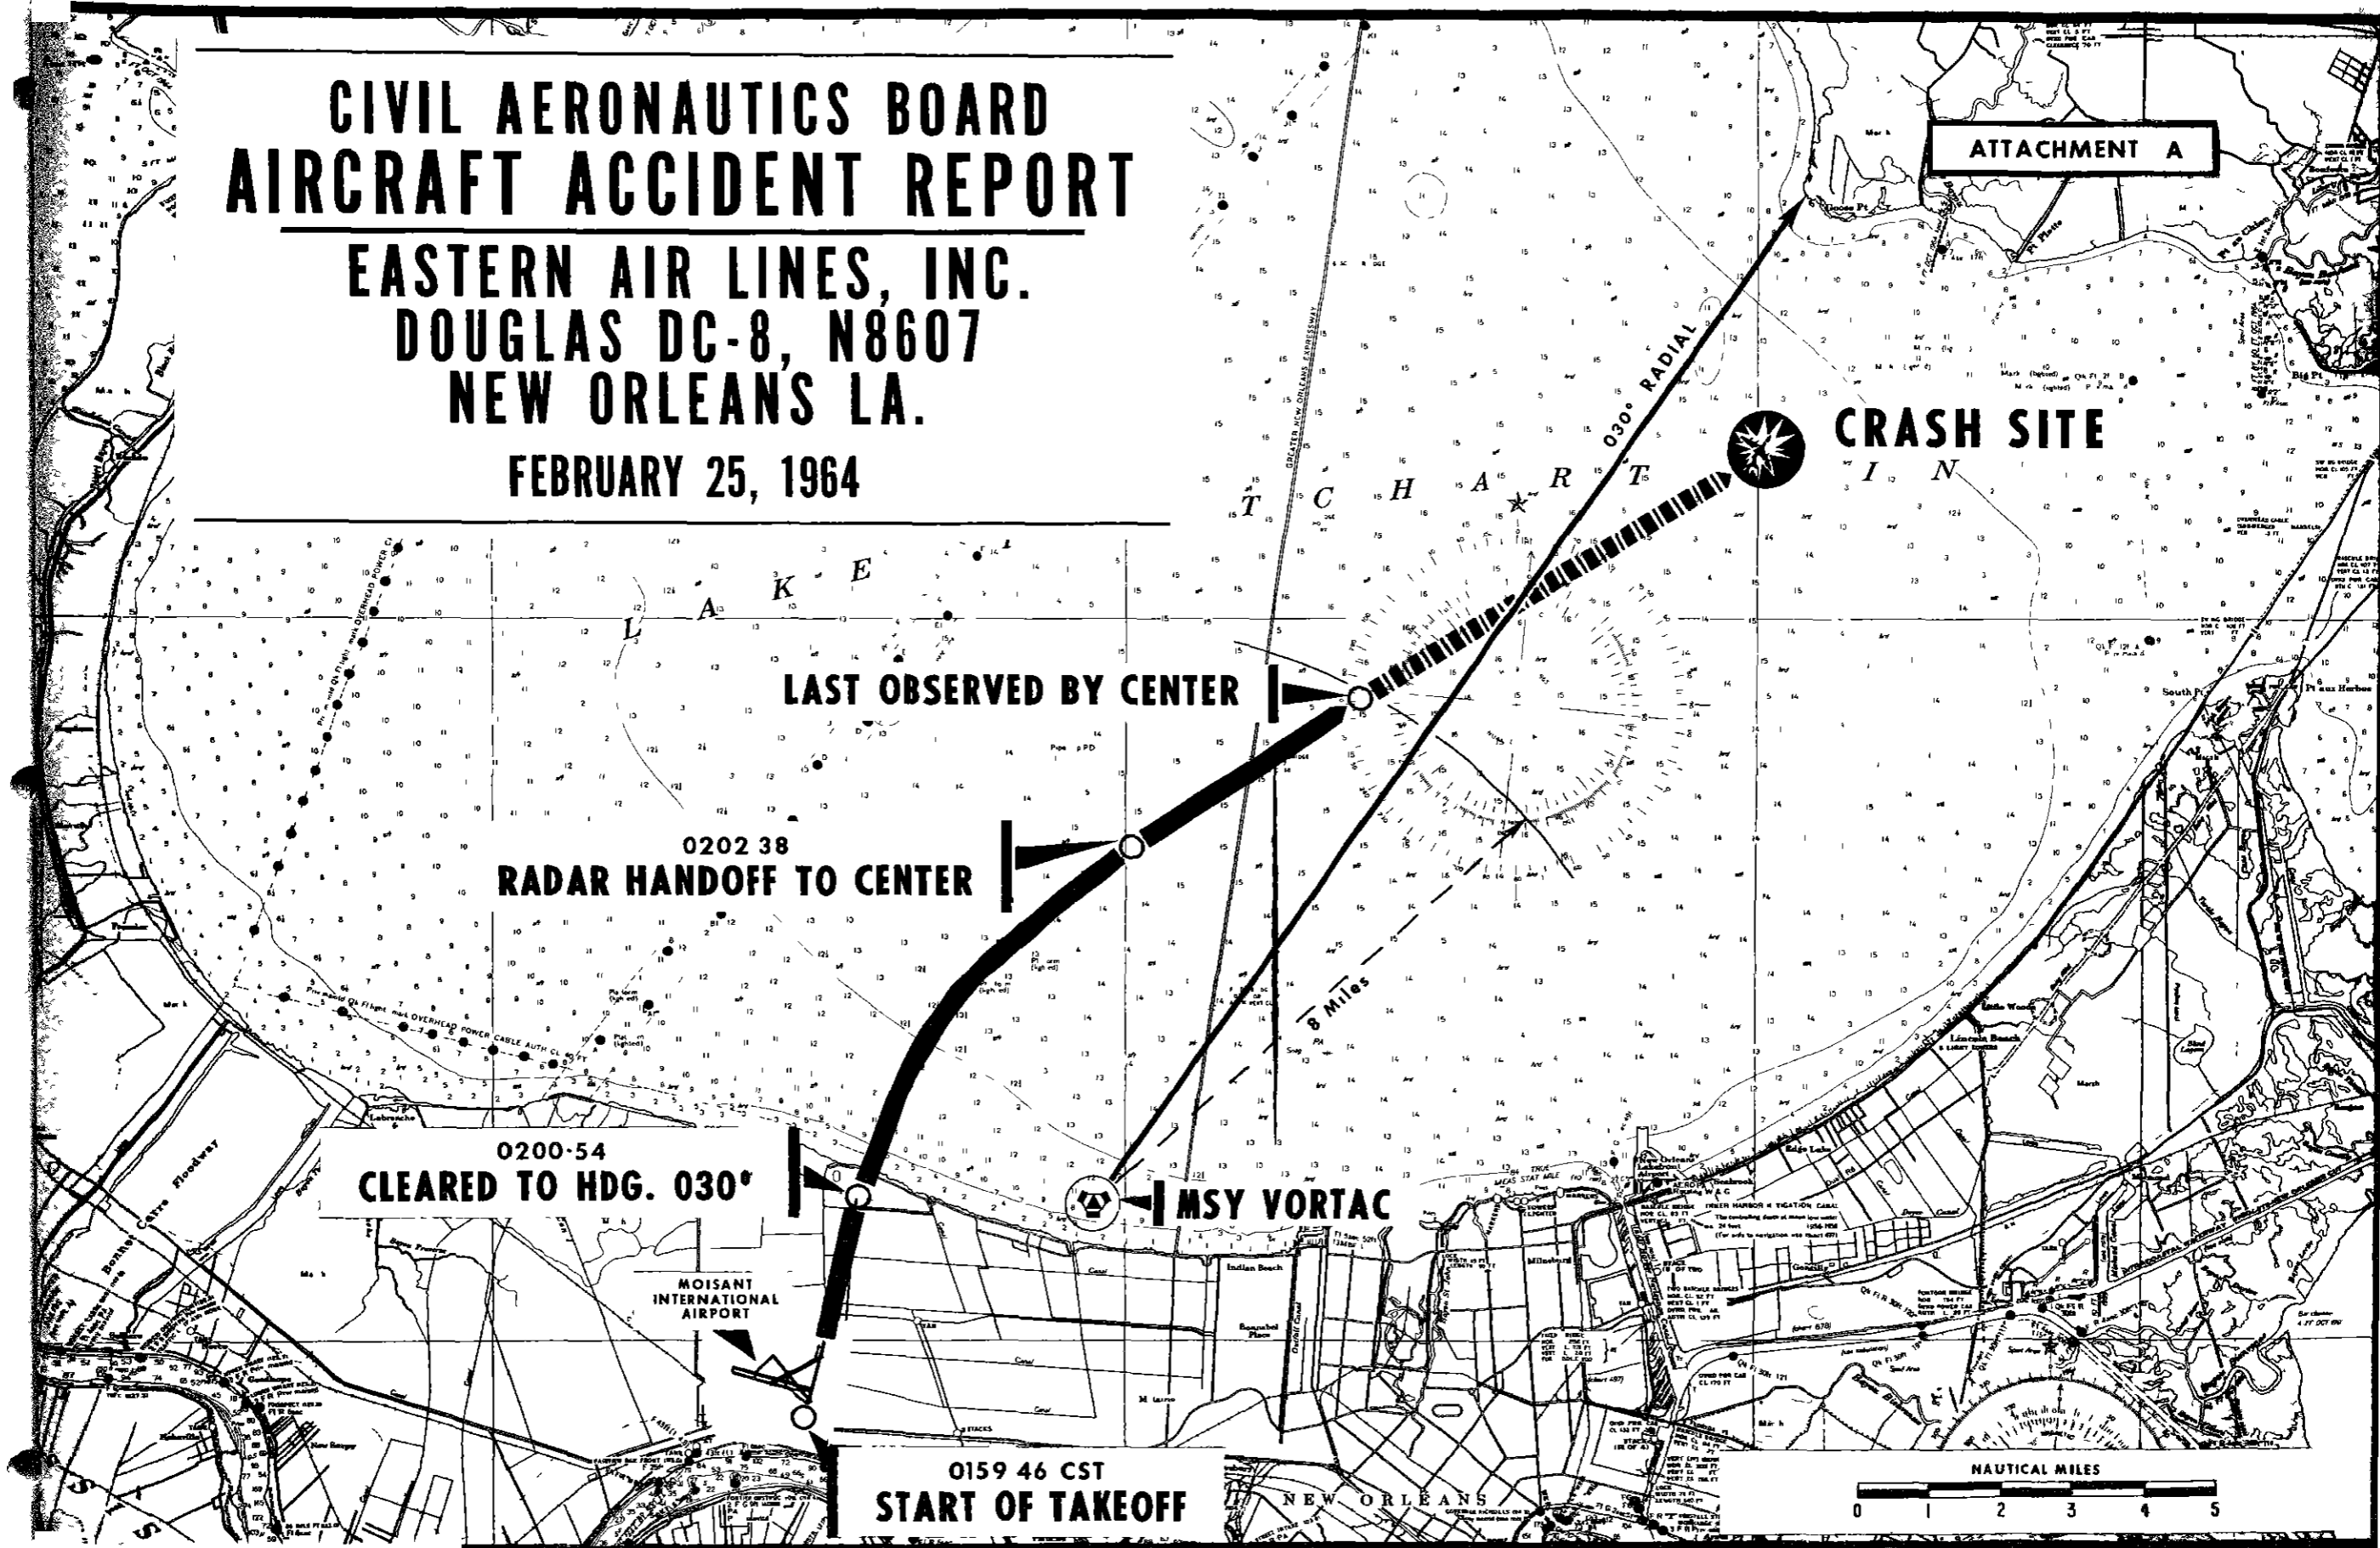
At 0159 46 the local controller in the tower observed Flight 304 commence the takeoff (See Attachment A). The lift-off appeared normal, and at approximately 0201 he advised the flight to contact Departure Control, which was acknowledged. He estimated that the flight was two or three miles north of the airport when the lights disappeared into the overcast. Voice communication and radar contact were established immediately between the flight and the departure controller who advised them to ". . . turn right heading 030, be a vector north of J-37 (the planned route of flight)". While the flight continued on this vector, the departure controller contacted the New Orleans Air Route Traffic Control Center (ARTCC). The radar target was identified five miles north of the New Orleans VORTAC, and a radar handoff was effected at 0202 38. Flight 304 was instructed to ". . . contact New Orleans Center radar, frequency 123.6 now." At 0203 15 the crew replied, "OK". This was the last transmission from the flight. At 0205 40, when no transmissions had been received from the flight, the center controller contacted the departure controller to verify that proper instructions had been given. During this conversation both controllers confirmed that the radar target associated with the flight had disappeared from both scopes, and emergency procedures were initiated shortly thereafter. The last position noted by the controllers was approximately eight miles from the New Orleans VORTAC on the 030-degree radial. The aircraft crashed at 14.5 miles on the 034-degree radial, in Lake Pontchartrain.

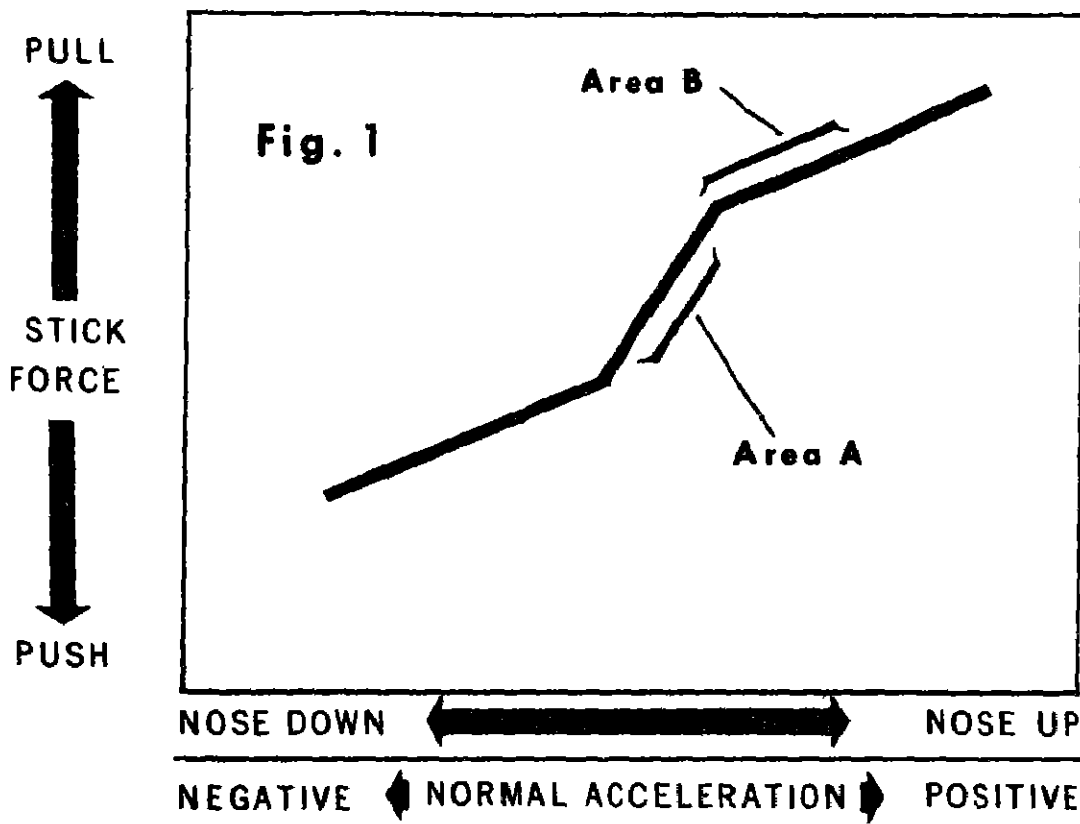
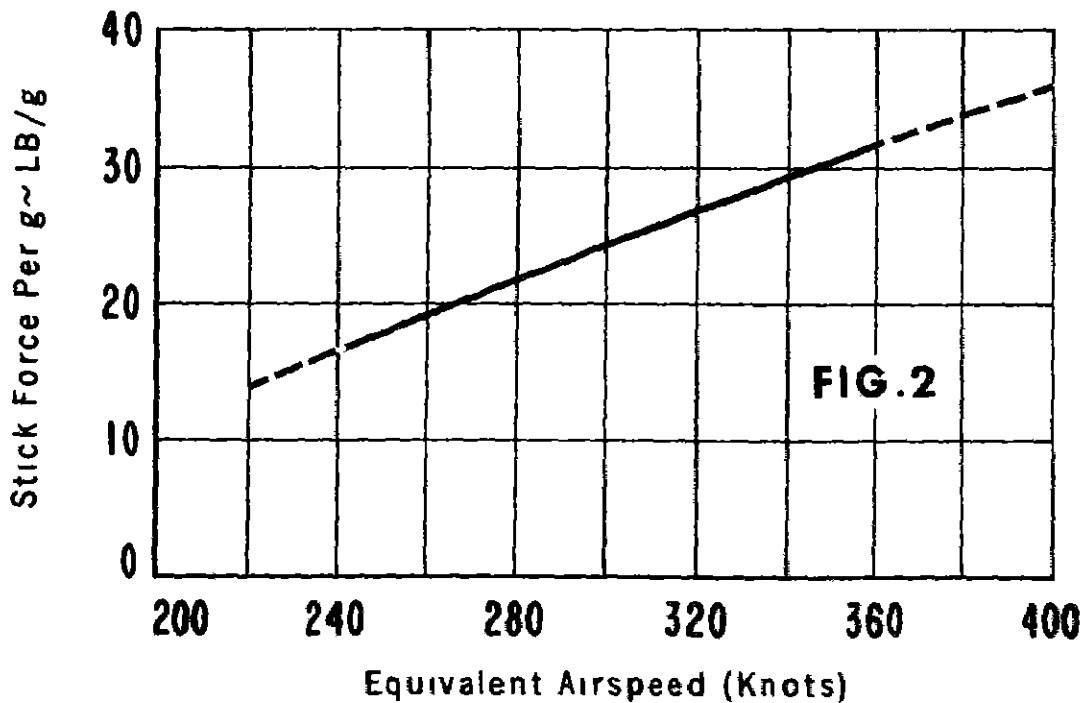
# ATTACHMENT C

The variation of stick force per g versus speed for the 2-degree AND case, shown in Figure 2 of Attachment C, is also significant. It should be noted that while the stick force per g is light but at a reasonable level at 310 knots, it degenerates to about 13 pounds at 220 knots. This level of force gradient is extremely light<sup>10/</sup> and is, to a large extent masked by the friction forces of the system which are about 5 to 6 pounds. Thus, at 220 knots a pilot could maintain a 1.5-g maneuver without feeling any resistive force, or he could hold limit load (2.5-g) by feeling out only about 14 pounds, considerably less than required for a similar maneuver in a military fighter aircraft.
