PB94-916301
NTSB/RAR-94/01

RAILROAD-MARINE ACCIDENT REPORT

**DERAILMENT OF AMTRAK TRAIN NO. 2
ON THE CSXT BIG BAYOU CANOT BRIDGE
NEAR MOBILE, ALABAMA
SEPTEMBER 22, 1993**

Adopted: September 19, 1994
Notation 6167B

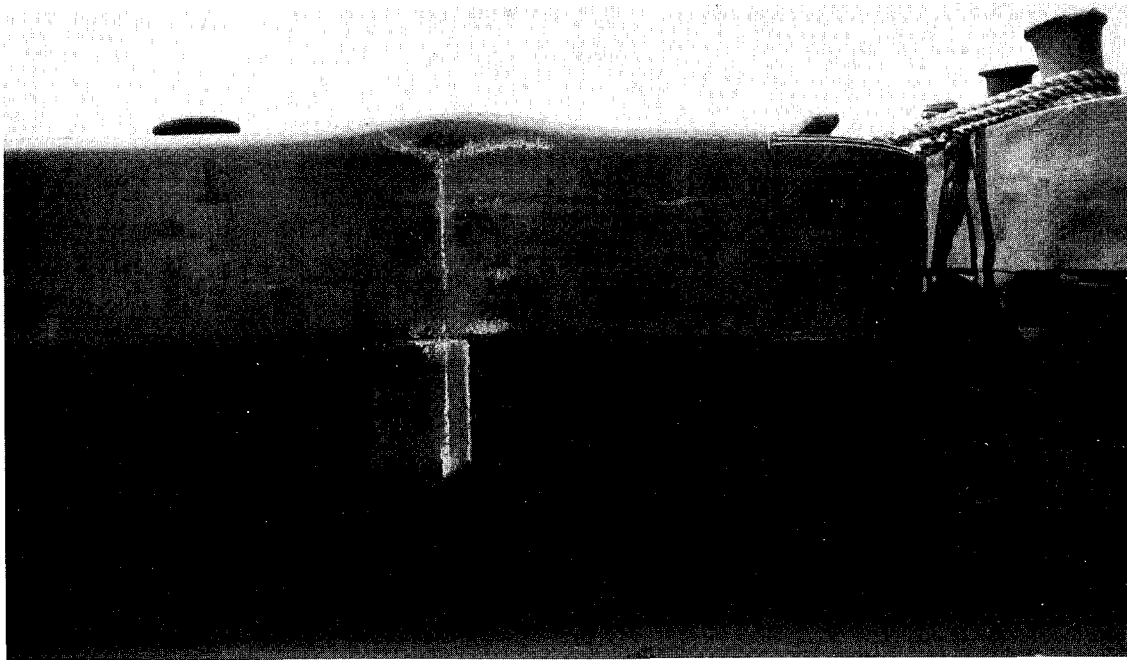
Figure 8.--Collision marks on barge.

was drydocked at W&GN's yard on September 27, 1993, for a hull survey. The marine investigative group noted no apparent damage to the hull, rudders, or propellers. Inspection revealed no evidence of a wire or other item having been wrapped around the propellers or rudders. The lead port (WGN 285) and starboard (WGN 208) barges (see figure 8) were slightly dented where they struck the bridge's concrete piers, and the center lead barge (WGN 258) had six marks on its headlog where it struck the vertical stiffeners on the bridge span (see figure 4). The other three barges were undamaged.
