✓ " RAILROAD ACCIDENT REPORT "

✓
" HEAD-ON COLLISION OF NATIONAL RAILROAD
PASSENGER CORPORATION (AMTRAK)
PASSENGER TRAINS NOS. 151 AND 168
ASTORIA, QUEENS, NEW YORK, NEW YORK
JULY 23, 1984

✓
NTSB/RAR-85/09.

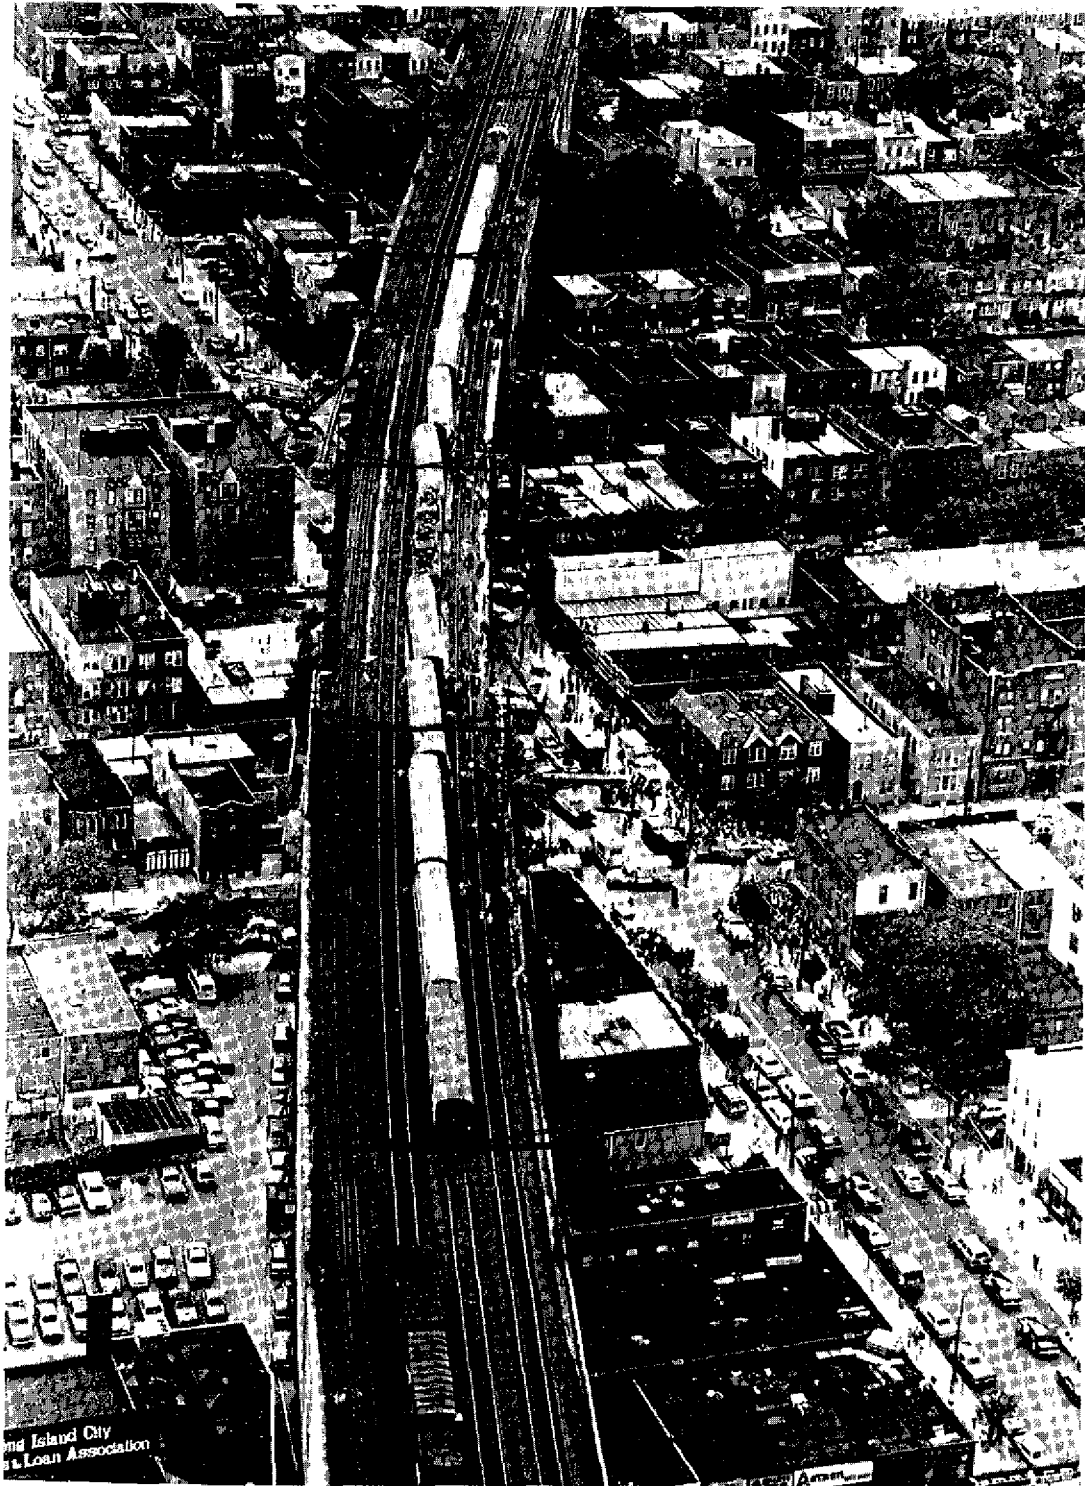
About 10:45 a.m., train No. 168 collided with train No. 151. Both trains were moving about 30 mph on an elevated section of track about 6,300 feet west of the 2E home signal. (See figure 2.) The locomotives and first four cars of each train derailed. The engineer of train No. 151 was knocked down in the engineroom of his locomotive, but he was able to recover and depart the locomotive through the rear operating compartment. The engineer of train No. 168 was found lying on the ground on the left side of his train adjacent to the locomotive of train No. 151.

Figure 2.--Aerial view looking west of accident site.
Train No. 168 is at top of of photograph, and train No. 168 is at bottom.

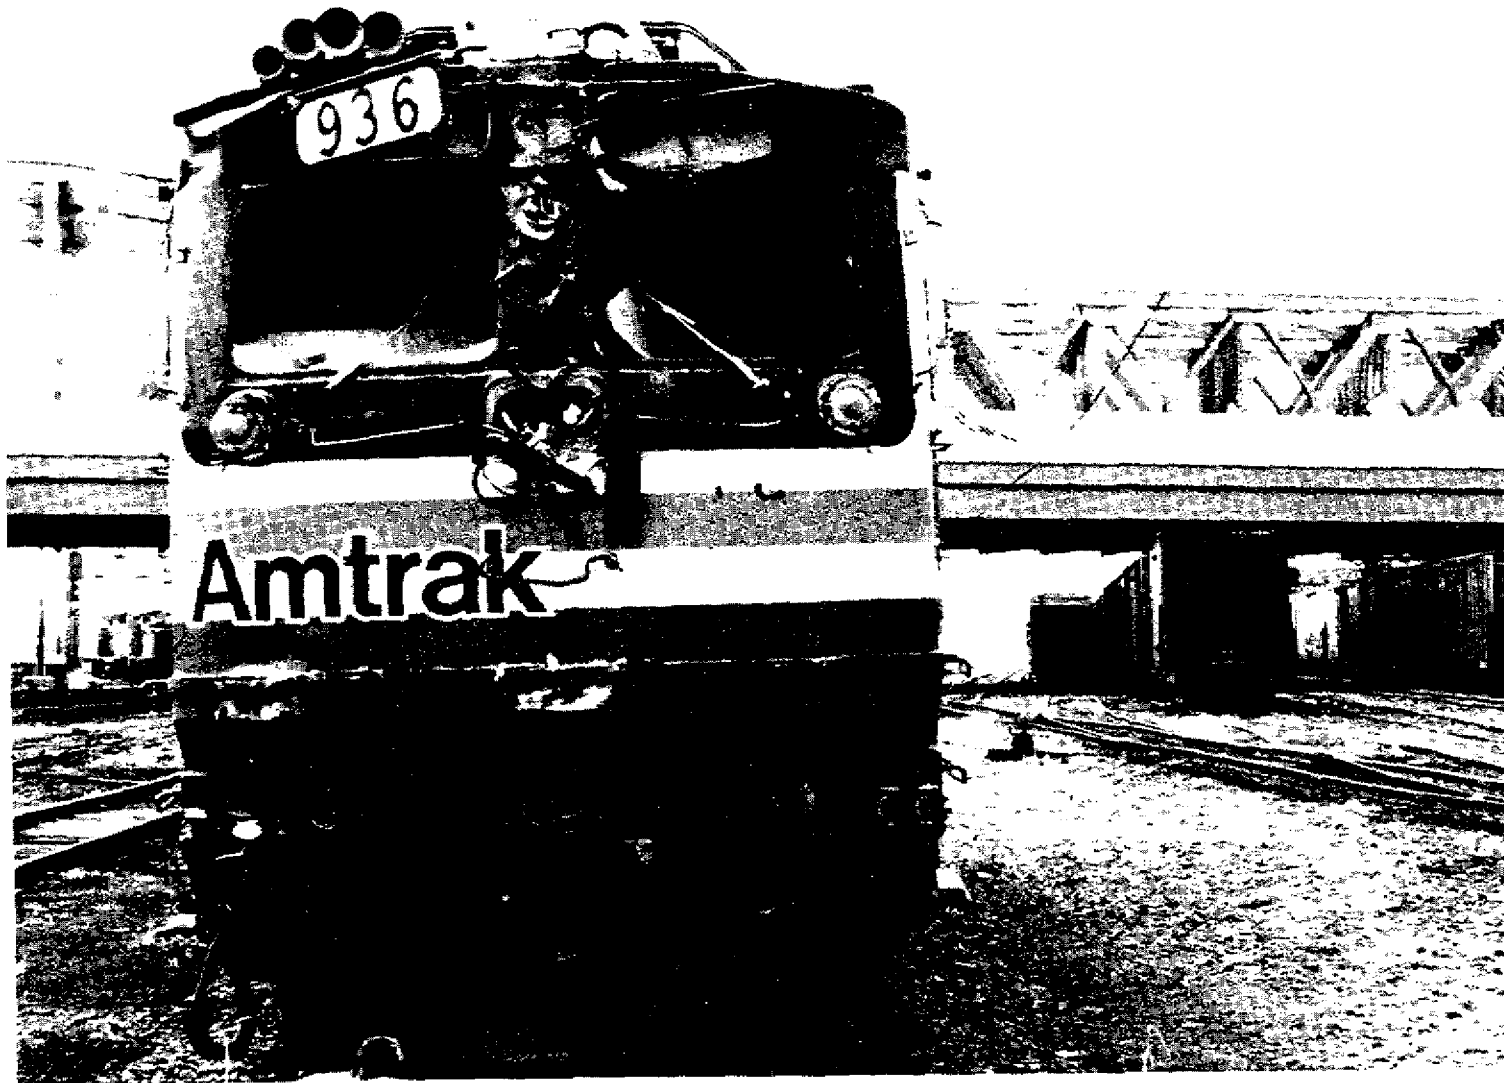
The predominant type of damage to the locomotives and coaches of both trains was end crush damage. The operating compartment of locomotive No. 936 on train No. 151 was displaced rearward about 2 feet at the floor and about 6 inches at the roof. The floor was buckled upward. The engineer's and fireman's seats were broken loose from the floor attachments and were leaning forward onto the operating desk. All components within the operating compartment were displaced and distorted. The side door on the engineer's side was ripped loose from its hinges, and the front of the door frame was moved backward about 18 inches. The door on the fireman's side was displaced backward, but it was not unhinged. Both halves of the two-part windshield were intact and the side window frames were buckled, but the glass was not broken. (See figure 3.)

Figure 3.--Damage to locomotive No. 936 train (No. 151).

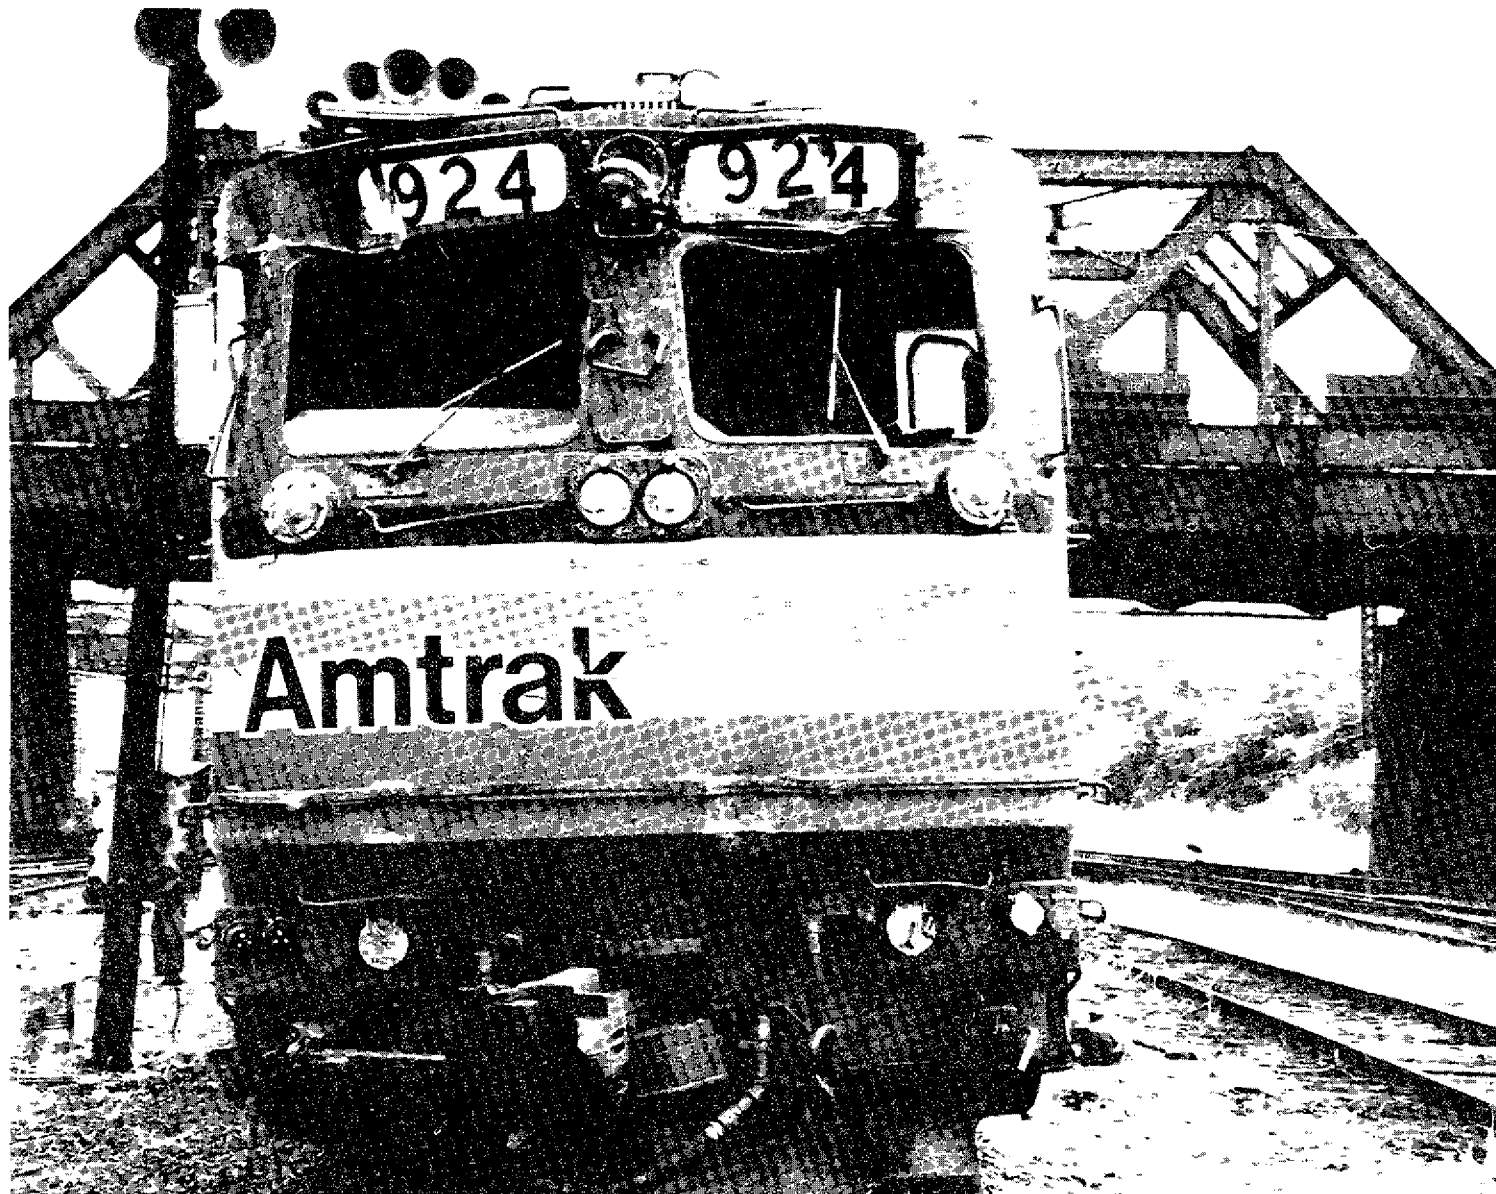
The same general crush damage was evident on locomotive No. 924 of train No. 168. However, the fireman's and engineer's seats were not broken loose from their attachments and the interior crush damage to the operating compartment was not as severe as it was to locomotive No. 936. (See figure 4.)

Figure 4.--Damage to locomotive No. 924 train (No. 168).

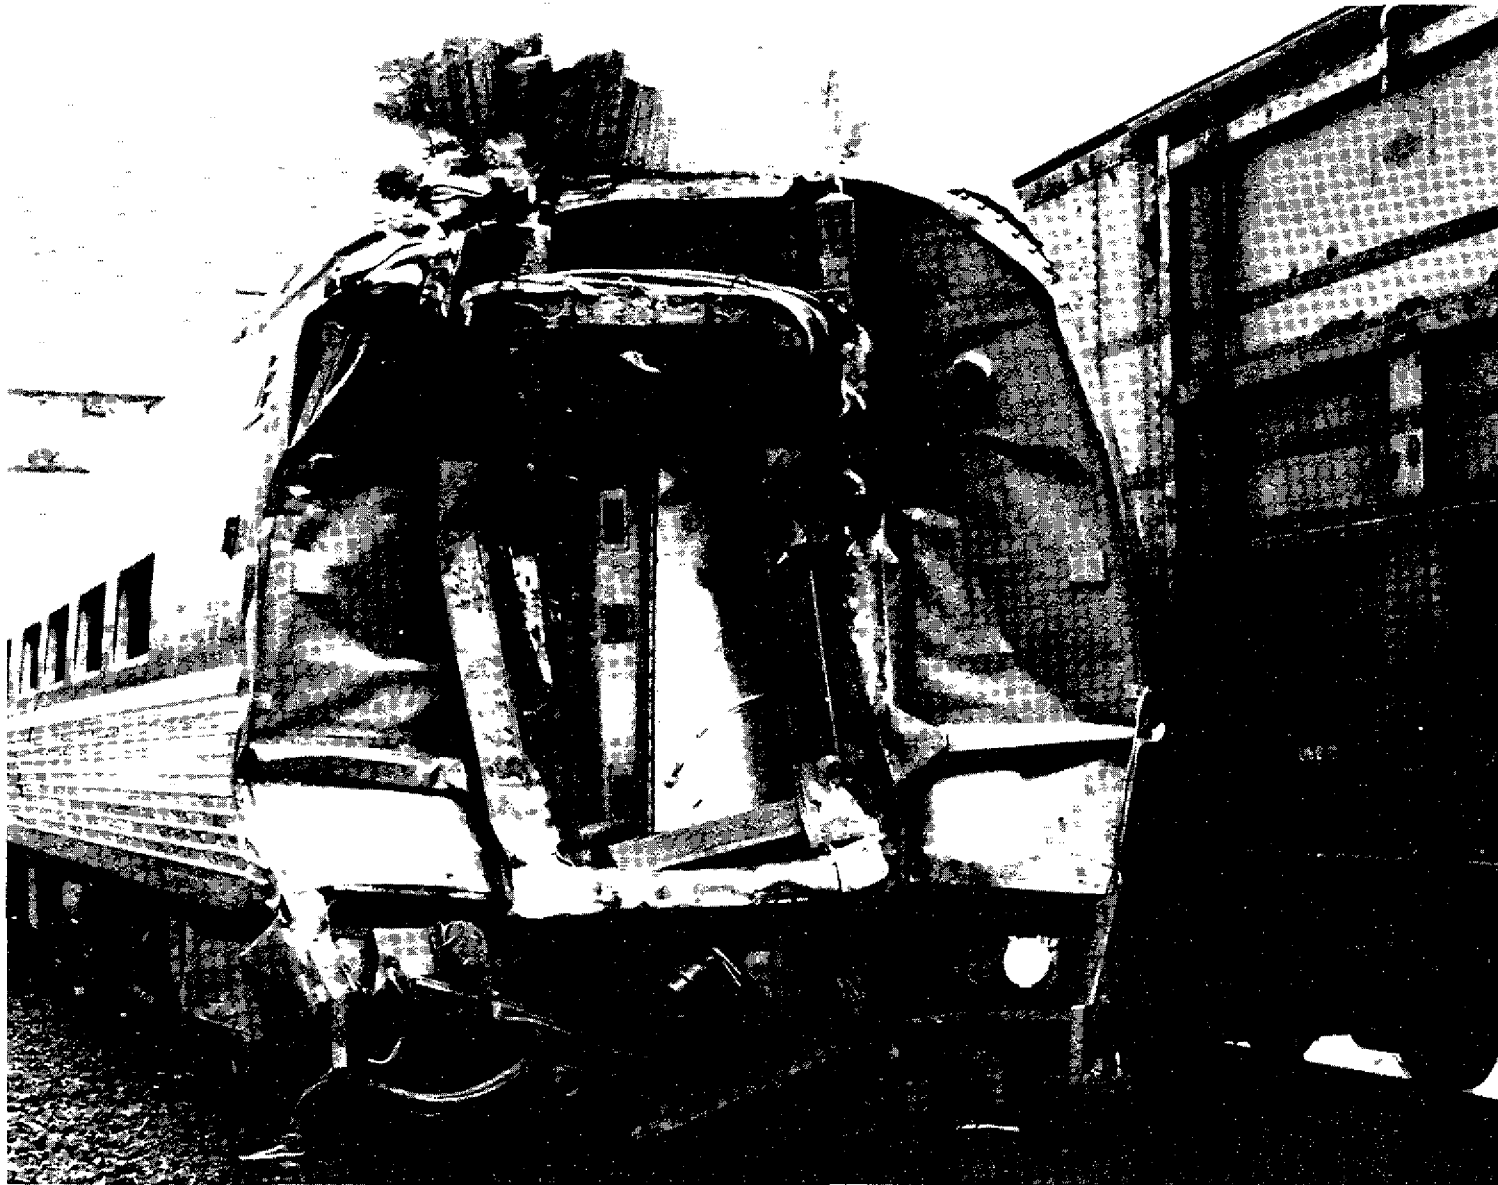
The vestibules of the first coach behind the locomotive of each train were crushed inward to the passenger compartment bulkhead. The side doors were either crushed or inoperative because of frame deformation. The end doors leading from the vestibules into the passenger compartments were in various positions and conditions. Some operating mechanisms were inoperable because of damage, and some operating mechanisms were operable but the doors would not function because of frame deformation which caused some doors to be jammed in either an open or closed position. Other coaches in the trains had similar damage, but the severity of the damage decreased as their location in the trains placed them farther from the locomotive. (See figure 5.)

Figure 5.--Damage to coaches typical for each train.

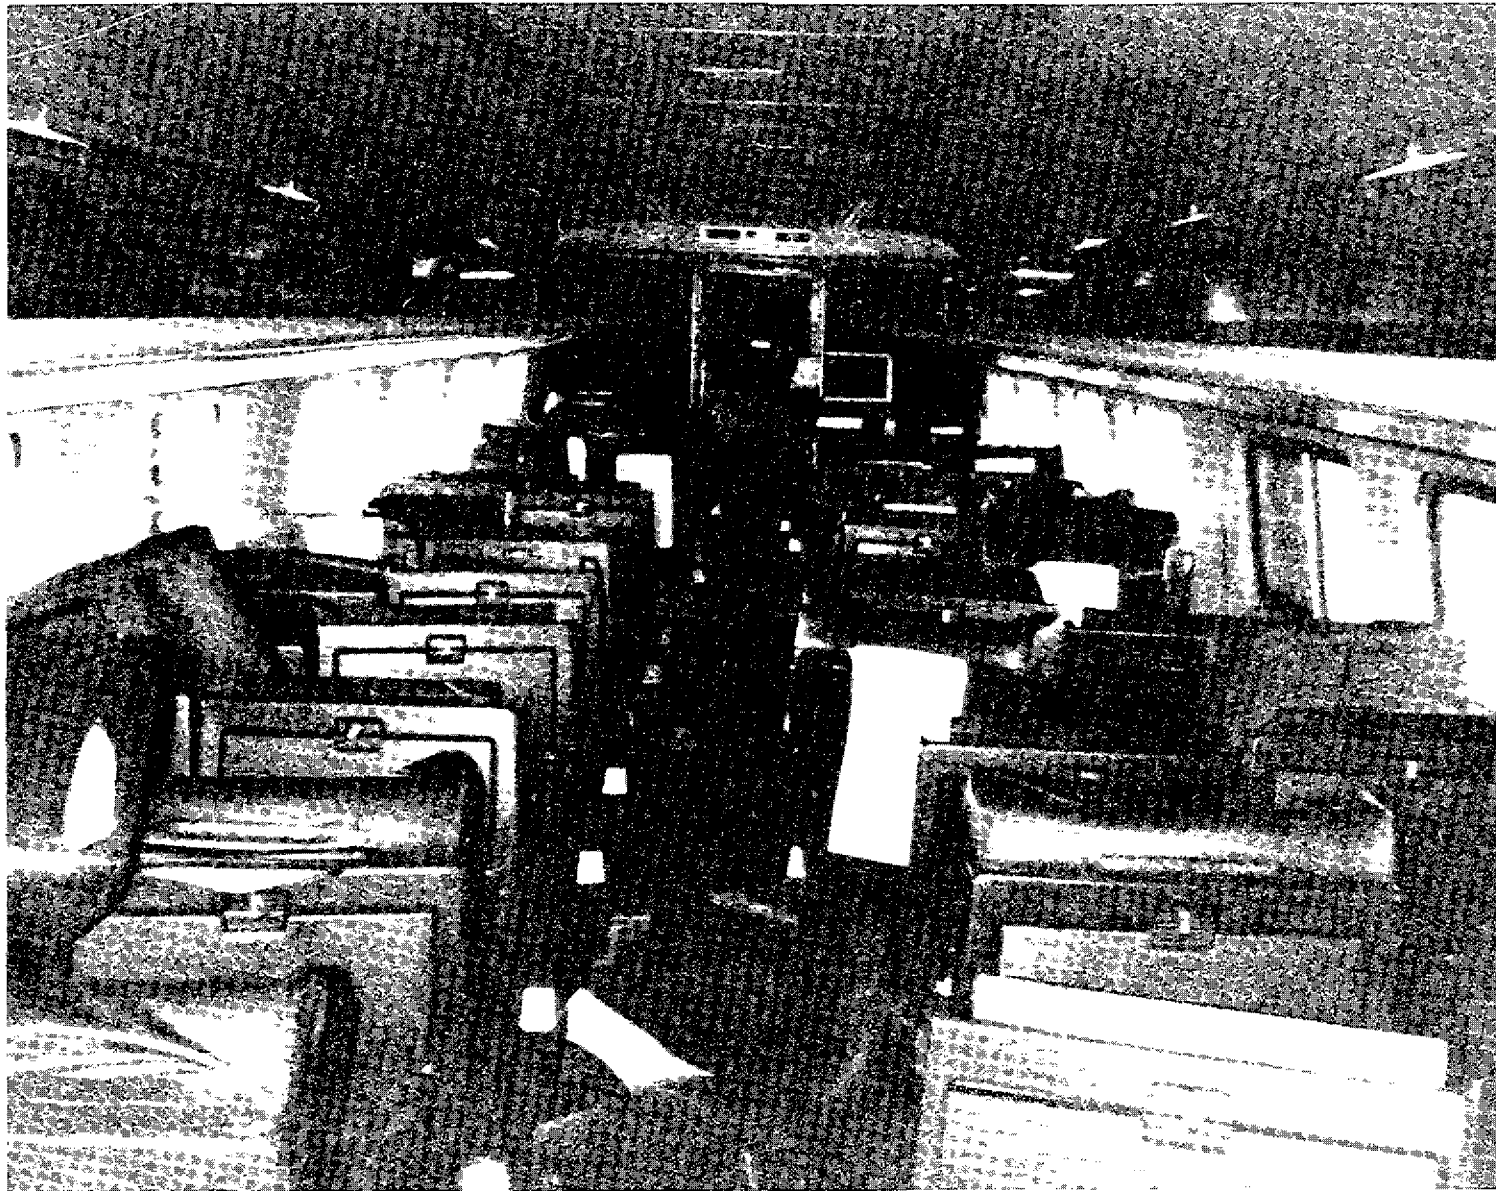
A large number of seat locking devices, which prevent seat rotation, were broken in the first and second head cars of train No. 151 and the first, second, third, and fourth head cars of train No. 168. The majority of the two-person seats had rotated. There were reports of some windows being knocked loose from their casings because of the impact forces. (See figure 6.)

Figure 6.--Interior view of typical coach disarrayment and condition.

The seat tracks were designed for a 5 G longitudinal force, which is more than the force which will pitch an unrestrained passenger from a seat. None of the seat tracks came loose even on the first two cars behind the locomotive where the greatest forces occurred. There was movement of the seats due to rotation, however.

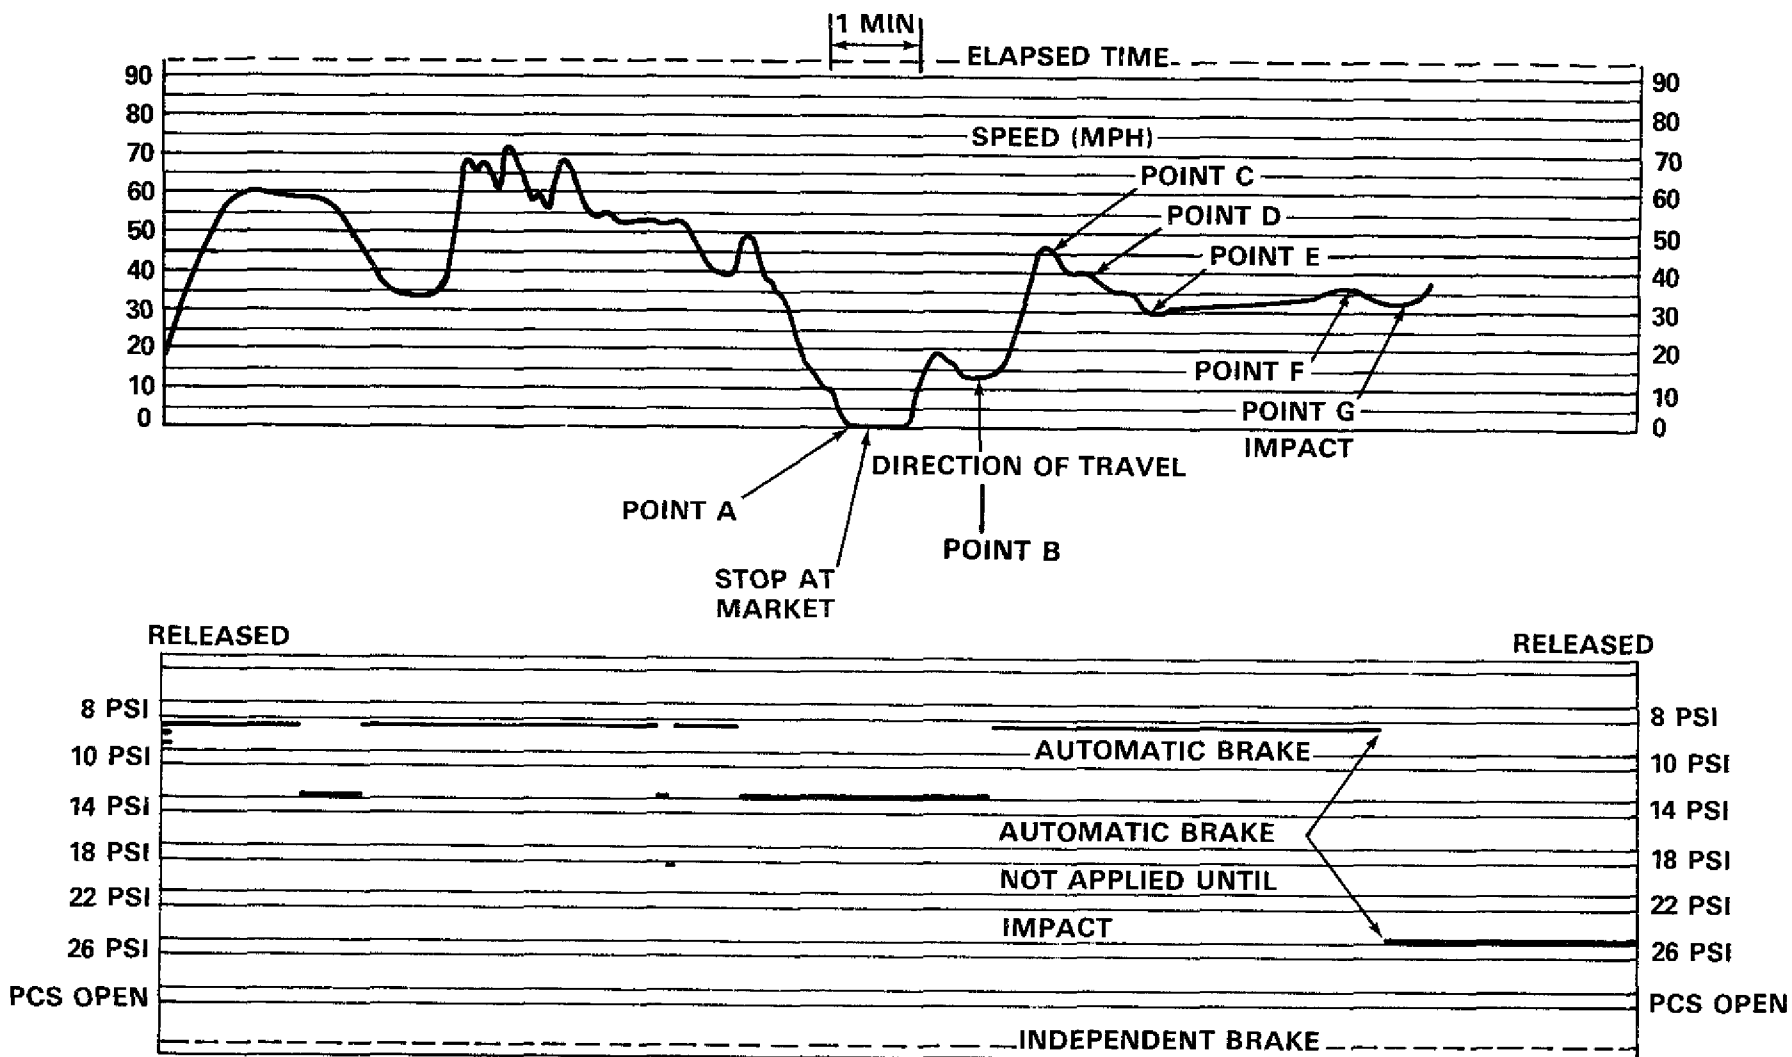
Speed Tapes from Train No. 151.--The speed tape from locomotive No. 936 train No. 151 was produced from a Pulse Electronics, Inc. cassette event recorder. (See figure 9.) The tape indicates that train No. 151 stopped at MARKET for the stop signal, point A, and that it slowed to receive the train order, point B. The speed recorder indicates that after the train left MARKET, the engineer accelerated the train to about 45 mph, point C. At MP 9.09, there is a 1° right curve westbound with a 30-mph

Figure 9.--Speed tape for train No. 151.

permanent speed restriction. The acknowledgement of the 30-mph speed restriction is not shown. The speed was reduced to about 40 mph, point D, which continued to decrease to about 30 mph, at point E. From point E, the speed gradually increased to about 36 mph, at point F. The speed then decreased to about 30 mph, point G, the point of the collision. The elapsed time for train No. 151 between MARKET and the collision point was about 5 1/2 to 6 minutes.

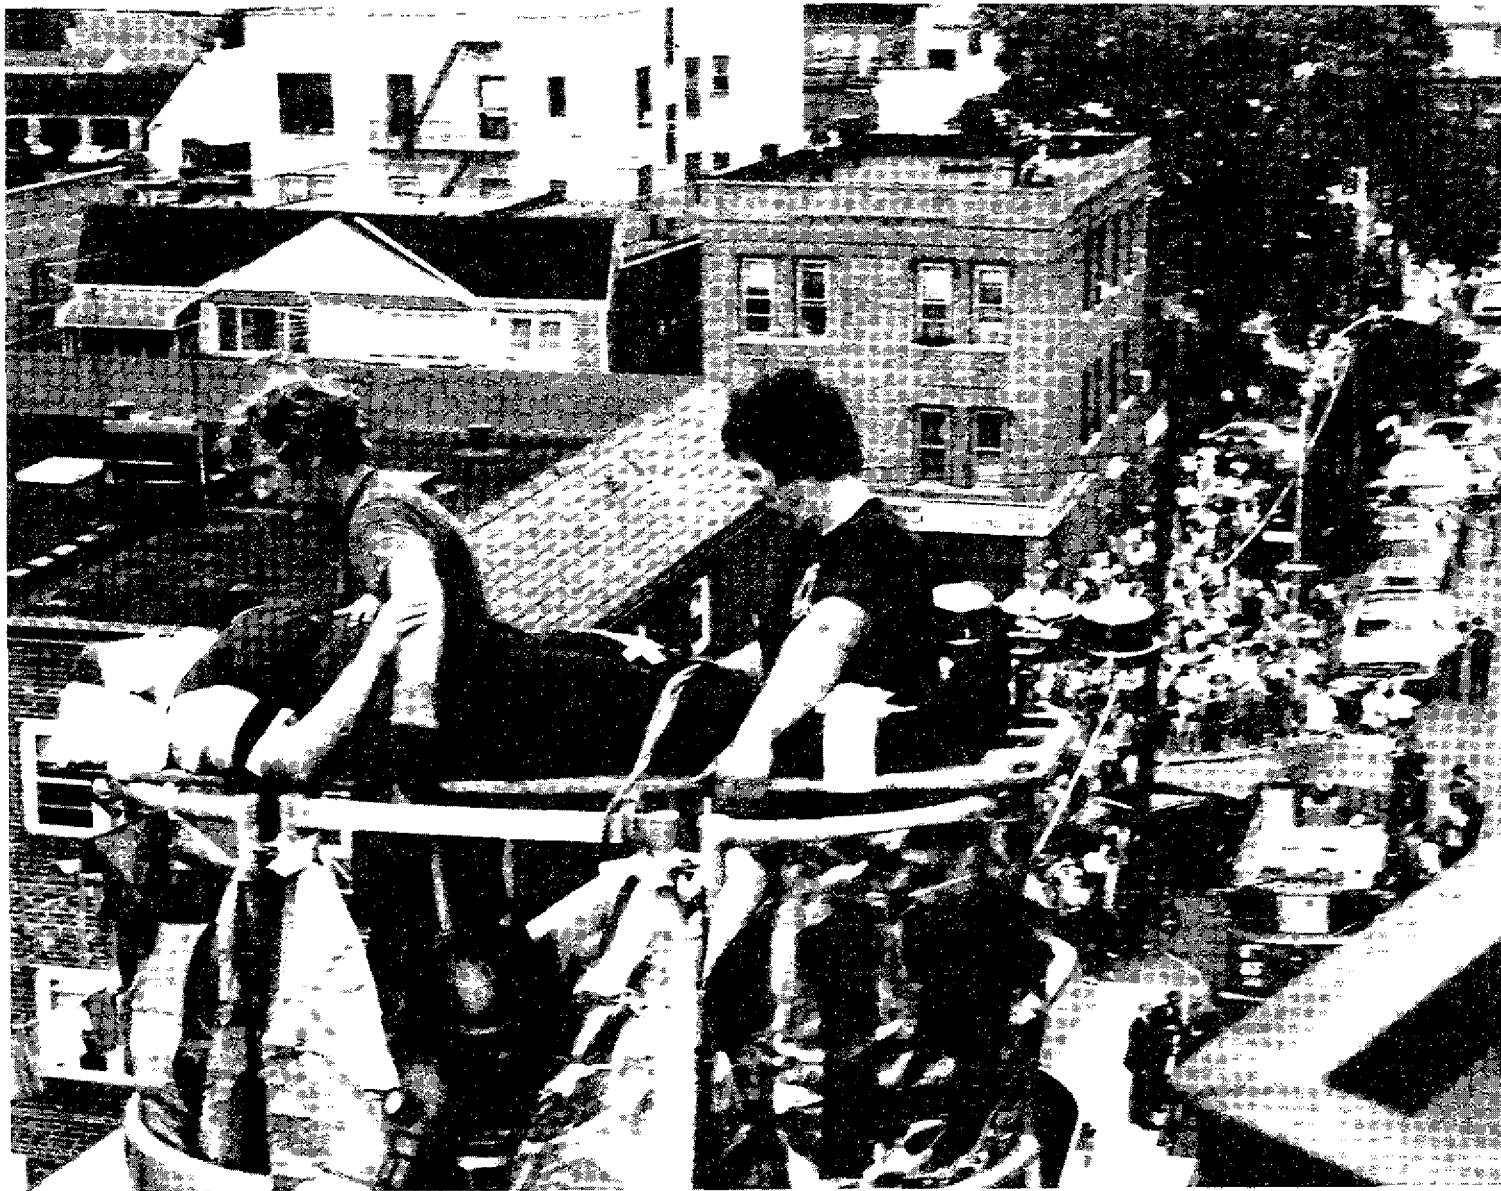
Emergency response personnel pooled their resources to facilitate the removal of injured passengers. In coaches with heavy end damage, windows were removed and passengers were taken out through the window openings. There was no difficulty reported in removing the windows. Some passengers were lowered to the street using "cherry pickers" (see figure 11) and tower ladders. Three triage ^{20/} centers were established

Figure 11.--Injured passengers being removed from the 80-foot viaduct by rescue workers.
