# Worker Deaths by Electrocution

## A Summary of Surveillance Findings and Investigative Case Reports

## **A Summary of NIOSH Surveillance and Investigative Findings**

**DHHS (NIOSH) PUBLICATION No. 2000-115**

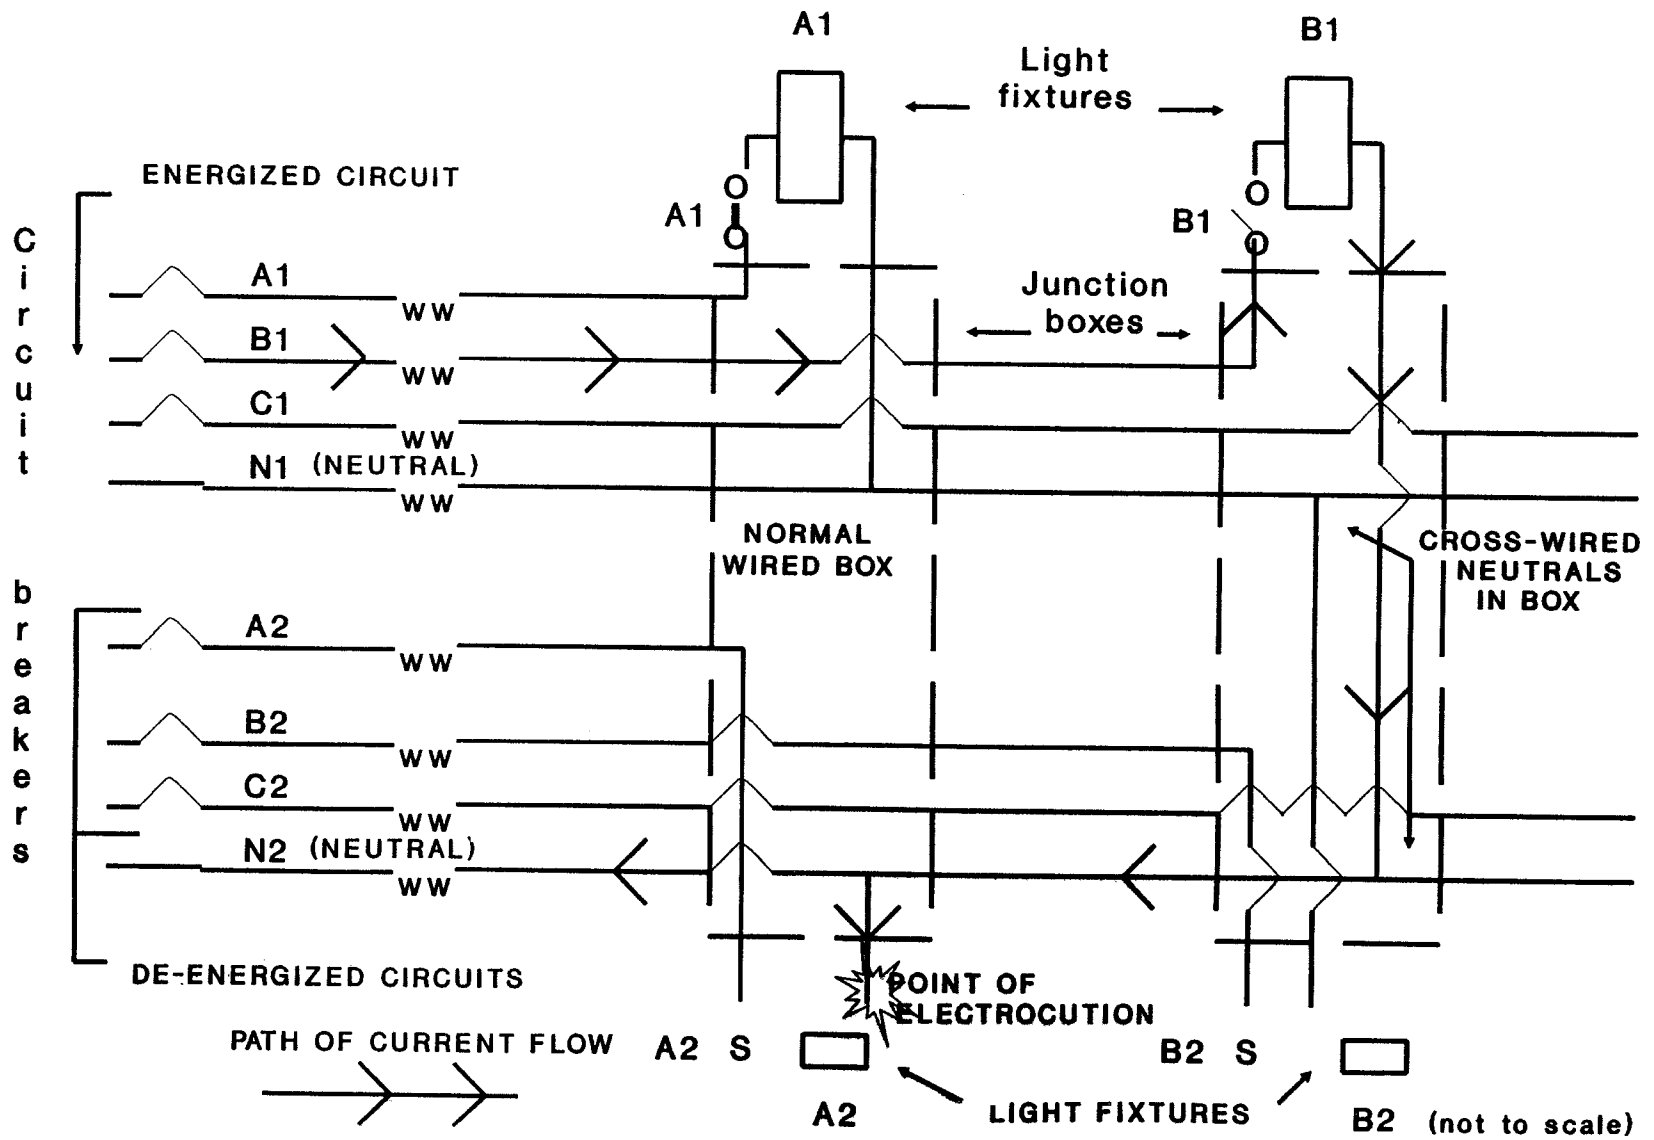
Figure. Cross-wired Neutrals

Discussion: Since the revisions to the blueprints were being sent directly to the jobsite, the contractor did not have a chance to review the modifications. For this reason, the supervisor at the jobsite should review all the revisions to the system to identify potential hazards. The changes were being made on blueprints, with small sections of the marked-up blueprint being sent by FAX machine to the jobsite. Some of these changes involved rewiring connections in various junction boxes. As a result of the rush nature of the job and the many design changes, the potential for error was increased. The evaluation of the changes by the jobsite supervisor might have identified areas where potential electrical hazards could exist, such as areas where connections were to be rewired. Once these areas were identified, they should have been carefully inspected to ensure proper wiring techniques.

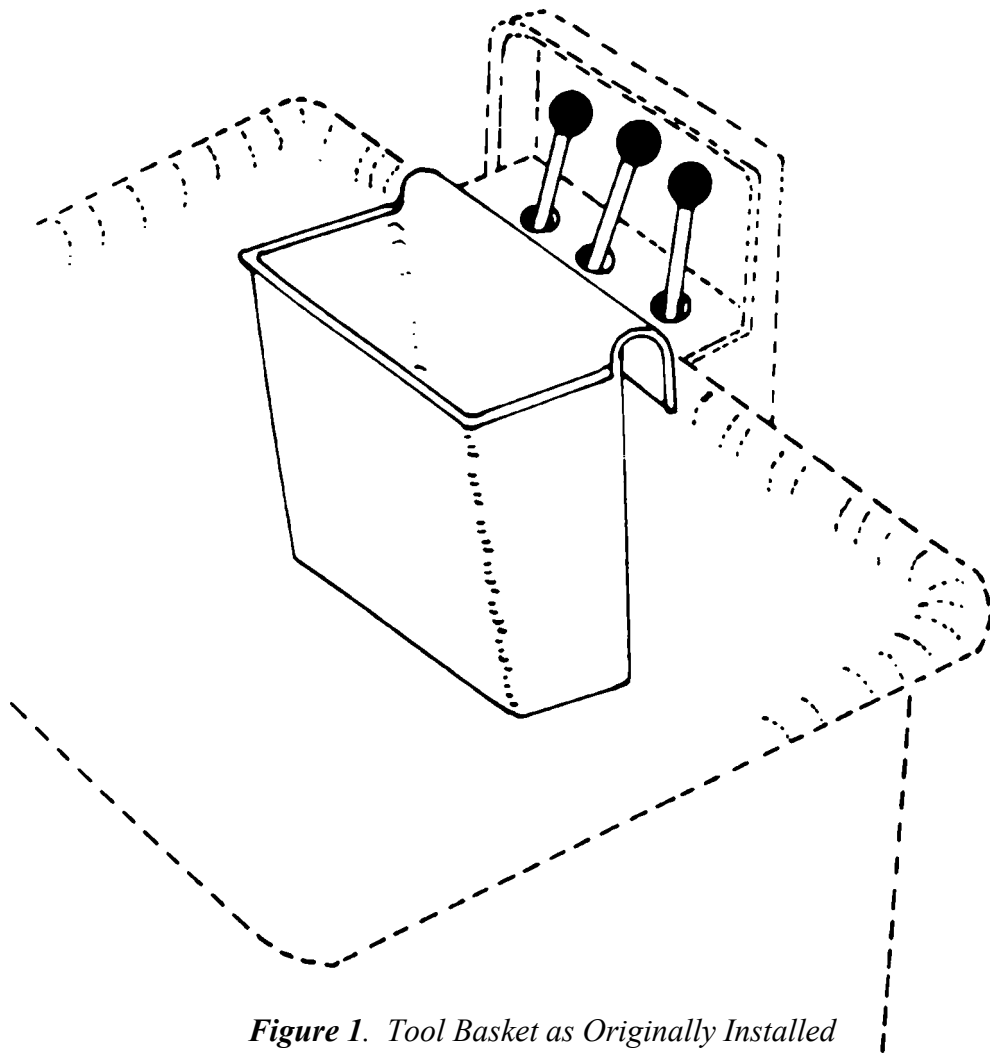
*Figure 1. Tool Basket as Originally Installed*

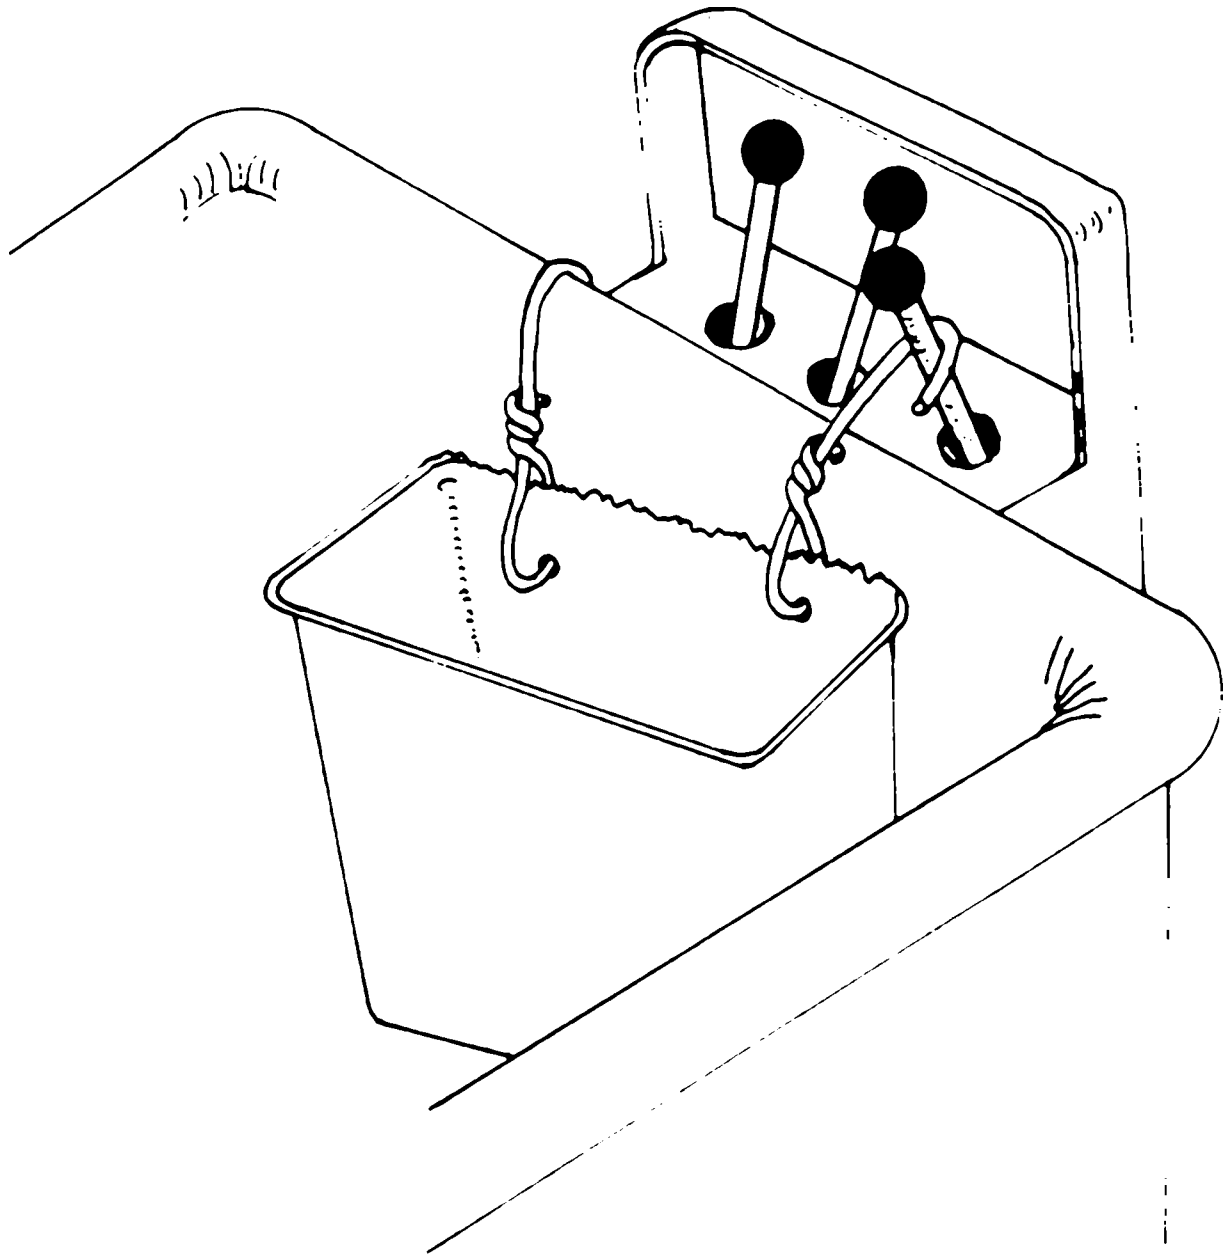
*Figure 3. Position of Tool Basket at Time of Incident*

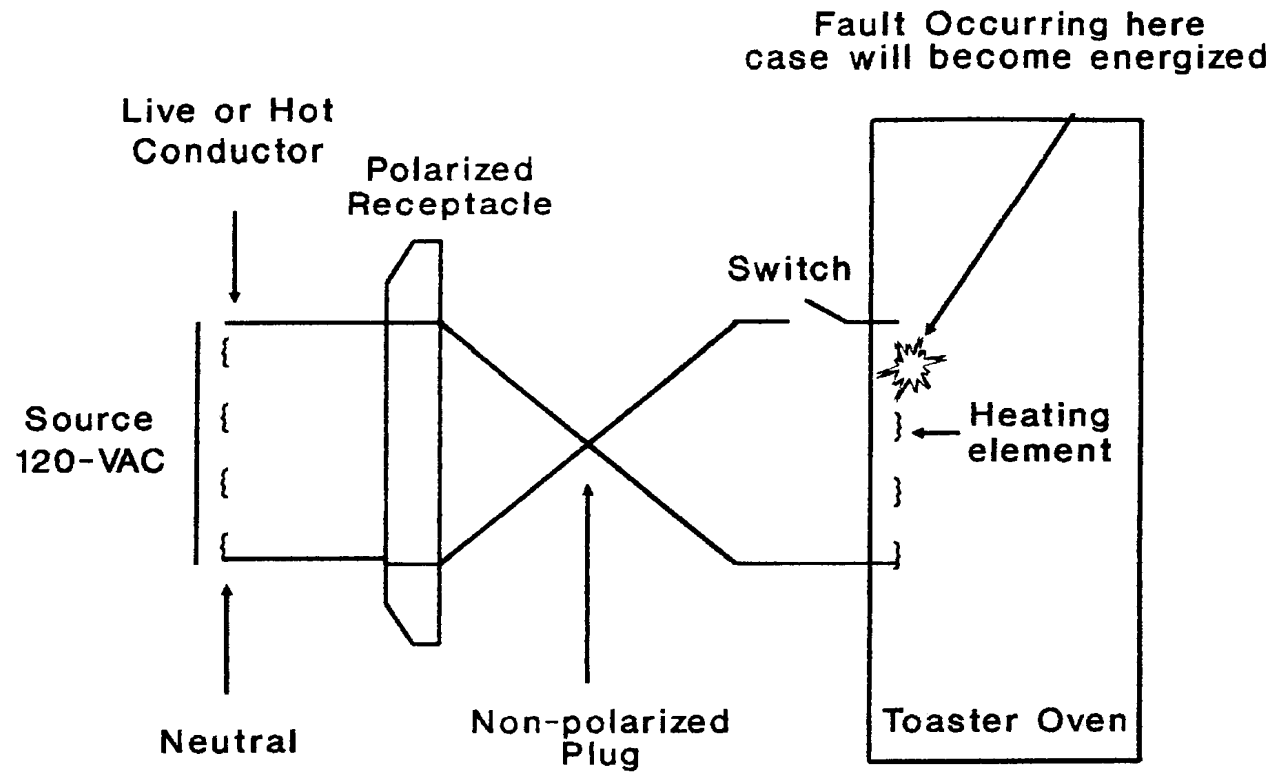
When the Live/hot conductor and Neutral wire are reversed, the current path is also reversed.

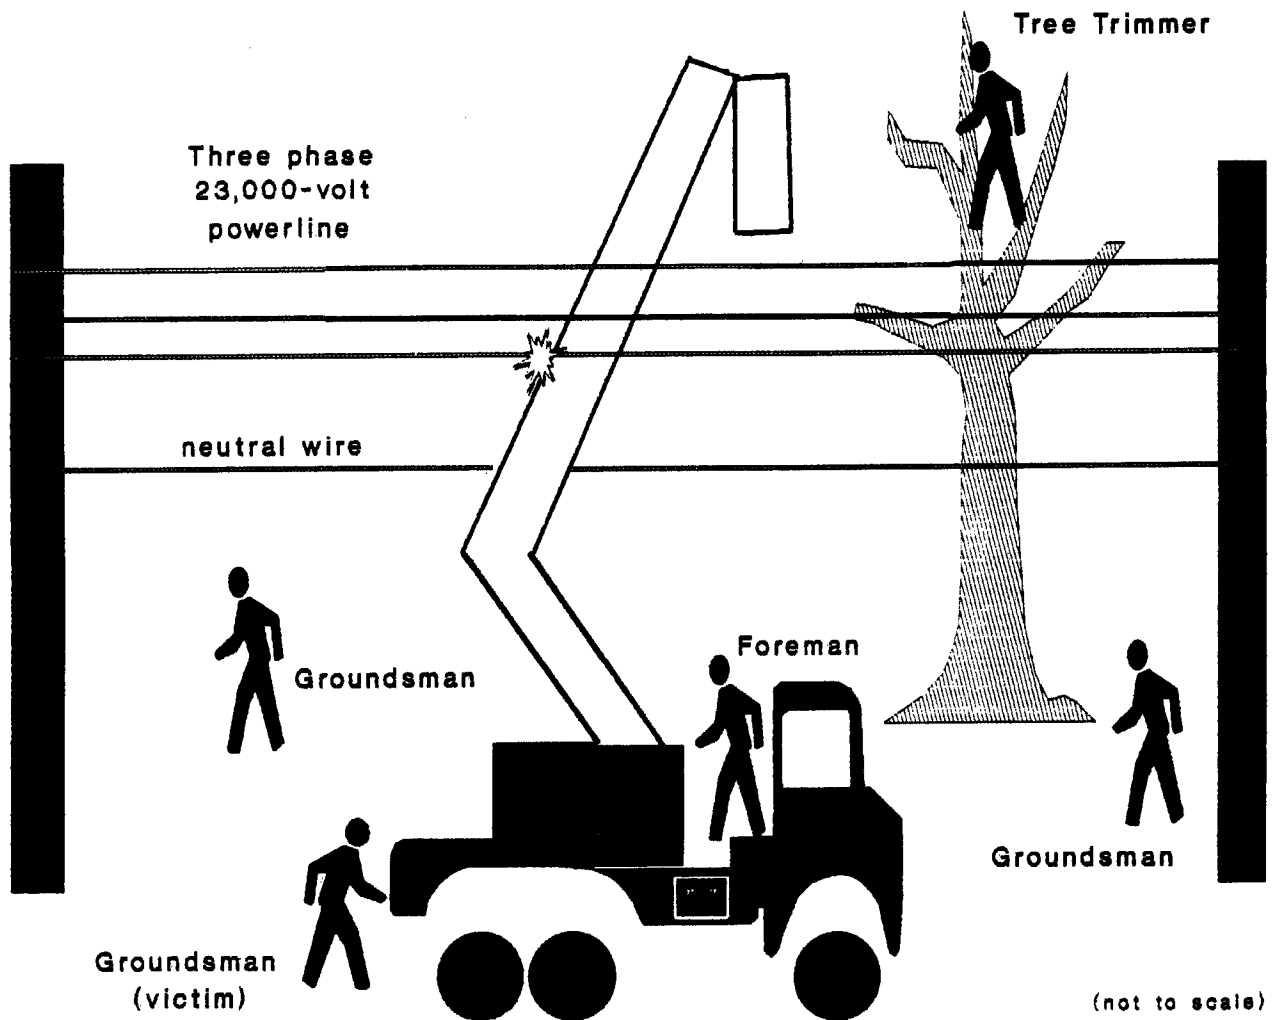
*Figure 2. Tree Trimming Operations  
Boom Contacting Powerline*

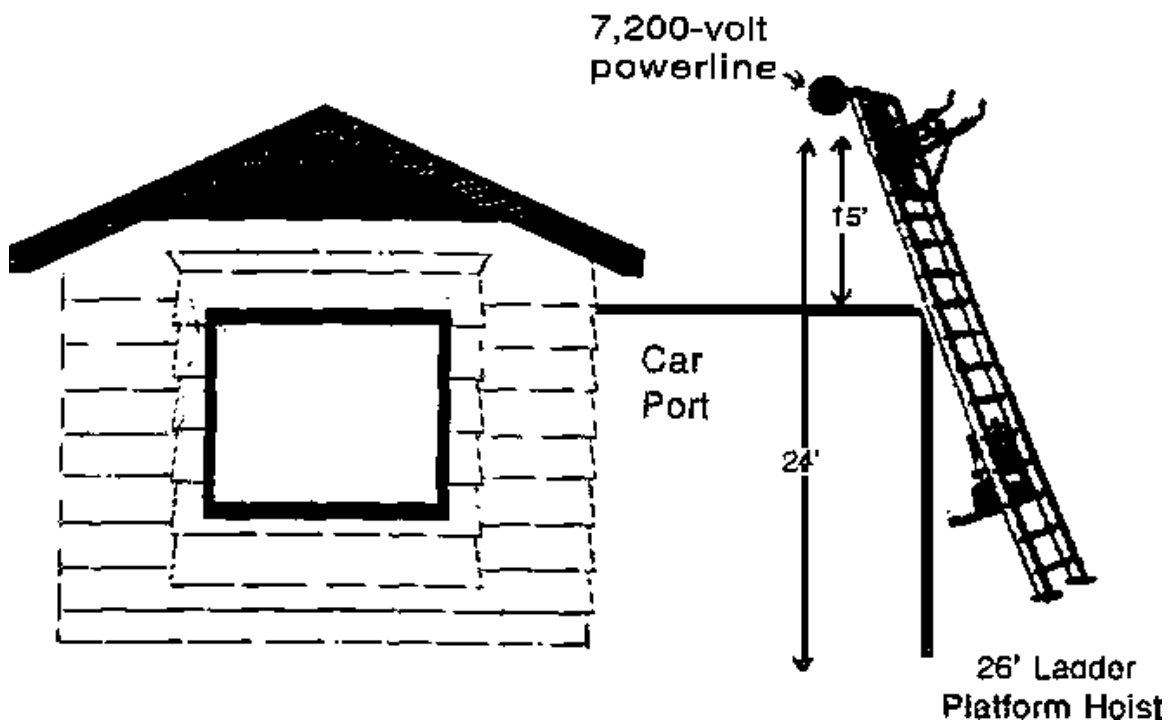
*Figure. Ladder Platform Hoist Contacting Overhead Powerline at Private Residence*

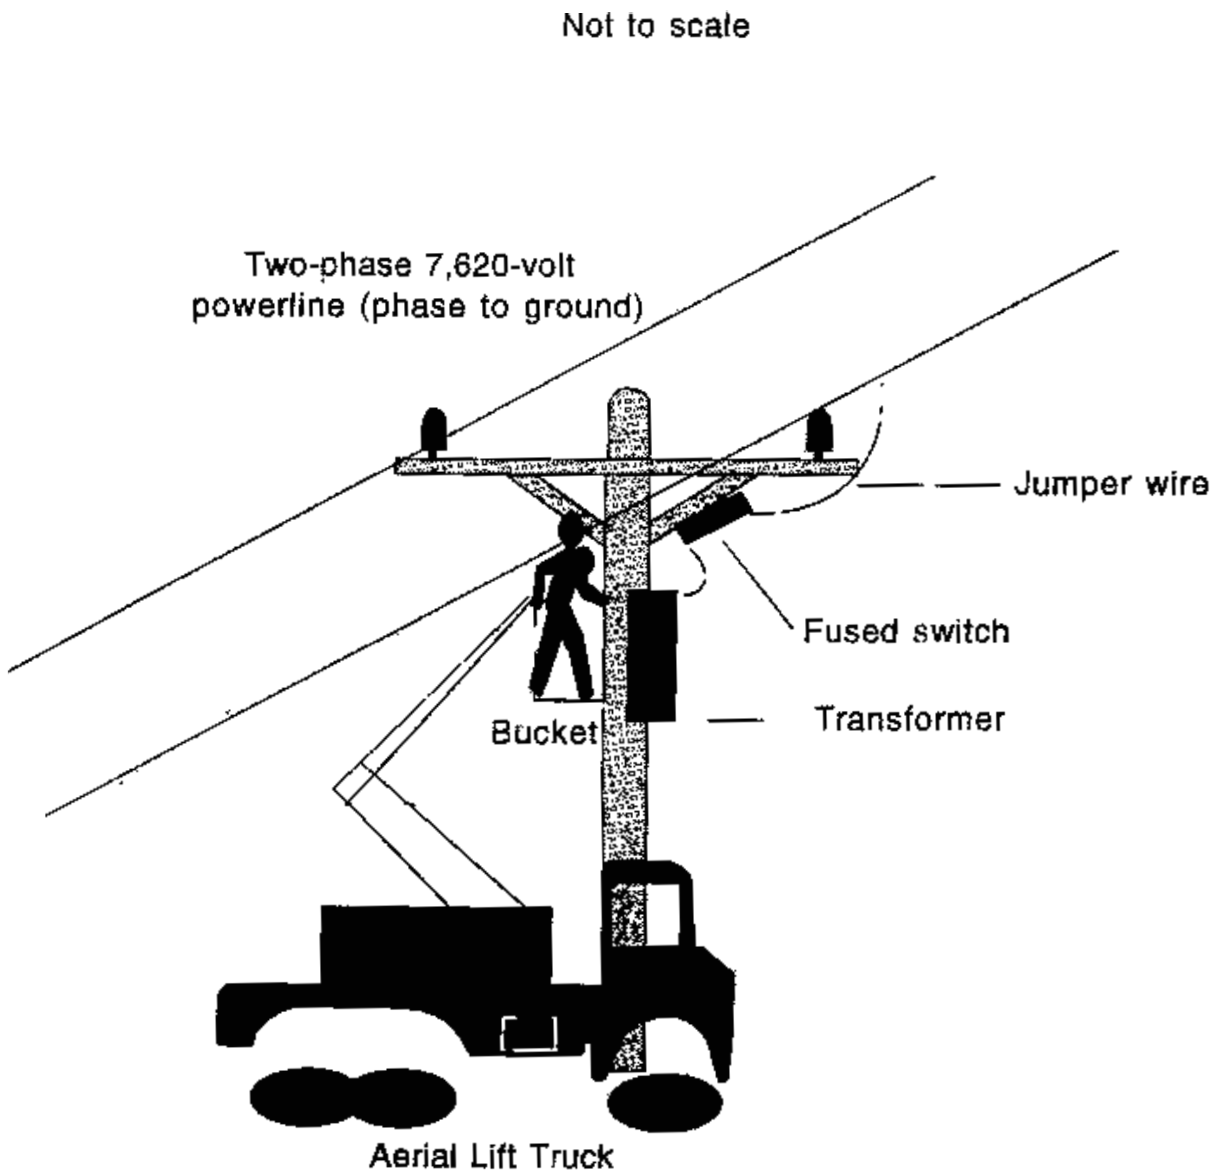
*Figure. Worker Contacting Overhead Powerline*
