# AIRCRAFT ACCIDENT REPORT

EASTERN AIR LINES, INC  
DOUGLAS DC-8, N8607  
NEW ORLEANS, LOUISIANA  
FEBRUARY 25, 1964

## SYNOPSIS

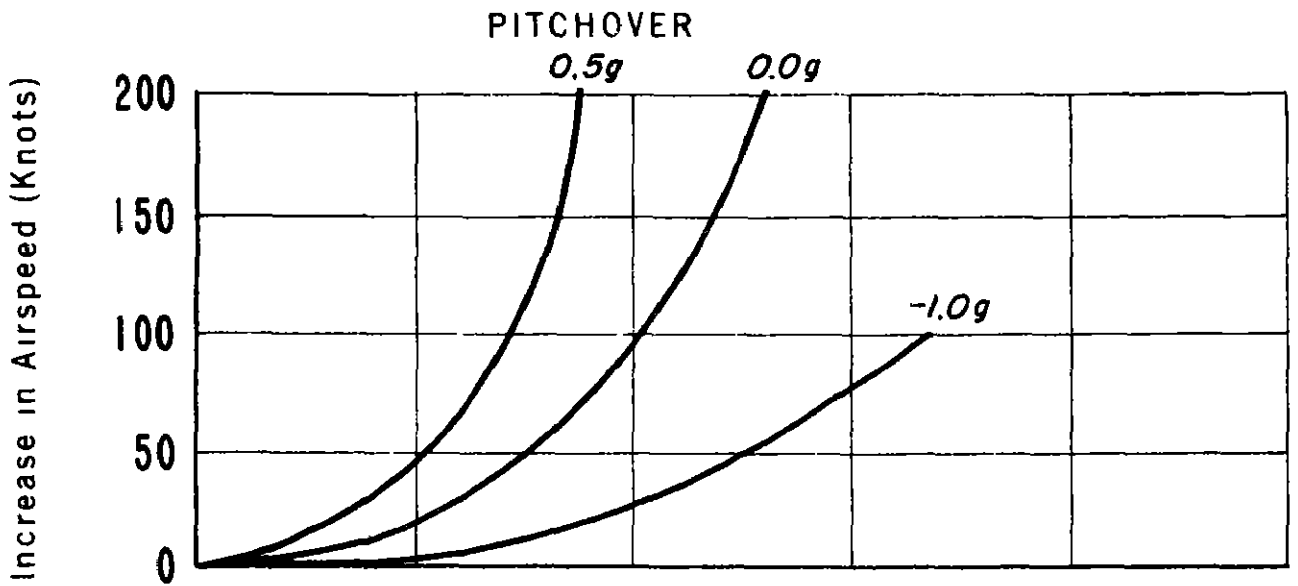
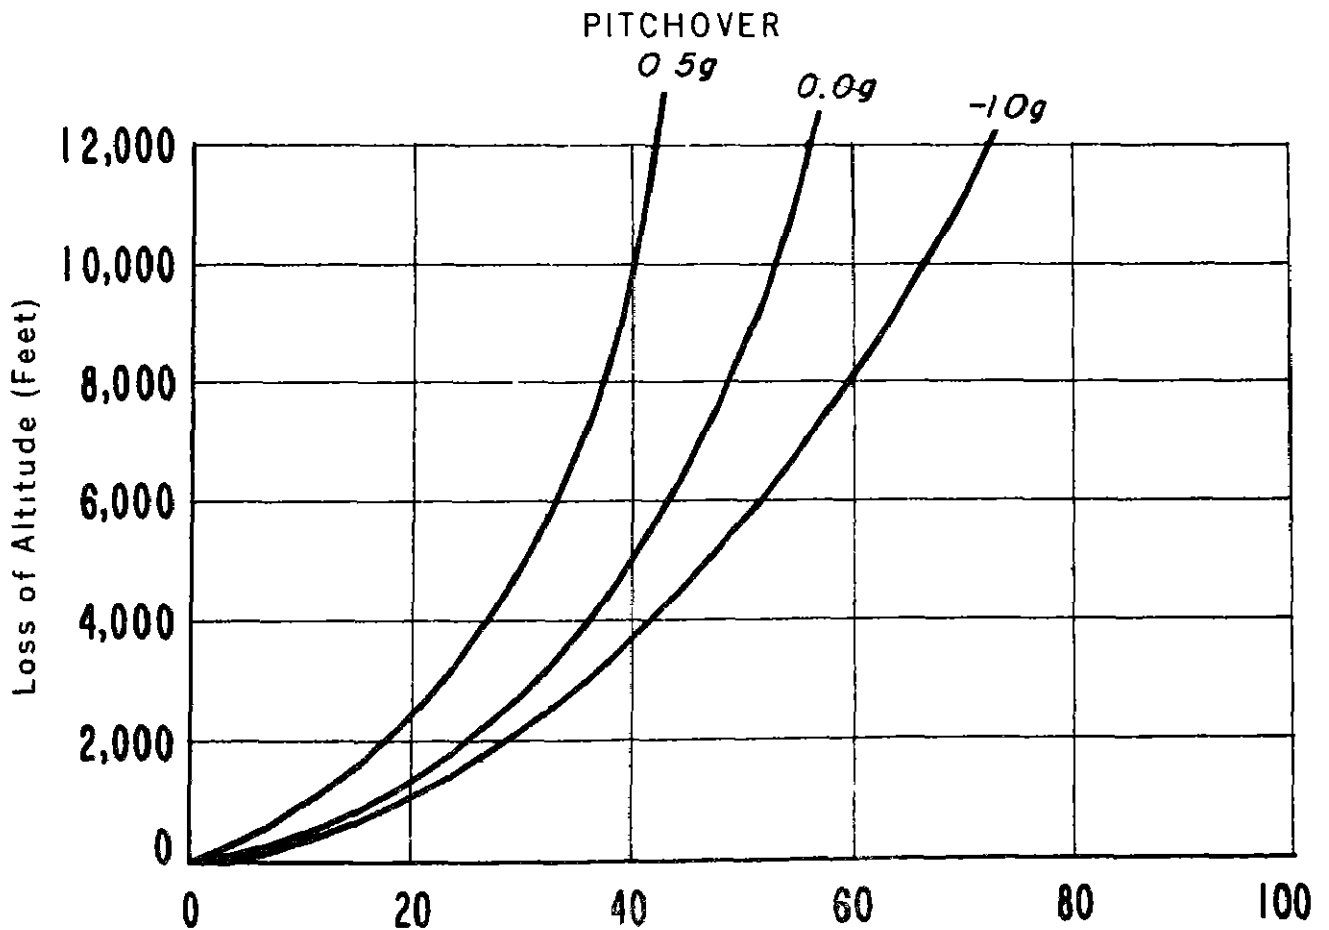
# ATTACHMENT D

Airspeed Gained and Altitude Lost in a Pitchover Maneuver to a Dive Angle, Followed by a 2 0-g Pull-up to Level Flight
