✓ " RAILROAD ACCIDENT REPORT "

✓
" HEAD-ON COLLISION OF NATIONAL RAILROAD
PASSENGER CORPORATION (AMTRAK)
PASSENGER TRAINS NOS. 151 AND 168
ASTORIA, QUEENS, NEW YORK, NEW YORK
JULY 23, 1984

✓
NTSB/RAR-85/09.

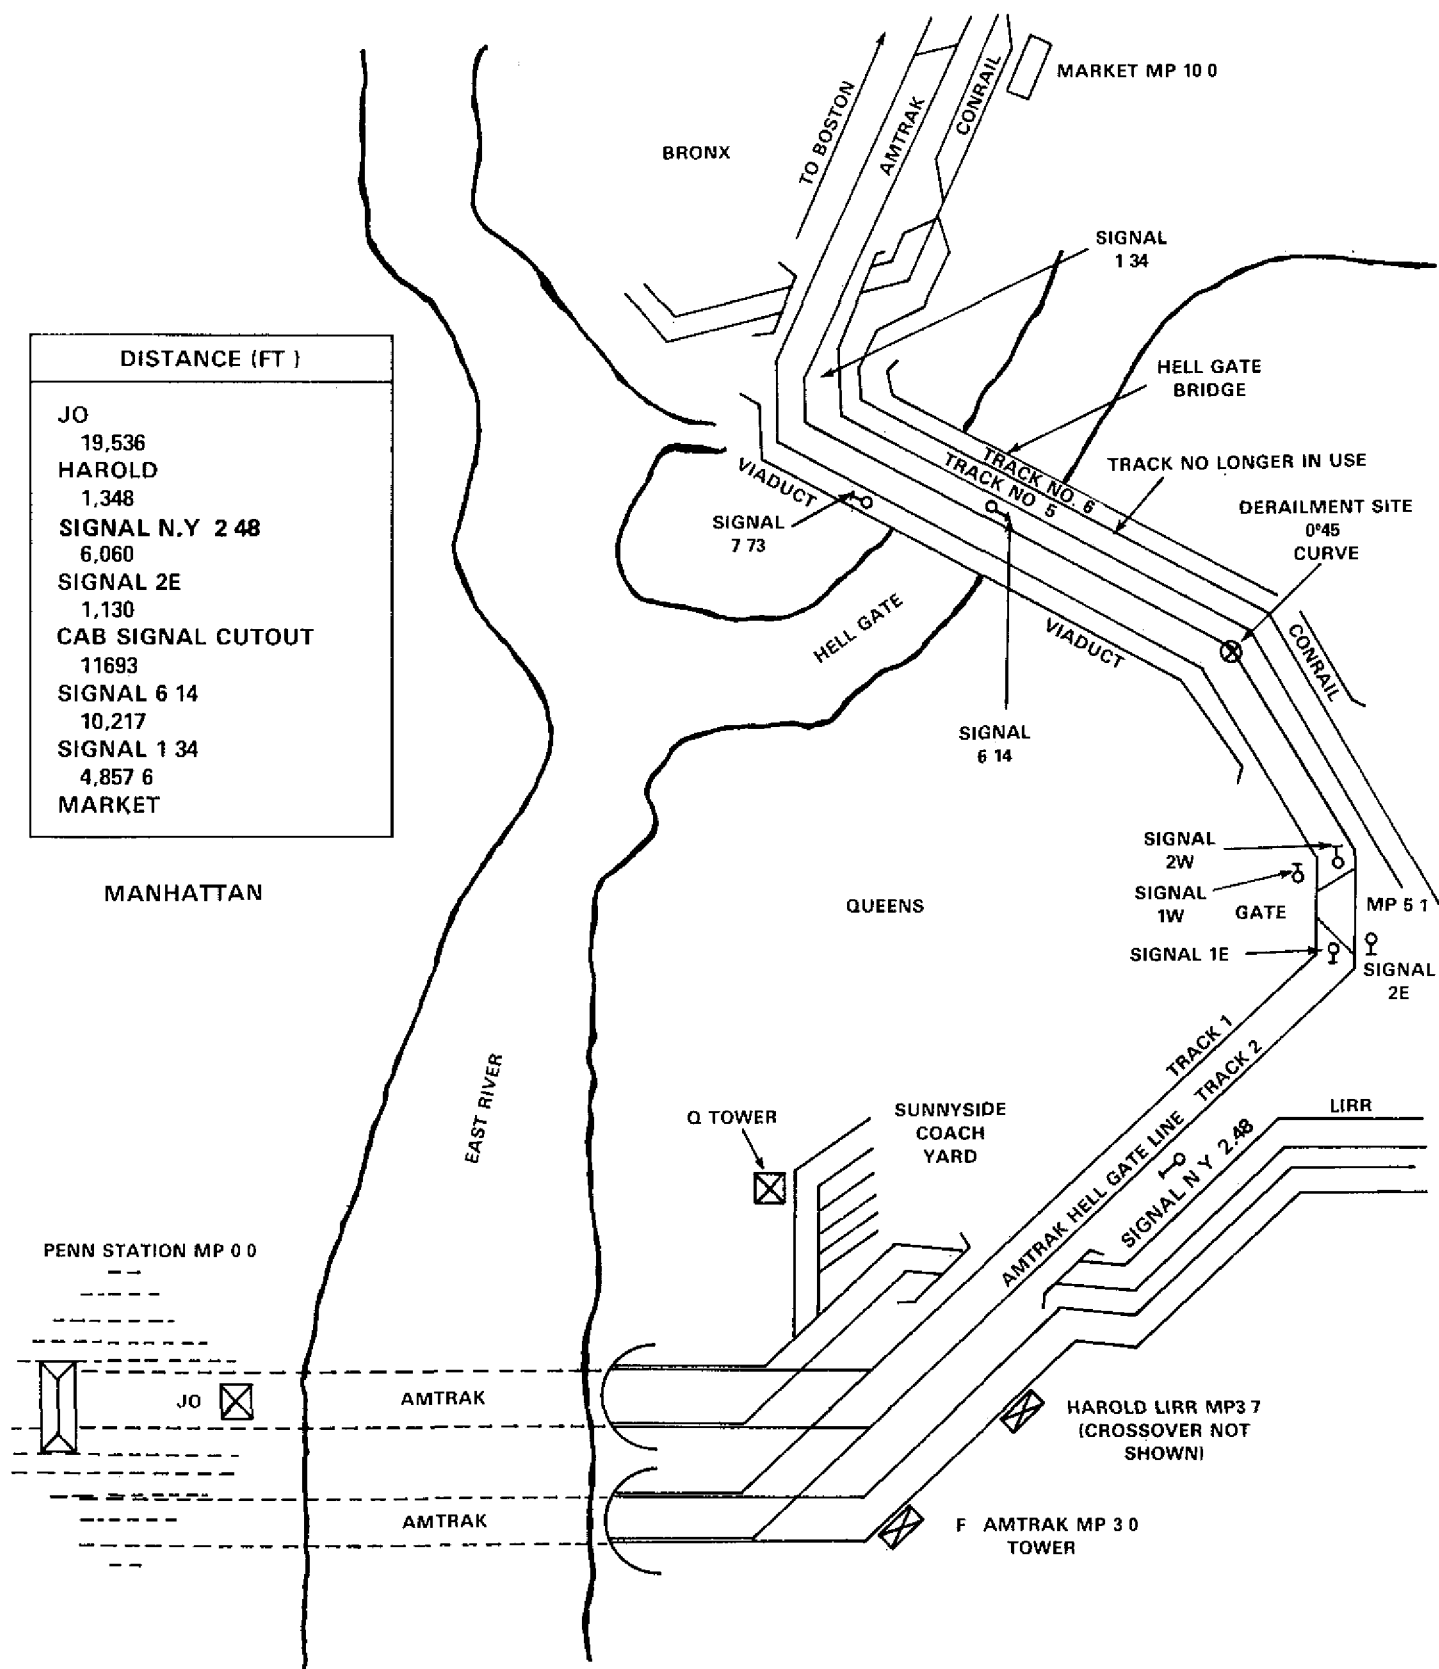
Figure 1.--Amtrak's Hell Gate Line
Penn Station to MARKET Interlocking showing the mainline only.

is a locally controlled interlocking facility and is manned 24 hours per day. Trains normally are operated westbound by wayside signal indications on the No. 1 main track and eastbound by wayside signal indications on the No. 2 main track. 2/ (See figure 1.)

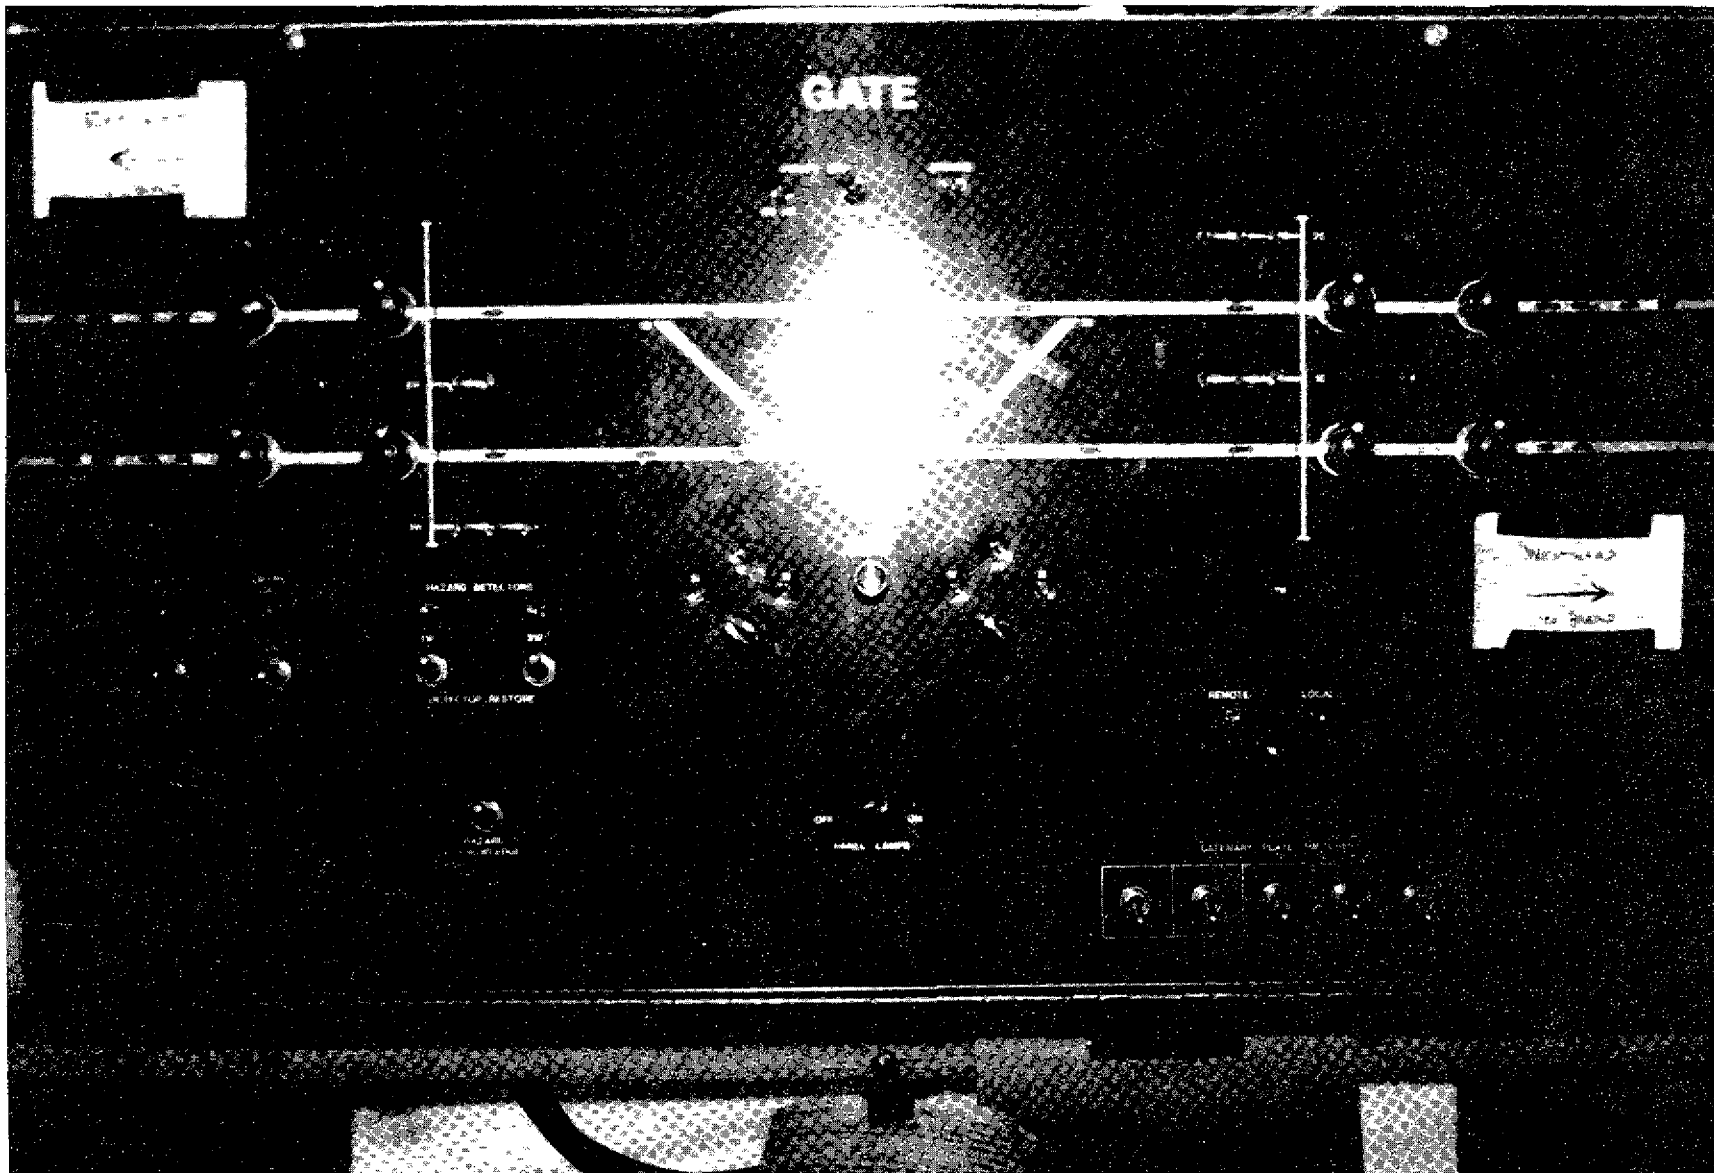
Figure 8.--Gate control panel. (Hand written labels not applied by the Safety Board.)

The operator at F Tower cannot see the interlocking facilities at GATE which he remotely controls and operates. GATE Interlocking consists of two crossovers between tracks Nos. 1 and 2 and four signals. The remote control panel is equipped with four signal control buttons, four control buttons for panel blocking devices, two switch control levers, some propulsion control levers for future application, several other nonvital control functions, and various indication lights. (See figure 8.)

Panel Blocking Device.--When a PBD at GATE is activated, the operator cannot operate any signal to cause it to indicate a proceed aspect over a route that would lead onto the blocked track. The activated PBD does not block switches, only signals. The activated PBD opens the signal control circuit for any route onto the blocked track so a proceed signal cannot be displayed.

An event recorder for monitoring operations at GATE has been placed in service since July 23 and similar equipment is planned for other interlockings in the Northeast Corridor to record and preserve a record of the times and movements made at interlocking locations. Also, a redundant blue light to indicate a PBDA has been installed on the GATE control panel since the operator involved in the accident and others had experienced some difficulty in seeing the single blue indicator light.

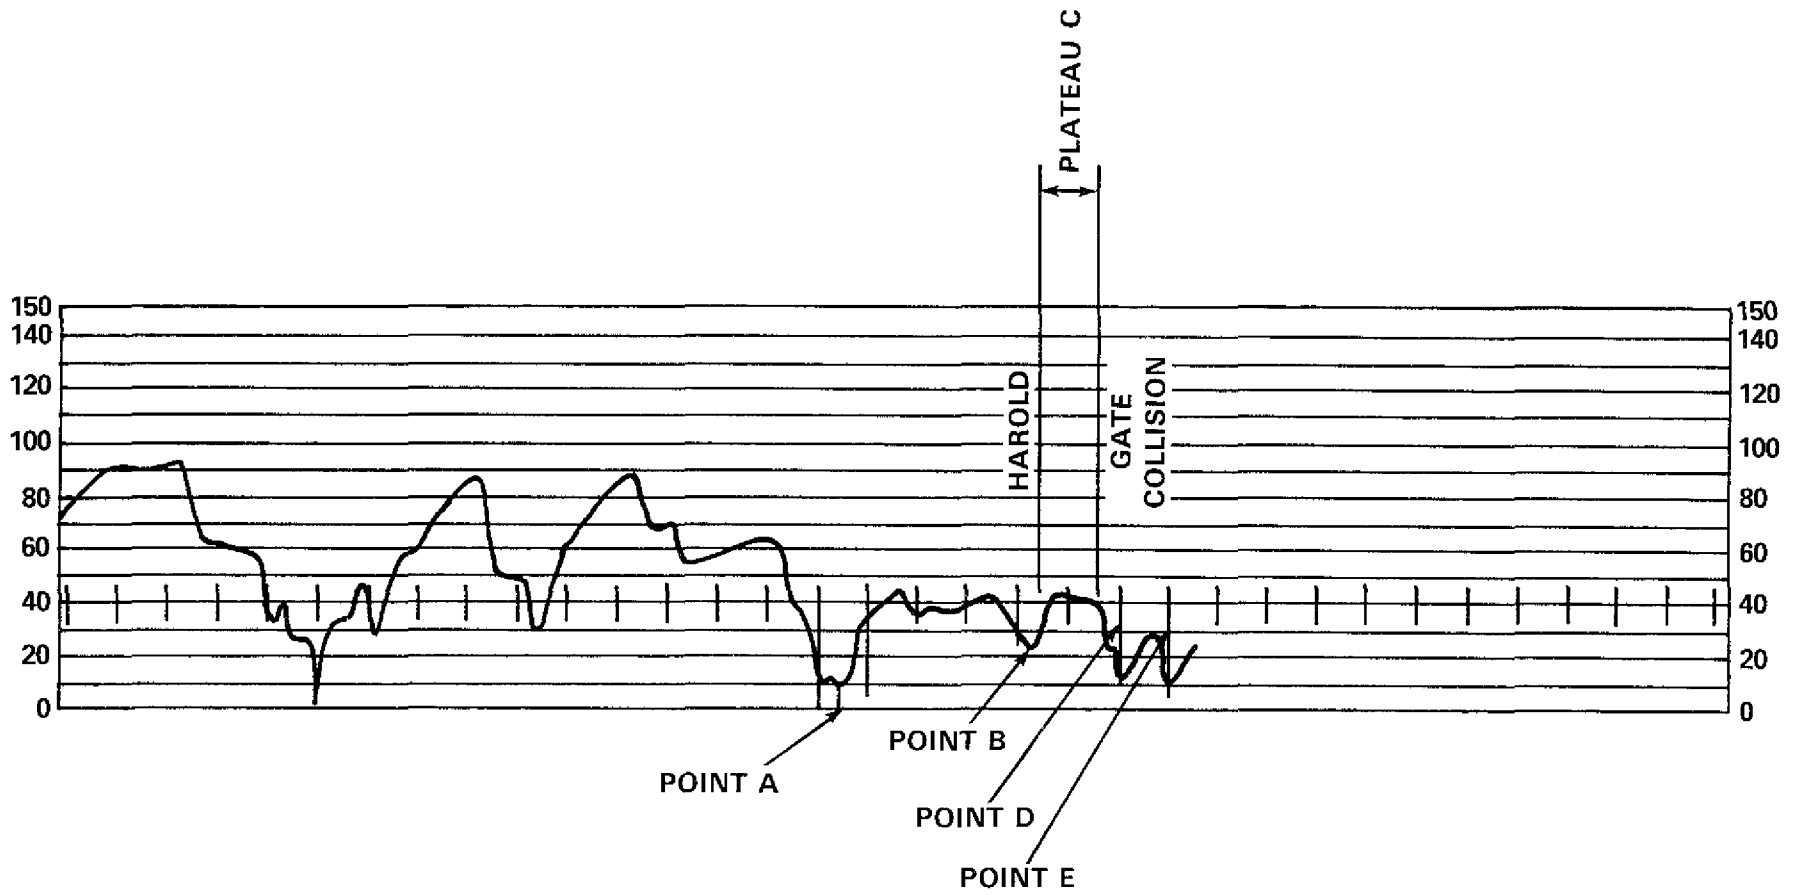
Figure 10.--Speed tape from train No. 168, July 23, 1984.

Speed Tape from Train No. 168.--The speed tape for train No. 168 was produced by a Barco speed recorder. (See figure 10.) The tape indicates that train No. 168 stopped in Penn Station, point A. Upon departing Penn Station, the train accelerated to a speed of about 45 mph, decelerated to about 40 mph, and then further decelerated to about 22 mph, point B. The 22-mph speed represents the speed at which train No. 168 was being operated through Harold Interlocking. After the train passed through Harold Interlocking, the speed was increased to about 43 mph which was maintained for about 1 mile, plateau C. After about 1 mile, the speed was decreased to about 12 mph in the vicinity of GATE, point D. After the train reached the 12-mph speed, the speed was increased to about 30 mph, point E, which was maintained for about 0.3 mile, to the point of the collision. The speed tape indicates a distance of about 6 miles from Penn Station to the collision point.

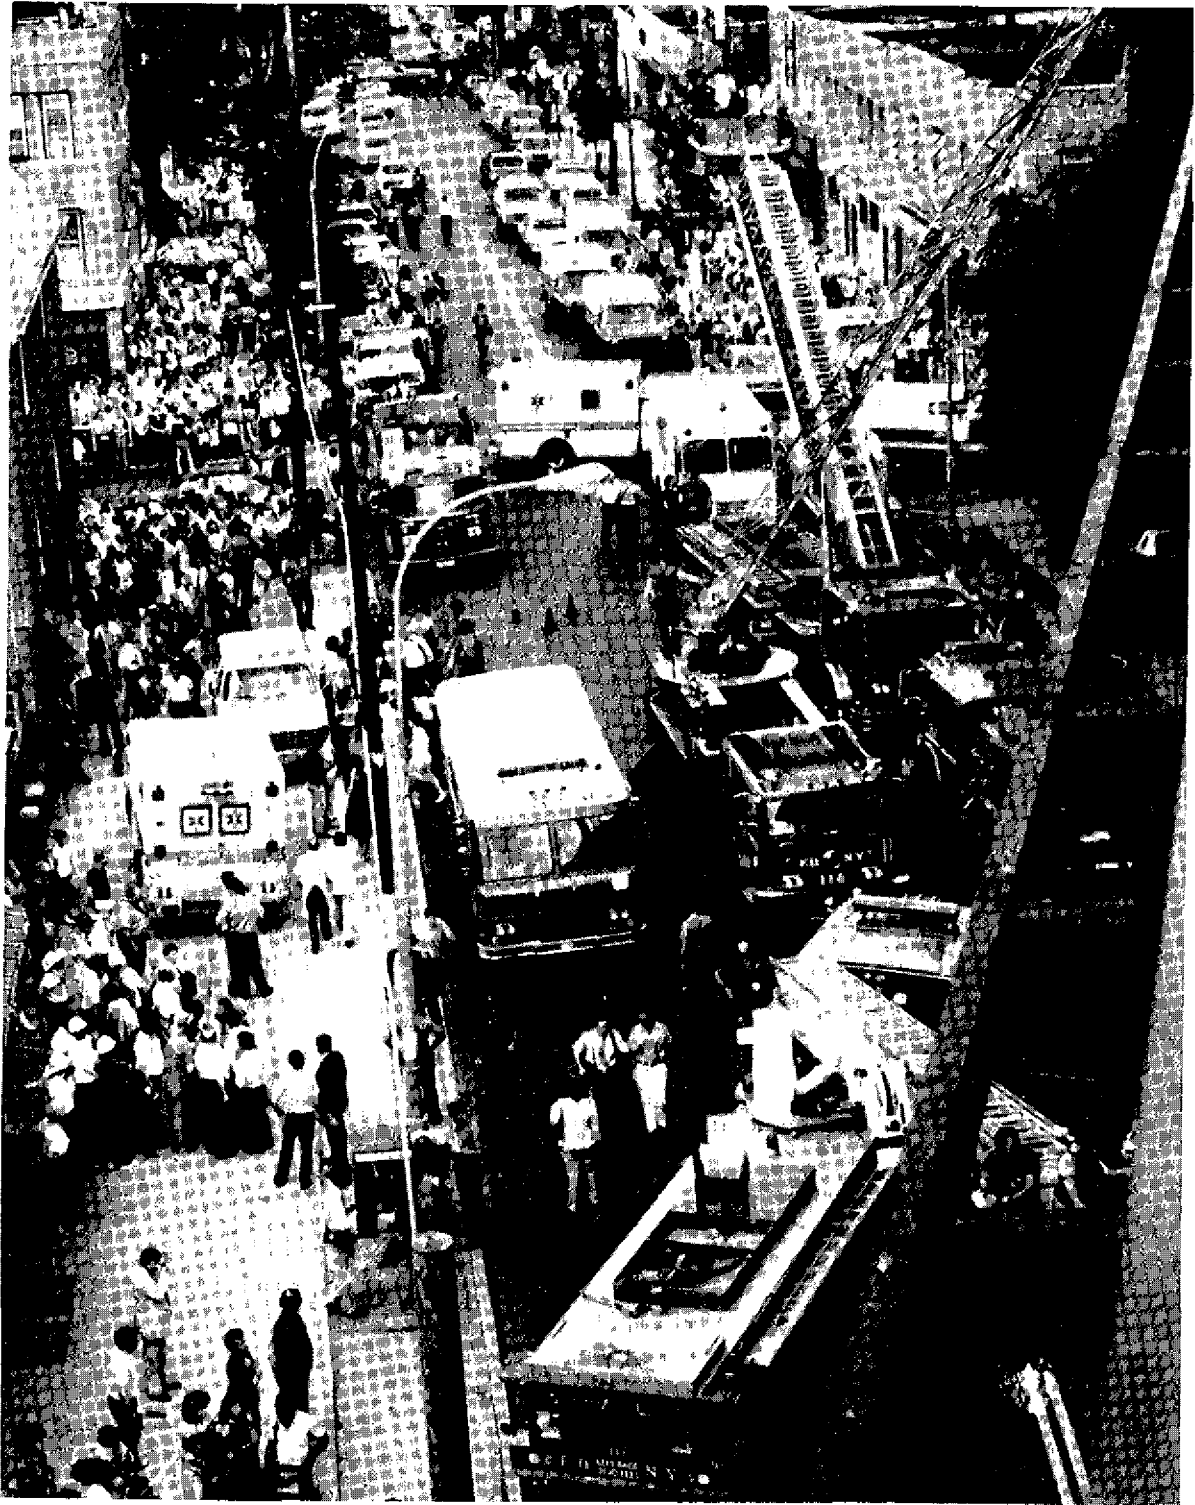
Figure 12.--Street scene below the viaduct at the accident site.

At the time of the accident, there was no formal disaster plan in effect between Amtrak and the New York emergency forces. Rescue efforts were hindered because some emergency response personnel carelessly parked and abandoned their vehicles, creating confusion in the streets below the wrecked trains. (See figure 12.) Also, emergency personnel were unfamiliar with Amtrak's catenary and power distribution system. Power was removed from the catenary system about 11 a.m. and restored over part of the impact area about 12:45 p.m. Power restoration and passenger removal was delayed because the Fire Department would not permit the restoration of catenary power until the request for restoral had been channeled through and approved by the Borough Alarm office. Both Amtrak and the Fire Department procedures require that the restoral of catenary power only be authorized by the same individual who asked for its removal.

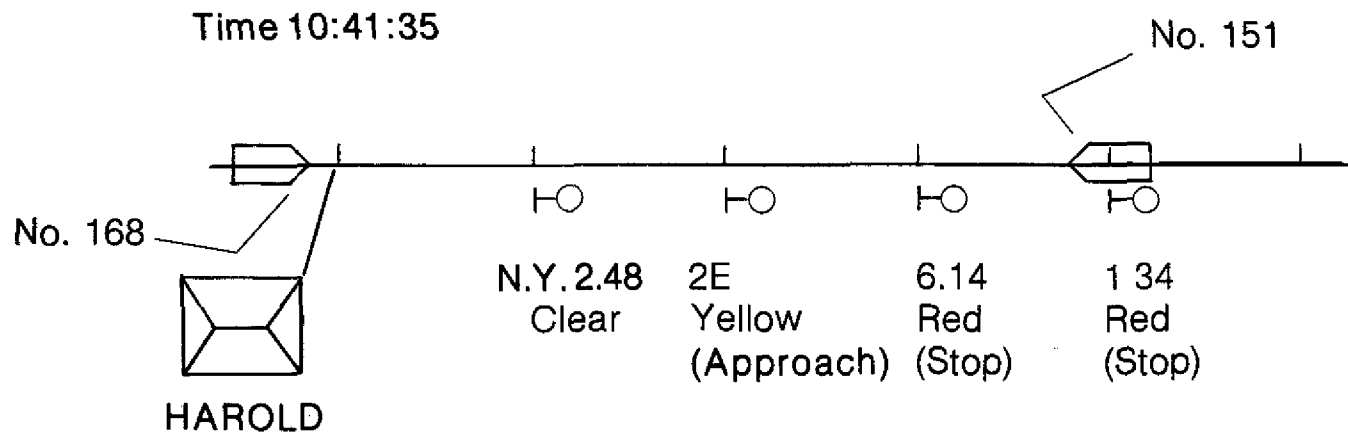
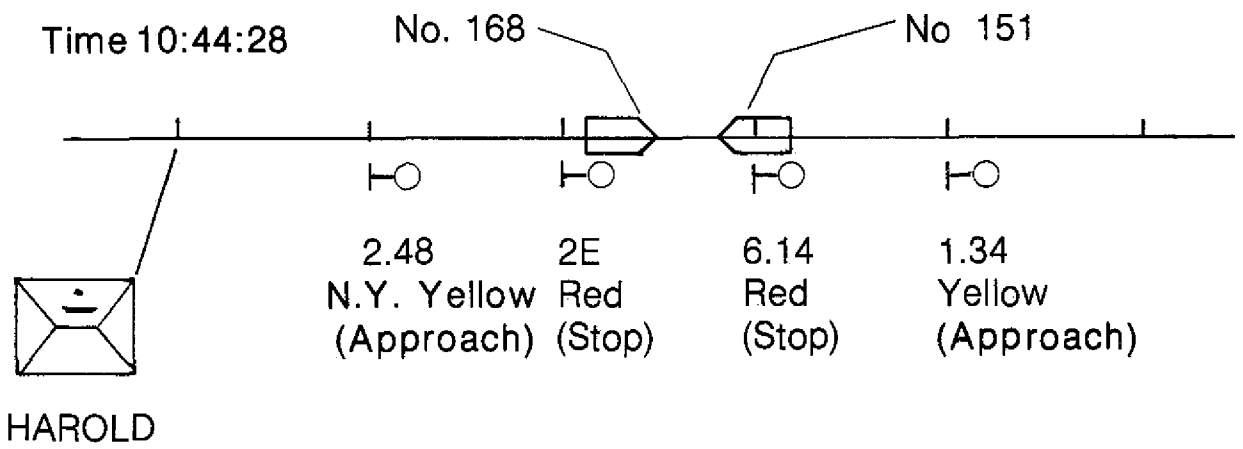
Figure 13.—Reconstruction of collision sequence.

Based on the time-distance calculations, when train No. 151 passed signal No. 1.34 about 10:41:35 a.m., train No. 168 would have been approaching Harold or passing through the interlocking. (See figure 13.) At that time, signal 2E at GATE should have displayed an approach aspect for train No. 168, and distant signal N.Y. No. 2.48 should have displayed a clear aspect.

When train No. 151 passed signal No. 6.14 about 10:44:28 a.m., signal 2E would have changed to stop, 28 seconds after train No. 168 passed signal 2E at GATE, and the engineer of train No. 168 would not have seen the change. Even if the timing was such that train No. 151 passed signal No. 6.14 before train No. 168 arrived at signal 2E, the change to stop could have been overlooked by the engineer as he was dealing with the move past the cab signal cutout point. If train No. 168 had passed the cab signal cutout point before train No. 151 passed signal No. 6.14, the cab signal aspect on the locomotive of train No. 168 would have changed from approach to restricting, either as a result of the
