# Worker Deaths by Electrocution

## A Summary of Surveillance Findings and Investigative Case Reports

## **A Summary of NIOSH Surveillance and Investigative Findings**

**DHHS (NIOSH) PUBLICATION No. 2000-115**

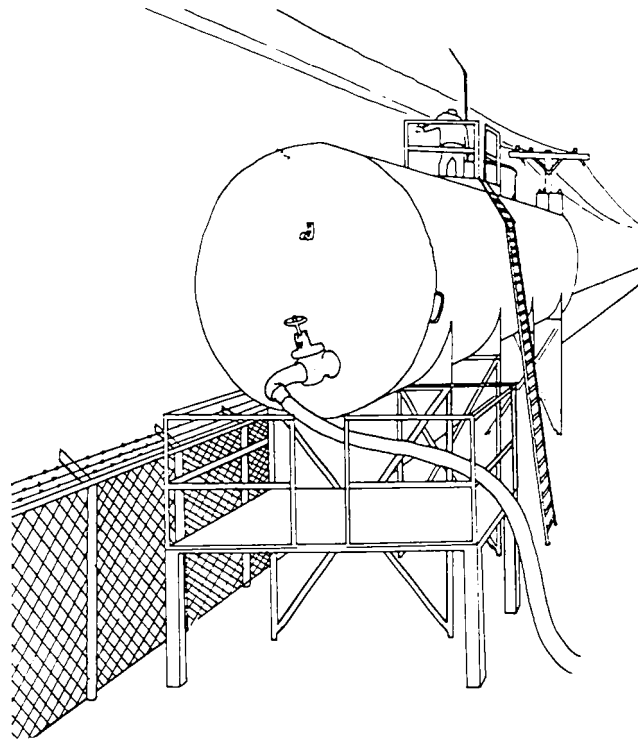
*Figure. Configuration of Accident Site*

7. The inexperience of the victim and possibly his physical condition. No experience with the task and no SOP minimized the worker's ability to recognize the electrical hazard. Since no SOP existed, the worker possibly did not realize that the task was often done with two workers rather than just one. The only witness stated that the victim's back had been bothering him that day. Consequently, the victim might have chosen the body position (posterior of body against rail and towards powerlines) he did in order to reduce strain on his back. However, regardless of the condition of his back, it most likely did not directly cause the rod to contact the powerline.

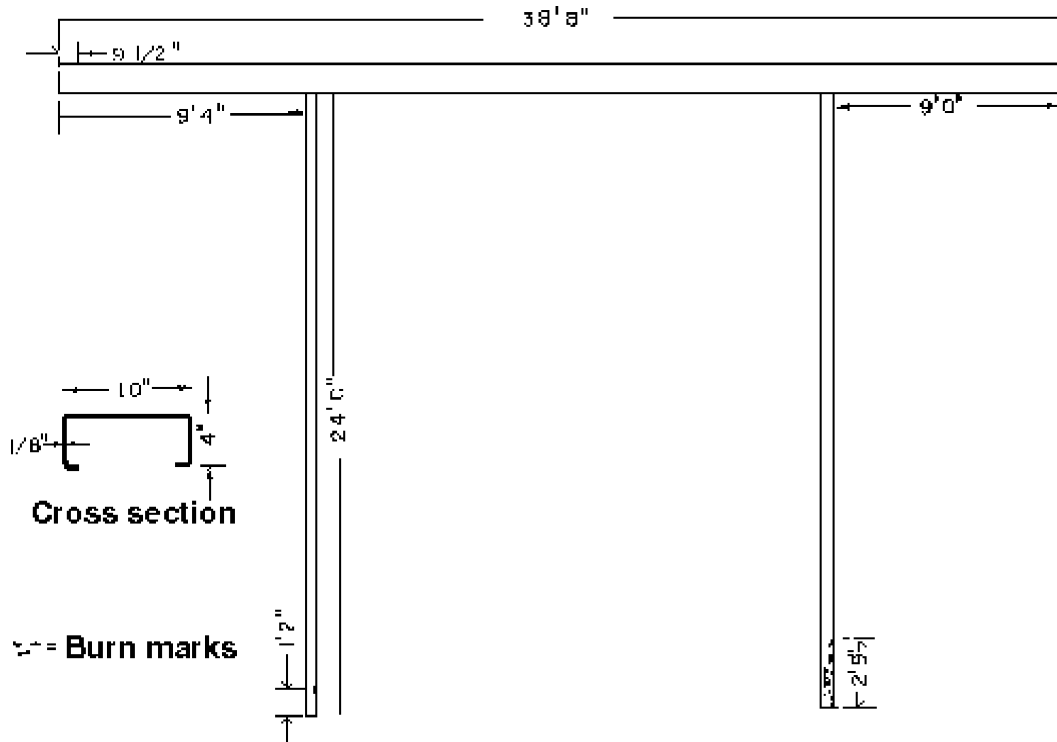
*Figure 1. Steel Framing Configuration*

At the time of the accident, the major steel framework had been erected except for the end sections. After the south end was erected, the workers discovered that an incorrect roof beam had been installed (Figure 1). To replace this beam, a decision was made to use a crane to lower the south section to the slab (Figure 2). The incorrect beam was unbolted from the two corner columns, but was left connected to the two intermediate columns. These intermediate columns were disconnected from the anchor bolts on the slab. A lifting sling was placed around the incorrect beam with the intention of raising the whole assembly (beam and support columns) off the anchor bolts, tipping it in a northward direction, and laying the whole assembly on the slab. Then the columns would be unbolted and the correct beam installed.

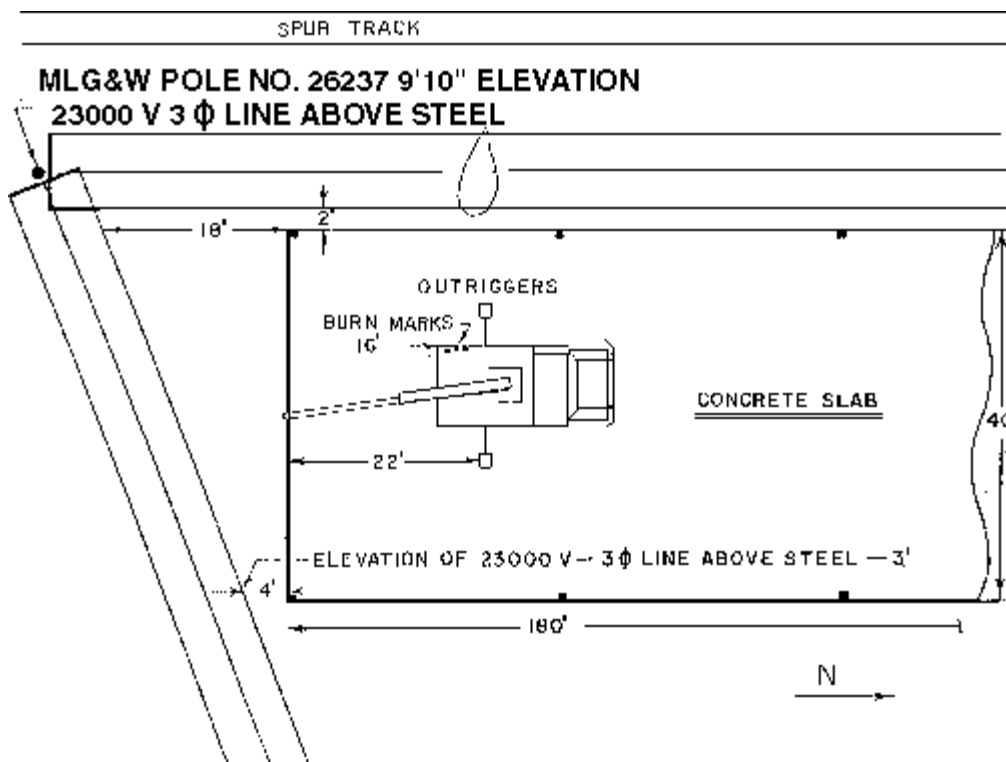
A plan view of the building layout and the proximity of the two sets of 23 KVA overhead power lines to the work area are shown in Figure 3. One set of power lines ran in an east-west direction. This set came from a corner pole (outside the fence) on the west side of the slab and steel uprights. These powerlines fed a transformer bank consisting of 3, single phase, 23 KVA transformers which supplied power to the facility. One of these lines was approximately a five foot diagonal distance from the structural section which was to be lowered. The second set of power lines ran on the west side of the structure along its entire 180' length. The inside phase of this set appeared to be approximately 10 feet diagonally from the upright columns of the structure's west side.

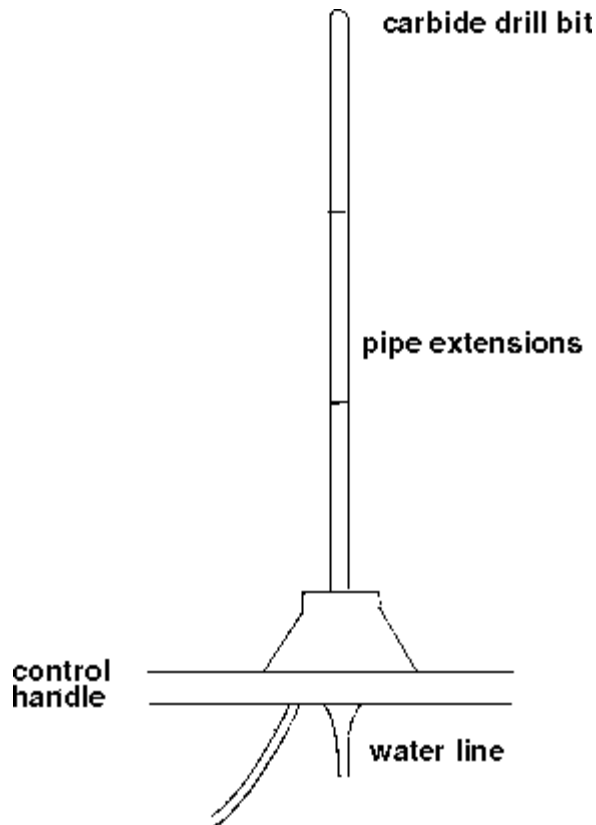
Figure 2. Schematic of Bore Motor

The crew was attempting to bore under the sidewalk and under the street to install a service line. The equipment used to bore this hole was an air driven, water-lubricated, low RPM drill with a carbide bit (see figure 2). Pipe extensions are added as required. This equipment is usually operated by two crew members, but is occasionally handled by three when difficulty is encountered. Three attempts to bore a hole under the street were made with the fatality occurring on the third attempt. The first attempt resulted in the drill bit coming up through the street approximately two feet from the hole that exposed the gas main. The second attempt was not successful because resistance was met and the drill could not be advanced. All three crewmen were pushing on the machine during the third attempt because excessive resistance was encountered. A 4160 volt power line, encased in four inches of concrete, was contacted at approximately 2:10 p.m. resulting in one fatality and one serious injury. The third crewman felt a shock in his hands and released the equipment. The crew leader tried to release the equipment and fell to the ground unconscious. He suffered third degree burns on his hands and shoulders. The victim went into convulsions and slumped over the equipment. The victim had burn marks on both hands and the front of his right thigh and was pronounced dead at a local hospital after resuscitation efforts failed.

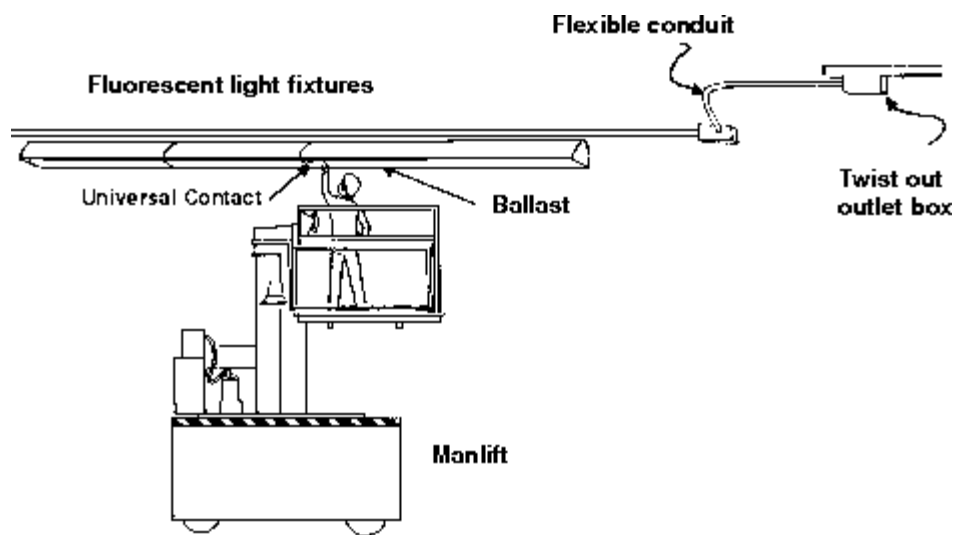
*Figure. Worker Replacing Ballast from Manlift Platform*

Discussion: The busway within the universal lighting duct is marked + and -. The twist out outlet box should be installed within the universal lighting duct so that polarity is maintained. The twist out outlet box and the universal contact involved in this incident were not polarized. One of these two units was installed backwards which caused reverse polarity. The twist out outlet box involved in this accident had been installed in 1965. Newer outlet boxes are polarized and will maintain polarity in the universal lighting duct. All electrical systems at the manufacturing plant should be evaluated to assure correct polarity is maintained.

***Recommendation #2: Correct electrical polarity should be maintained throughout the electrical service area.***

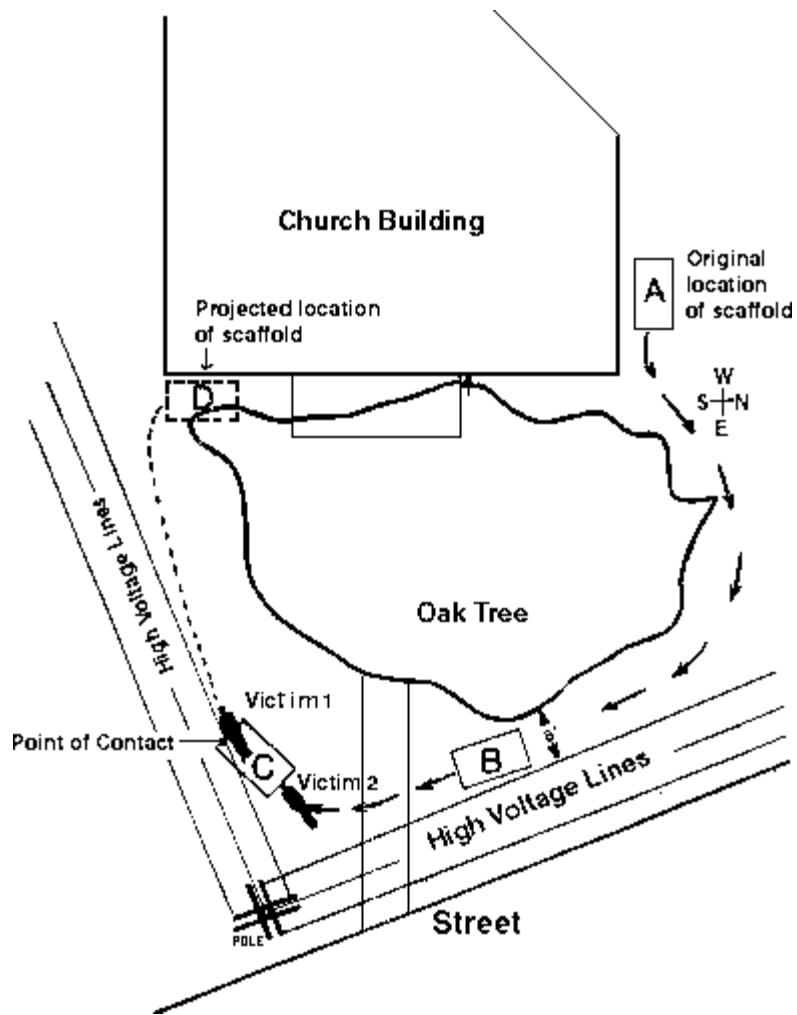
*Figure.*

Discussion: The midday sun may have affected the victims' view when they looked up at the high voltage lines running East/West and they may have assumed that these lines were the same elevation as those running North/South. An independent observer would have been free to choose a different vantage point and aid in maintaining separation between the scaffold and the high voltage lines.

***Recommendation #2: When moving a scaffold in the vicinity of electrical lines, an observer without other duties should be available to help maintain a safe distance between the scaffold and the electrical lines.***

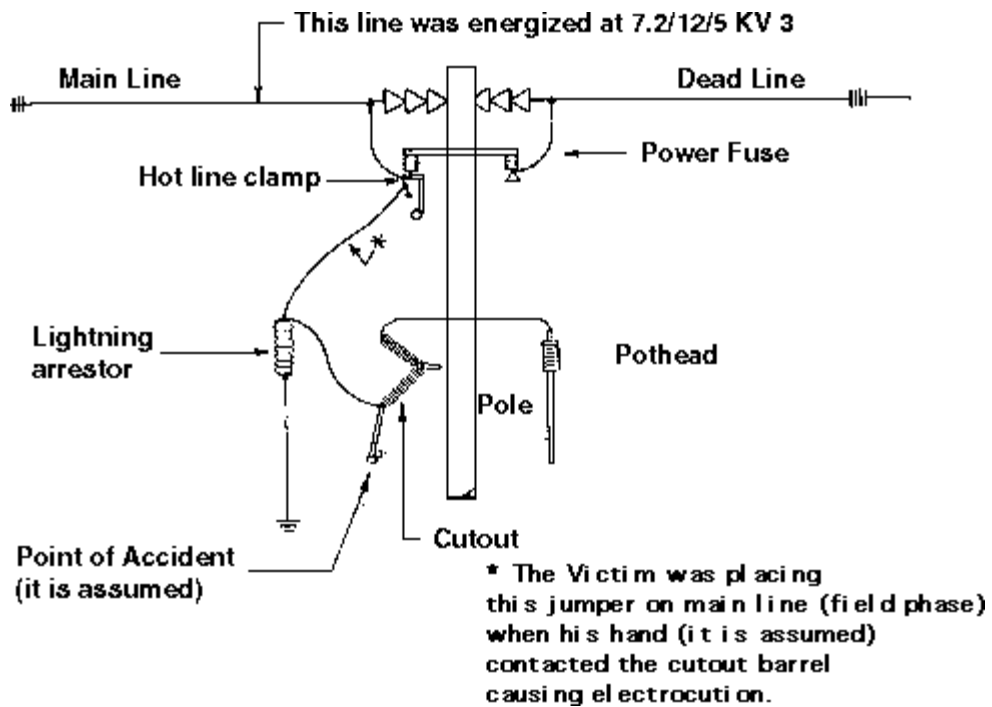
*Figure 1. Profile of Accident Pole*

After the underground repairs were made, four men were to re-energize the line by replacing the jumper and closing the fuse cut-out. The victim had climbed the pole and attempted to place a jumper on the main line using an eight foot long hot stick. The victim expressed to the workers on the ground that he felt the jumper was too short. When the victim tried to place the jumper on the main line he apparently made incidental contact with the 7200 VAC barrel of the cut-out (see Figure 1).

The autopsy report listed the cause of death as electrocution due to contact with 7200 VAC. Contact with electrical energy was with the back of the left hand with current passing through his body exiting through the victim's left foot where he was wearing steel climbing gaffs.

**Recommendation #3: All exposed high voltage conductors should be covered with rubber hoses, boots, or blankets.**

Discussion: The victim did not use any insulative barriers to cover the 7200 VAC power line system. When working in close proximity to high voltage powerlines, all exposed conductors in contact distance within a work area must be covered to eliminate the occurrence of an accident.

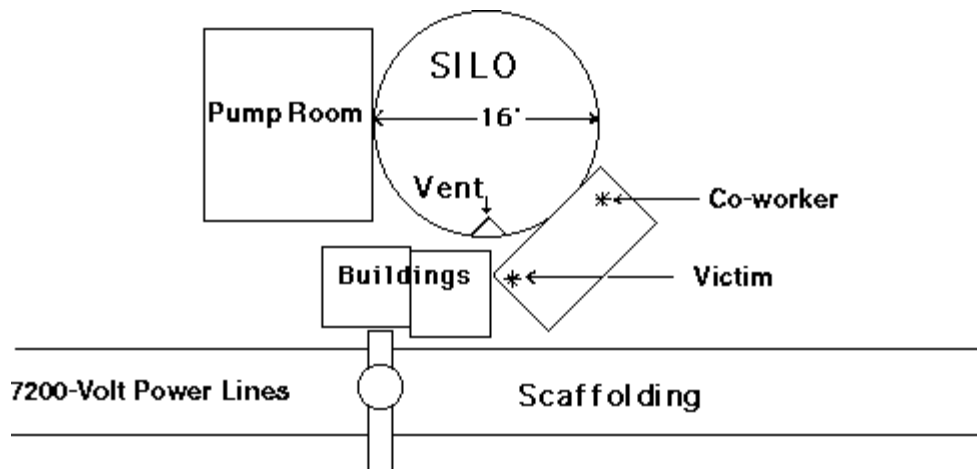
**(NOTE: Scaffolding was 5' by 7' tubular welded frame with an aluminum walk board, but no guardrails.)**

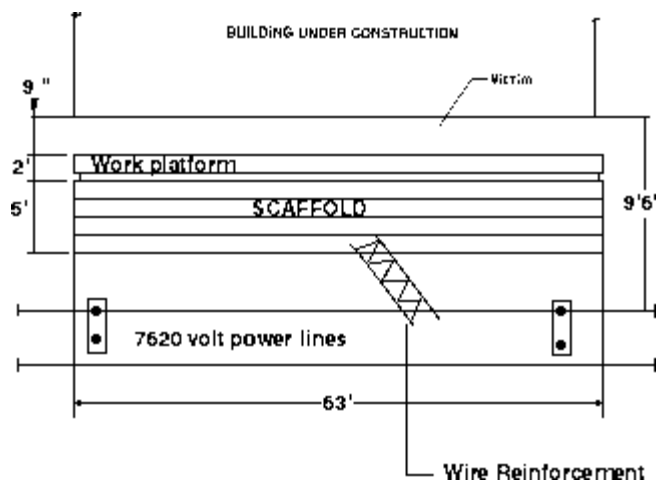
*Figure 1. Top View of Fatality Site*

review the hazards associated with overhead powerlines. The workers were not aware of the hazards associated with working near energized powerlines. Prior to the incident, an electrician told the workers on the scaffold that the 7620 volt line "might be hot." In an apparent attempt to see if he indeed would get shocked, an 18-year-old worker reached from the scaffold and touched the 7620 volt line. Fortunately for him, he was standing on the wood planks of the scaffold and did not provide a path to ground.

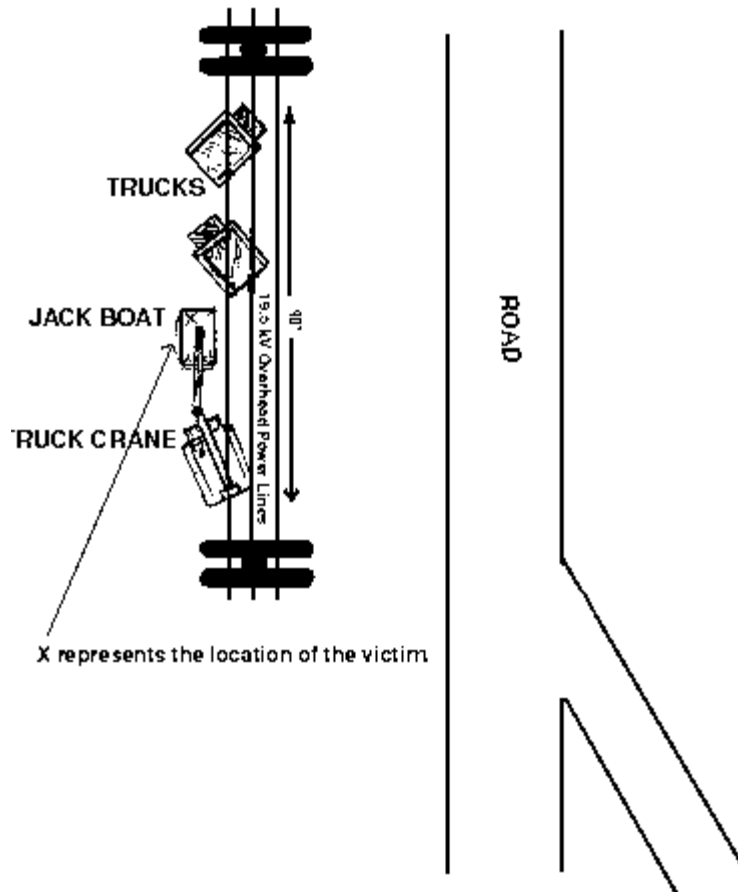
*Figure. Overhead View of Site*

Discussion: Employers should designate an observer for all operations where it is difficult for the operator to maintain desired clearances by visual means. The accident occurred just before noon, and the sun may have made it difficult for the operator to adequately judge the clearance. The use of an observer might have prevented the accident.

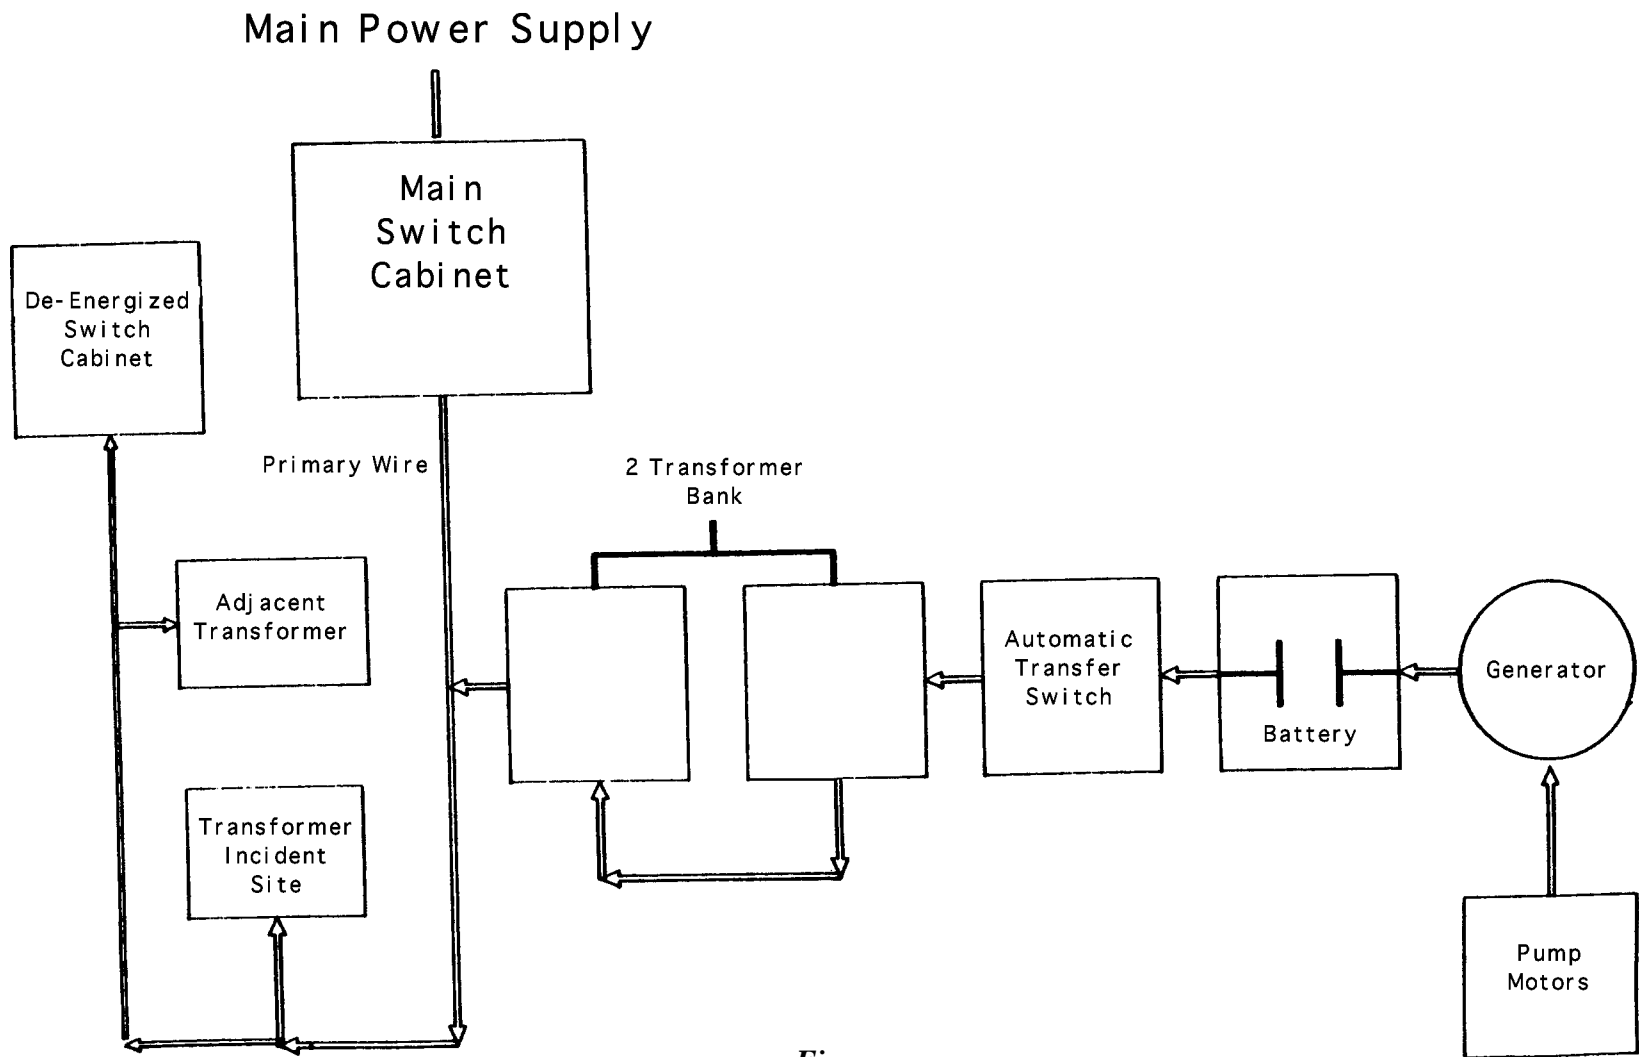
Figure.

Discussion: In this incident it appears that the victim was not aware of the existence of the back-up generator; therefore, he was not aware that current could feed back through the transformers to the primary line even with the fuse and fuse holder removed from the main switch cabinet. Before beginning work on any electrical system, all persons involved in working on that electrical system should be made aware of the function of all components of the systems. Workers should be made aware of any hazards that might be created by the functions of these components before any work is performed on the electrical system.

This is especially important when working on underground systems because the lines or the direction of current flow cannot be visibly traced. The victim thought he had de-energized the primary line at the beginning of the job. Yet, when the crew members cut the cable an arc occurred. This illustrates the fact that the victim was not familiar with all components of the system. If the victim had been aware of the possibility of the feedback of energy, he may have placed the required grounds on the primary line and placed a danger tag on the automatic transfer switch. These measures might have prevented this fatality.

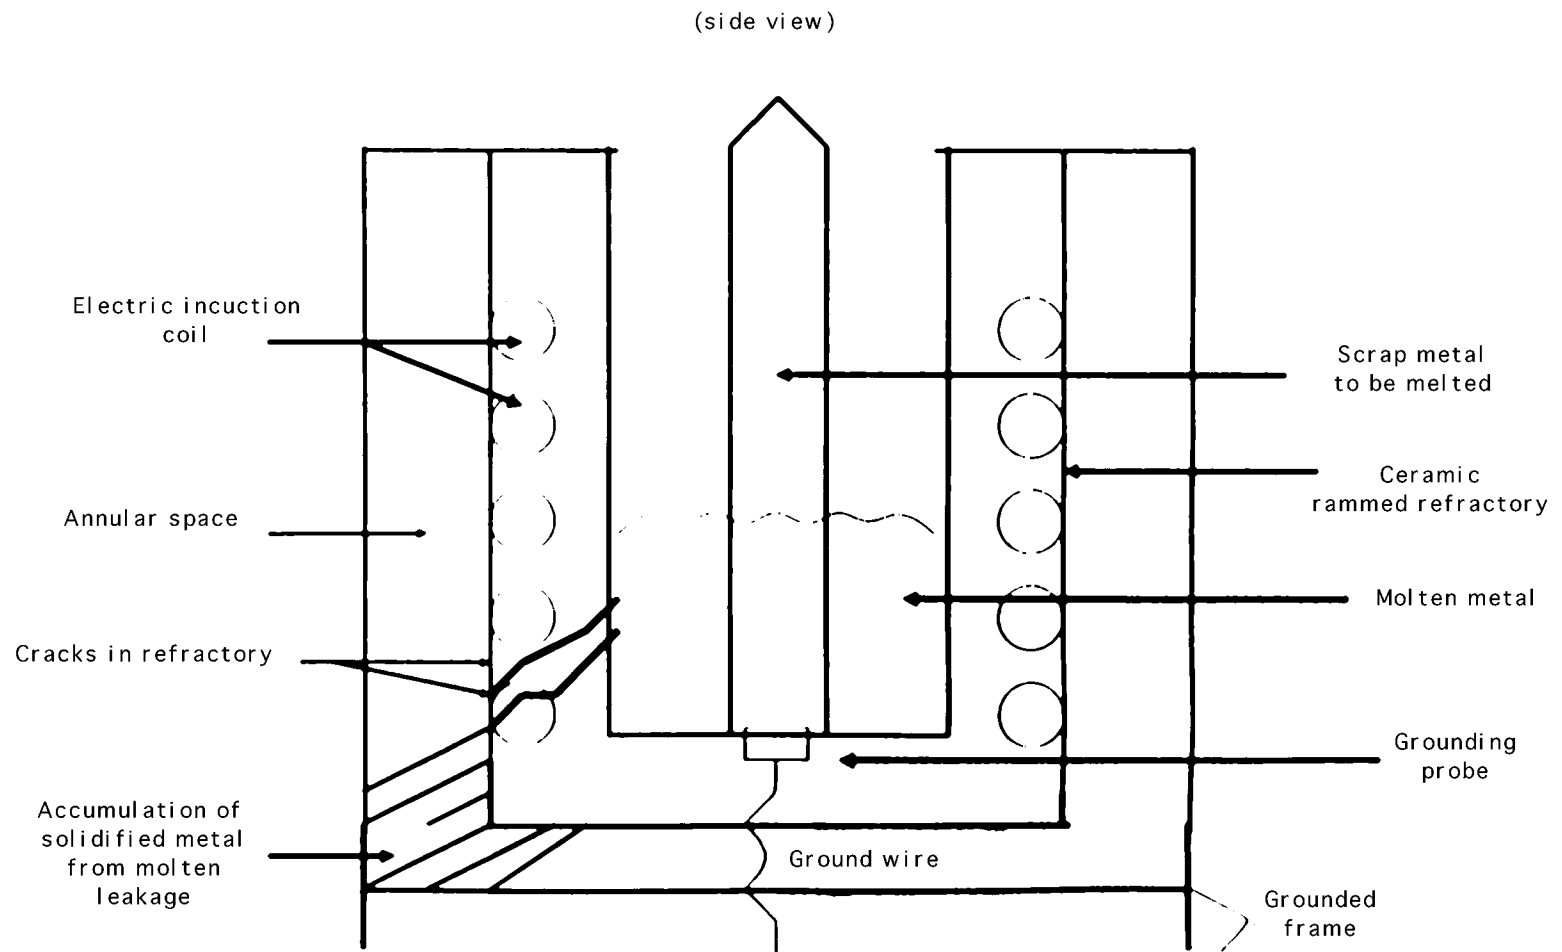
*Figure. Electric Induction Furnace*

Discussion: Because of the small interior size of the induction furnaces, each is basically a one-man loading operation. The scrap metal piece being loaded into the induction furnace in this incident weighed approximately 150 lbs. The co-worker was therefore unable to load it into the furnace by himself, so he was assisted by the victim. Since the scrap piece was so large and heavy, it jarred and damaged an already weakened refractory as it was lowered into the furnace. Therefore, such large scrap pieces should be cut into smaller pieces that one worker can easily handle. The employer should determine and specify a maximum scrap metal weight and dimension for manual loading into this type of induction furnace.

***Recommendation #5: The employer should establish a maximum scrap metal size and weight for manual loading into this type of induction furnace.***

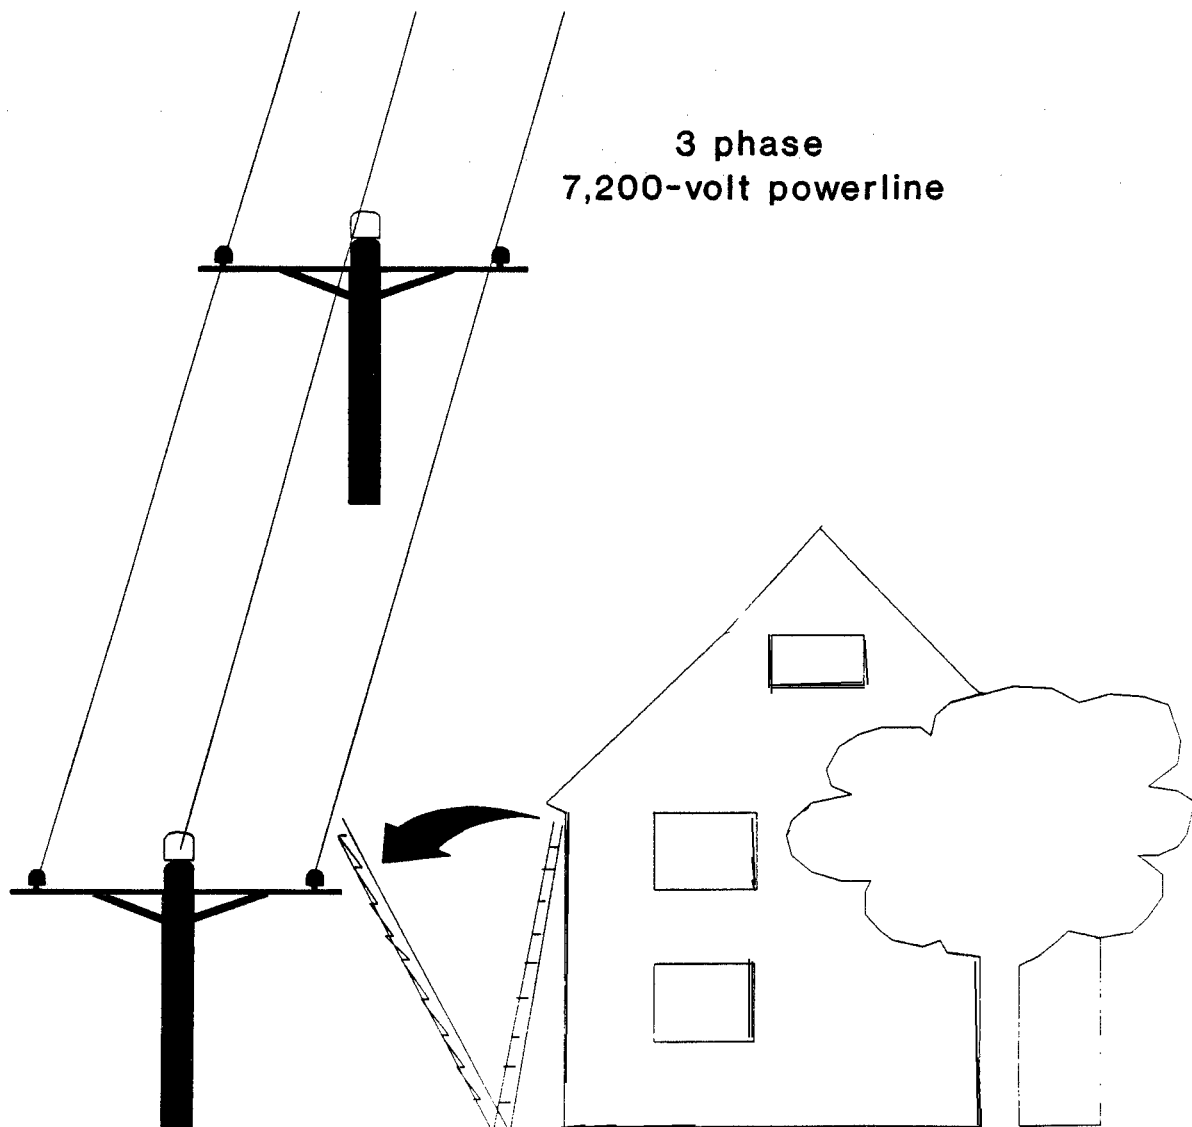
*Figure.*

An employer should conduct a jobsite survey prior to initiating work at each site. Hazards, such as potential contact between an aluminum ladder and an overhead powerline depicted below, can be identified and controlled.

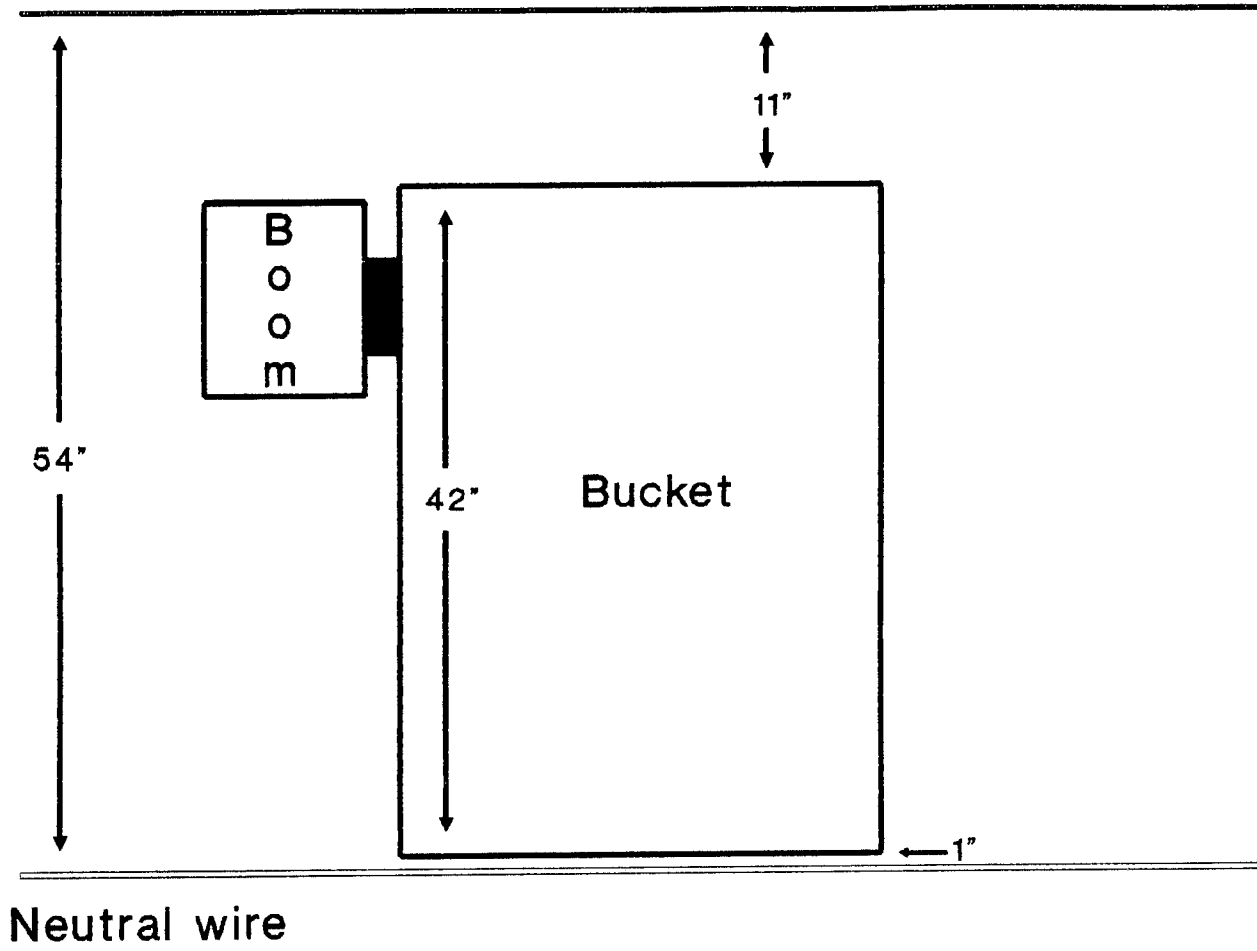
Figure 1. Boom/bucket Clearance Between Powerline and Neutral Wire

About 15 to 20 minutes before the incident, one of the company owners arrived at the worksite to observe the crew's progress and conduct a safety inspection. At that time, the tree trimmer had completed trimming tree limbs near the powerline and was bringing the boom/bucket back to the "landed" position over the cab of the truck. After retrieving his tree climbing gear, the tree trimmer re-entered the bucket and maneuvered the boom/bucket between the neutral wire and the bottom phase of a 23,000-volt, 3-phase powerline.<sup>1</sup> The boom/bucket was extended through the powerline about 15 feet and the operator climbed out onto a tree. At this time, the foreman climbed onto the aerial bucket truck to retract the boom using controls mounted on the boom pedestal.<sup>2</sup> The boom was inadvertently raised while still positioned between the neutral wire and bottom phase of the powerline (Figure 2). This action brought the boom into contact with the powerline and allowed current to flow through the uninsulated boom and truck to the ground. The victim, who was standing on the ground in contact with the bucket truck, provided an alternate path to ground for the electrical current. The current flow ceased when the powerline burned in half and the victim then collapsed to the ground.

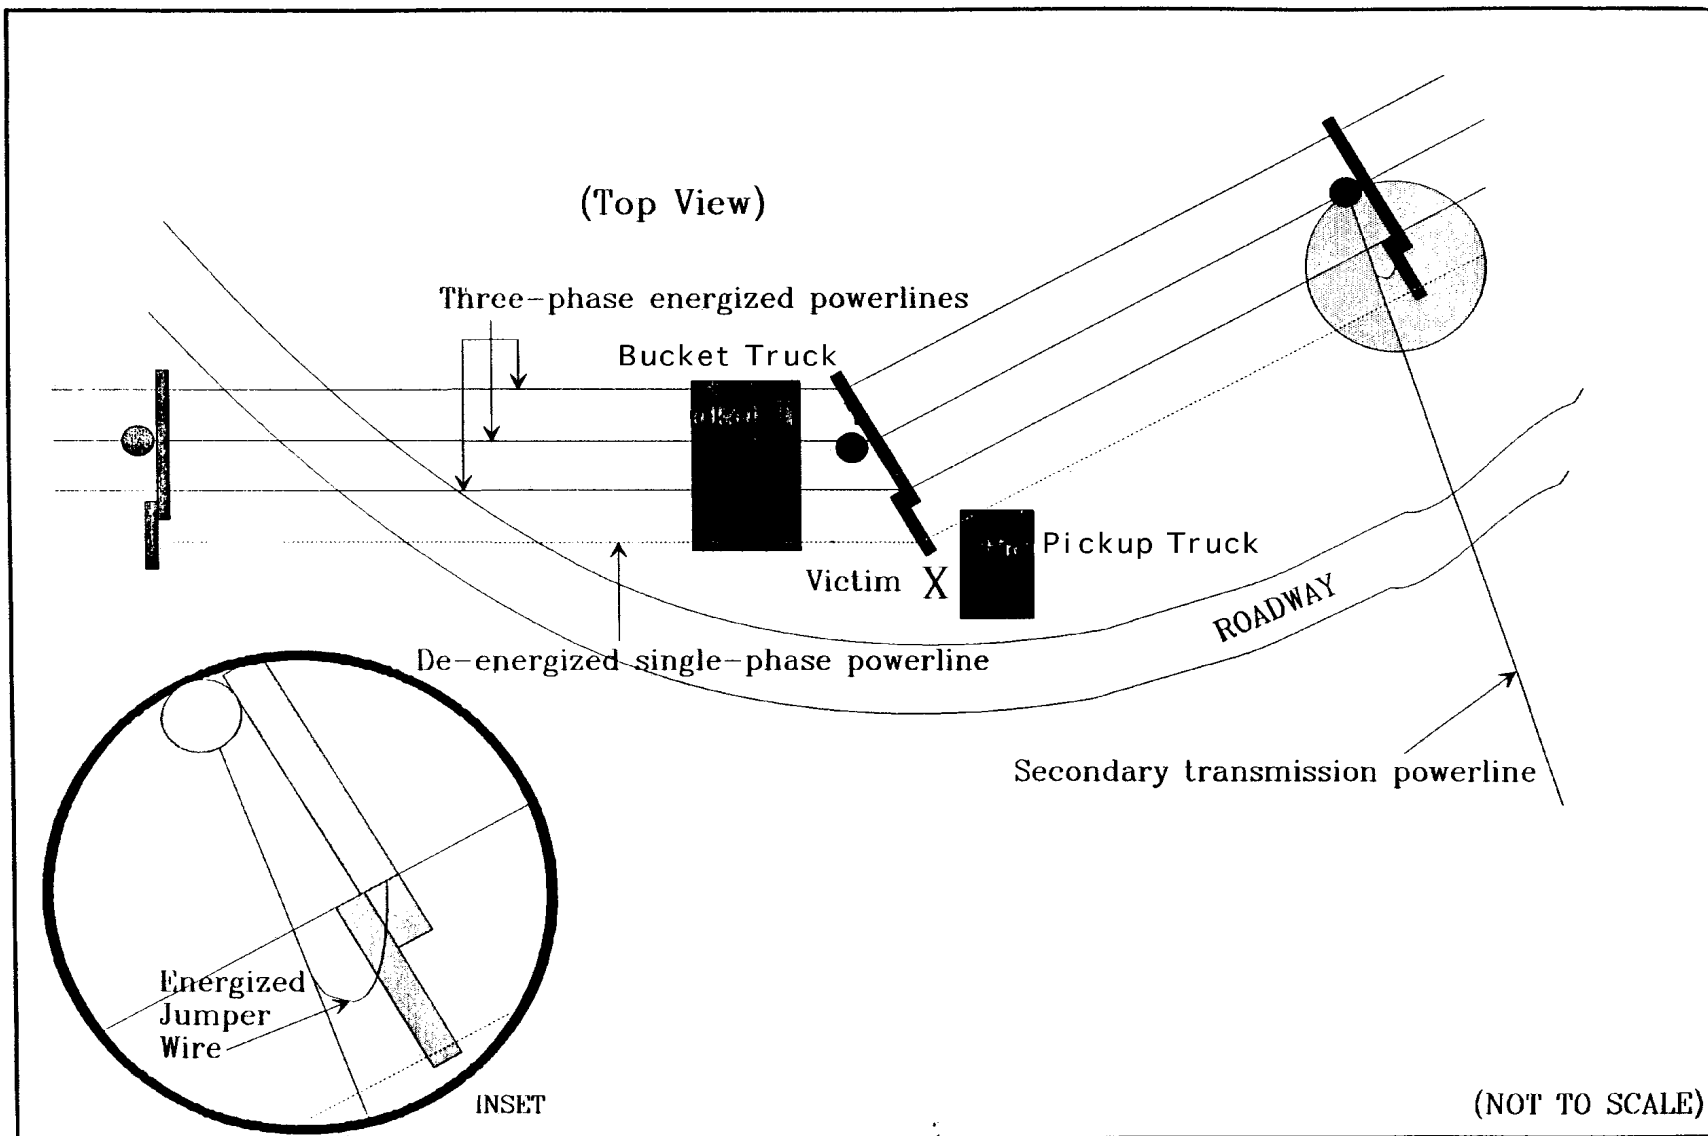
*Figure. Conversion of Single-phase Powerline to Three-phase Powerlines*

Discussion: The energized powerline contacting the ground and pickup truck should have indicated to any employee that there was an emergency situation and that contacting the truck was unsafe and a dangerously inappropriate response. An appropriate countermeasure may have been to use a "hot stick" to remove the energized powerline from the pickup truck, rather than trying to move the pickup truck from the area. Employers should evaluate the training programs to ensure that workers know appropriate response measures to emergency situations, and are drilled to respond properly under simulated emergency conditions.

***Recommendation #6: Employers should evaluate training programs to ensure that workers know and practice appropriate responses to emergency situations.***

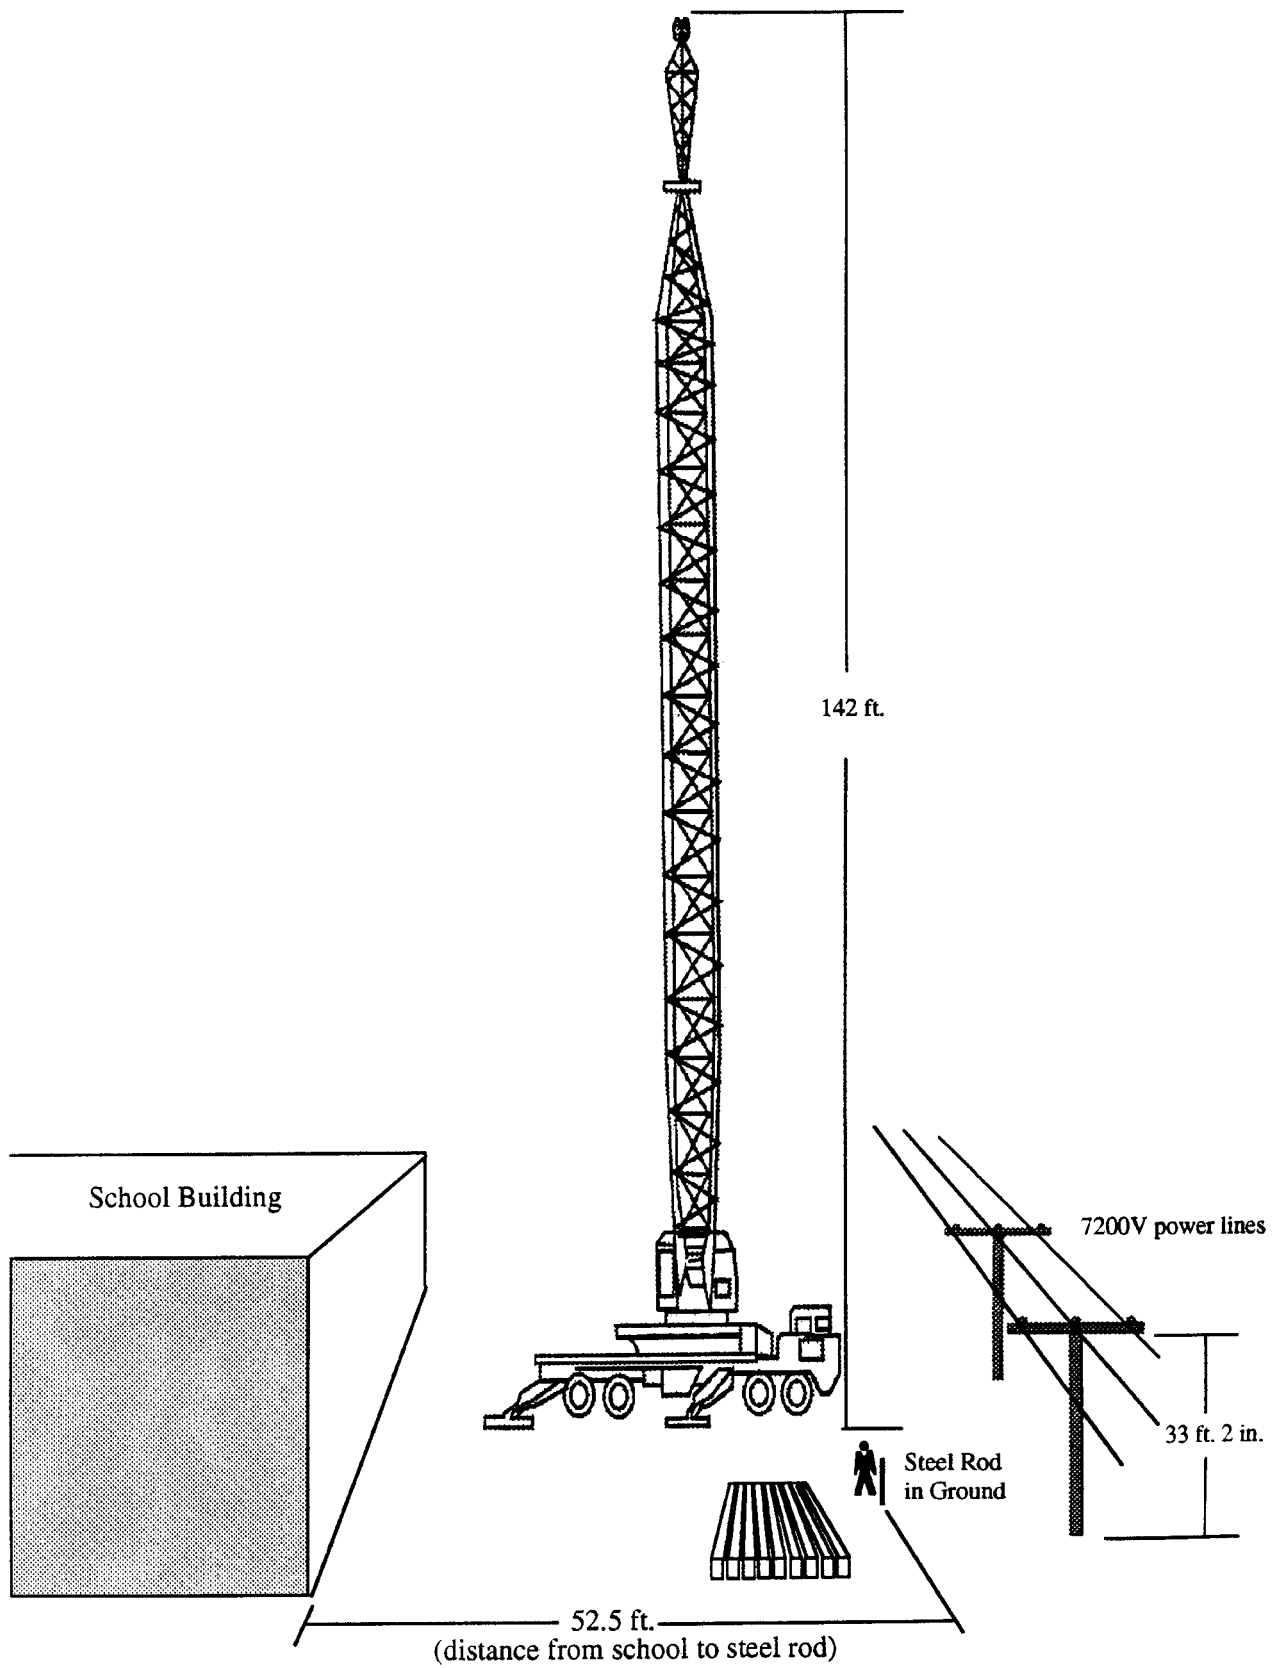
*Figure. Configuration of the Incident Site*

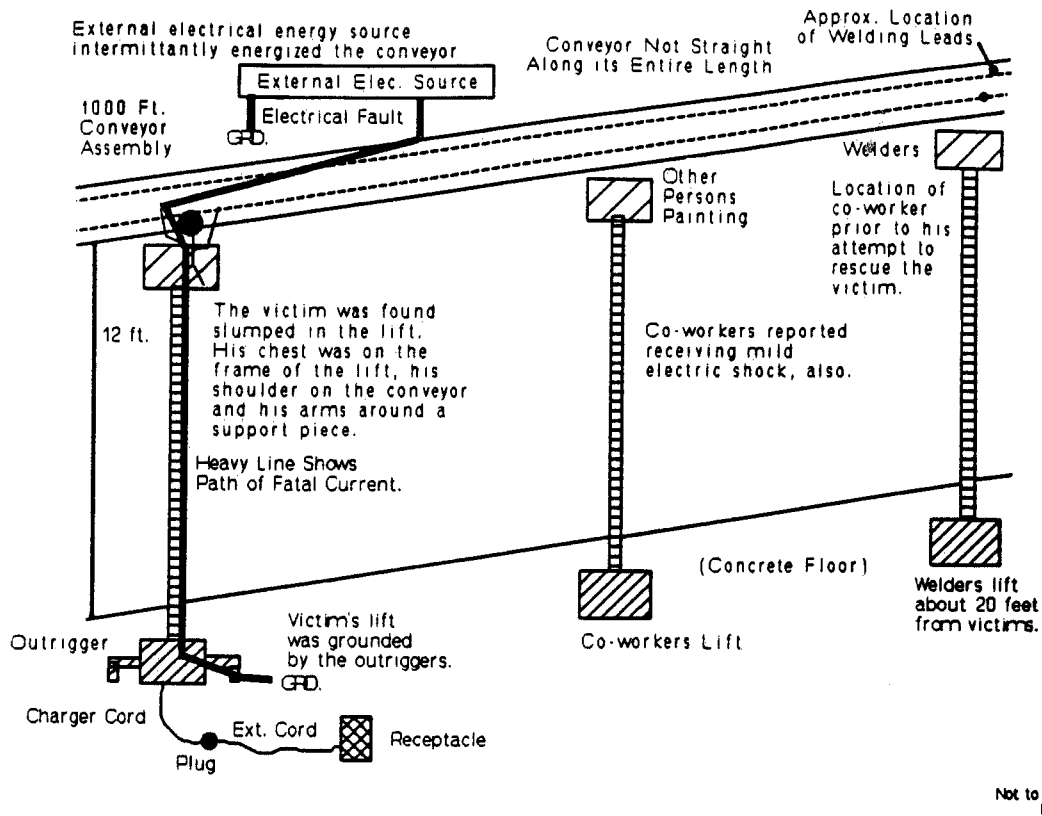
NIOSH investigators concluded that the secondary source of electrical energy causing the fatality was the conveyor. (The conveyor is considered a secondary source in this case because it acted only as a conductive path for the primary source; the defective device which energized it.) No conclusive evidence was found to indicate that the receptacle, extension cord, or lift acted as a source of electrical energy in the electrocution of the laborer. Statements of the co-workers, burns on the victim's hand, and test results substantiated this conclusion. The primary source of electrical energy which energized the conveyor could not be determined. It should be noted, however, that several welding machines, grinders, and other electrical tools were being used on or near the conveyor at the time of the incident. None of this equipment was available for testing by the NIOSH investigators.

*Figure. Conveyor Assembly, Lifts, and Worker Locations*

***Recommendation #1: Employers should conduct thorough investigations when workers report electrical "bites," "nips," or other descriptions of mild shock, and immediately implement appropriate corrective measures.***

***Recommendation #2: Employers should provide effective electrical grounding of all conductive assemblies and structures during the installation of a system, and ensure this provision is addressed during the planning and design phases of all projects.***

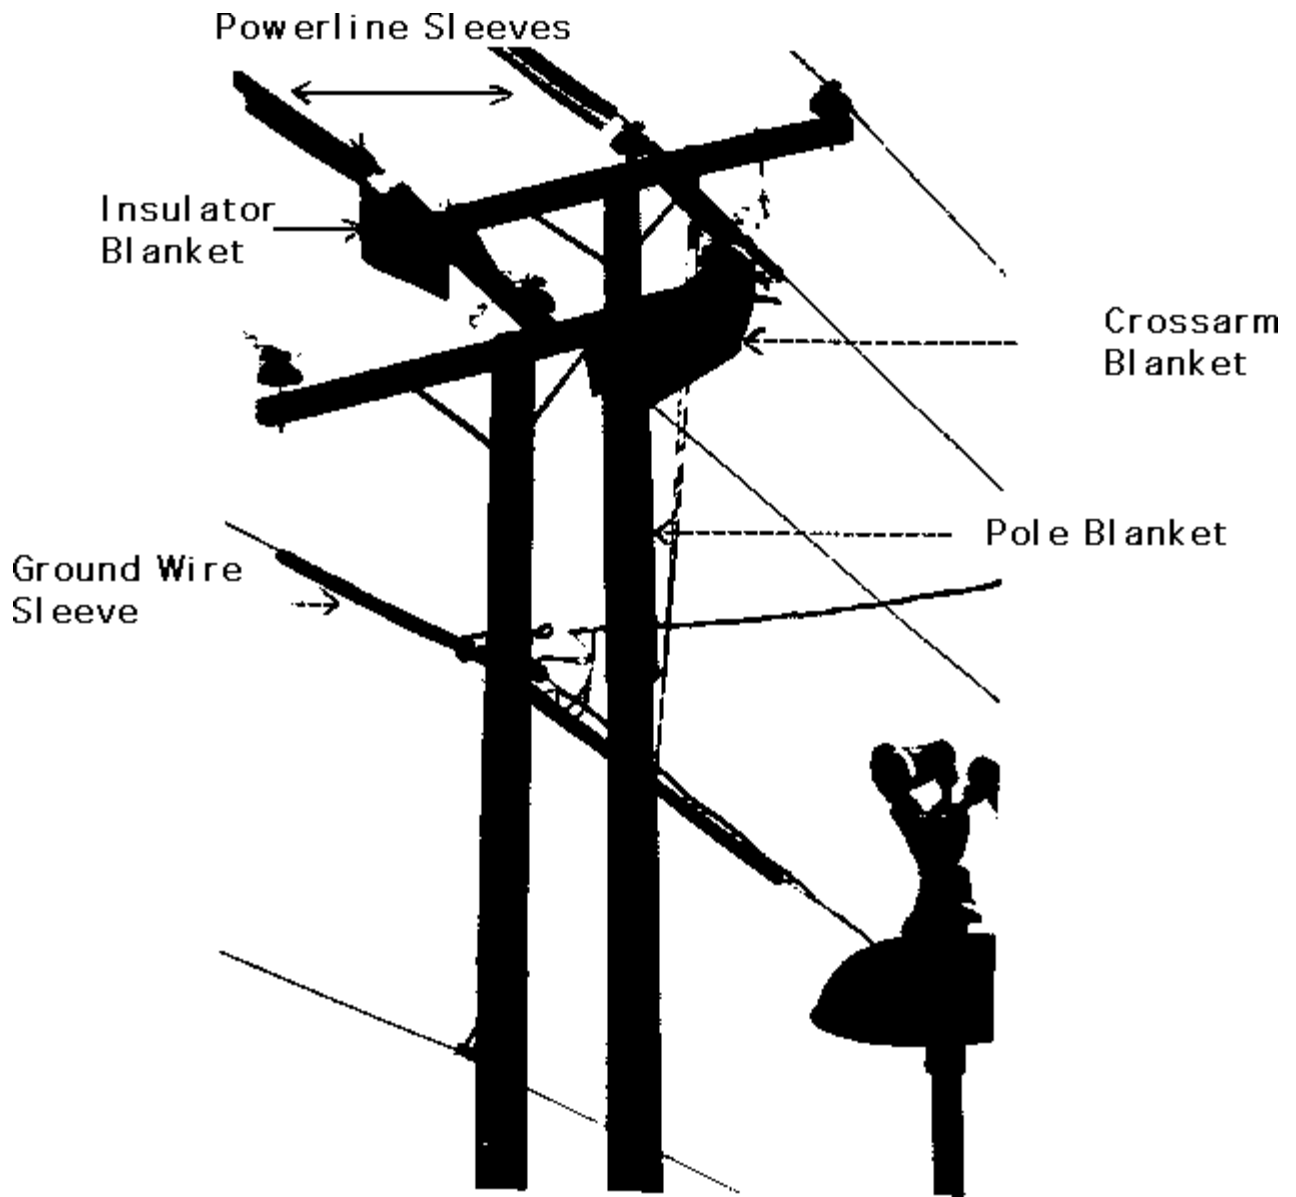
The line sleeves and insulating blanket were first removed from one of the outside phases. Next, the victim positioned the lip of the bucket next to the crossarm, between the other outside phase and middle phase. The insulating blanket was then removed from the crossarm and middle phase insulator. While trying to remove the middle phase line sleeve, located farthest away from the bucket, the victim's rubber glove became snagged on the aluminum wire which secured the powerline to the insulator (Figure 2). When he pulled his arm back, the rubber glove was pulled partially off, and his exposed right wrist contacted the powerline. Current passed through the victim's right arm and exited the body at the lower abdomen on the left side where he was in contact with the crossarm attached to the utility pole.

*Figure 1. Insulating Materials*

Discussion: Safe work procedures regarding the removal of the insulating blanket from the crossarm before the removal of the line sleeves and insulator blankets should be reviewed and revised, where appropriate. A work procedure which specifies leaving the crossarm insulating blanket in place until after the removal of line sleeves and insulator blankets may help to reduce inadvertent contact with energized conductors. Safe work procedures regarding the positioning and repositioning of the aerial bucket should be periodically reviewed and revised where indicated, to assure the procedure is appropriate in providing access to the middle powerline sleeves, while allowing adequate clearances from ground potential items. The procedure used in securing powerlines to utility pole insulators should be reviewed and revised, where applicable, to ensure the procedure adequately addresses the appropriate manner in which the powerline is secured to the insulator. The tie down (i.e., a piece of wire used to secure the powerline to the insulator), should be fastened to the powerline in such a manner that the ends of the tie down do not protrude from the powerline. This would minimize any snagging hazard.
