# Worker Deaths by Electrocution

## A Summary of Surveillance Findings and Investigative Case Reports

## **A Summary of NIOSH Surveillance and Investigative Findings**

**DHHS (NIOSH) PUBLICATION No. 2000-115**

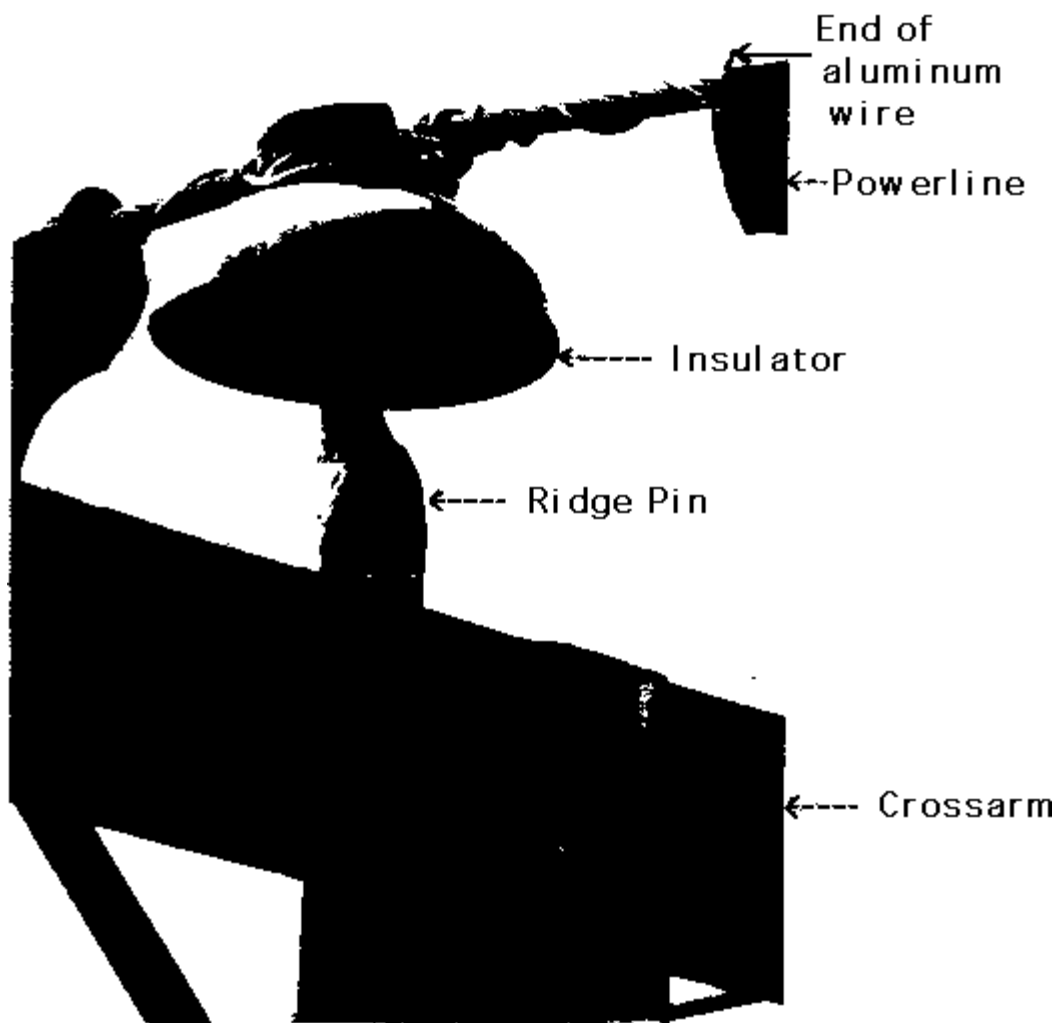
*Figure 2. Insulator and Powerline Connection*

Discussion: Safe work procedures regarding the removal of the insulating blanket from the crossarm before the removal of the line sleeves and insulator blankets should be reviewed and revised, where appropriate. A work procedure which specifies leaving the crossarm insulating blanket in place until after the removal of line sleeves and insulator blankets may help to reduce inadvertent contact with energized conductors. Safe work procedures regarding the positioning and repositioning of the aerial bucket should be periodically reviewed and revised where indicated, to assure the procedure is appropriate in providing access to the middle powerline sleeves, while allowing adequate clearances from ground potential items. The procedure used in securing powerlines to utility pole insulators should be reviewed and revised, where applicable, to ensure the procedure adequately addresses the appropriate manner in which the powerline is secured to the insulator. The tie down (i.e., a piece of wire used to secure the powerline to the insulator), should be fastened to the powerline in such a manner that the ends of the tie down do not protrude from the powerline. This would minimize any snagging hazard.

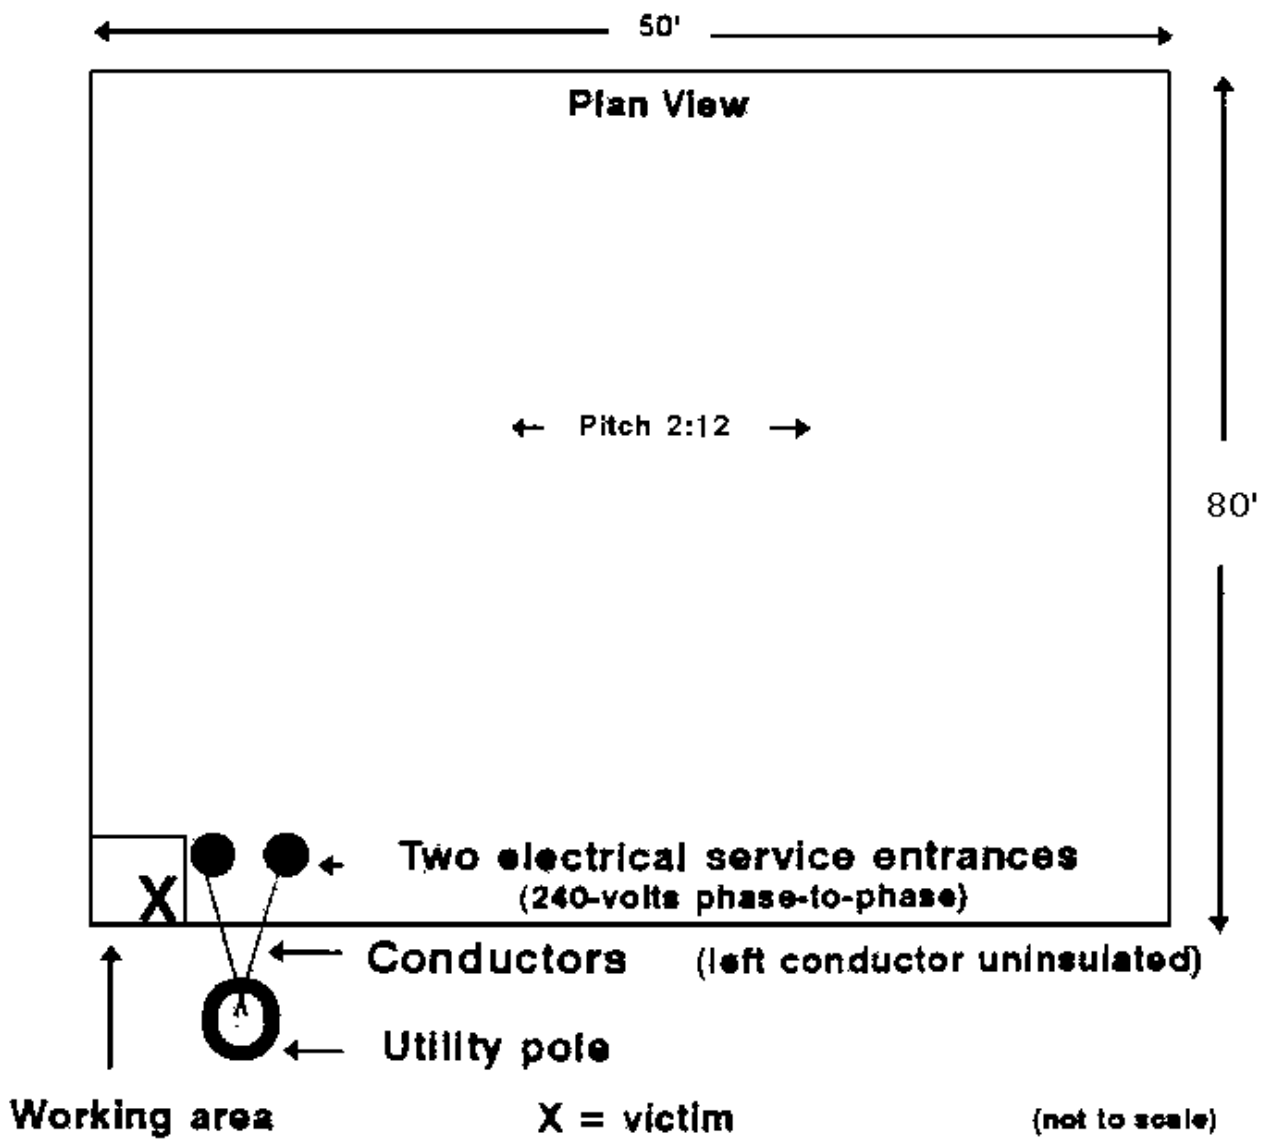
*Figure. Warehouse Roof and Utility Pole with Service Entrances*

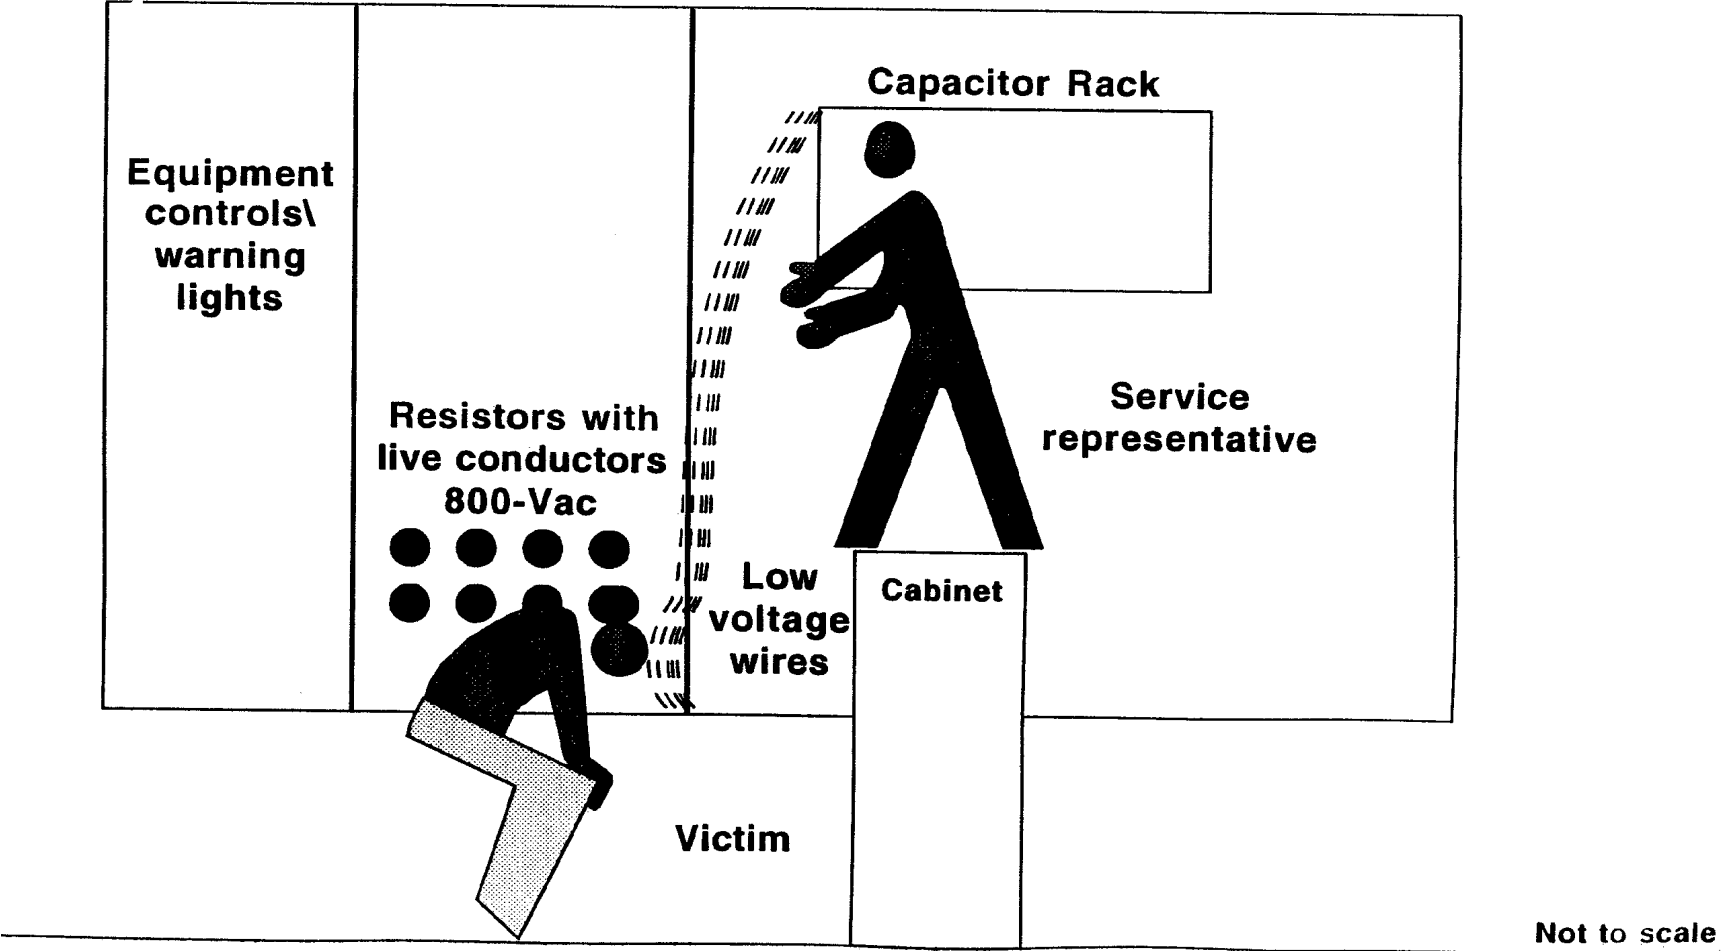
Figure. Mini-Comp System

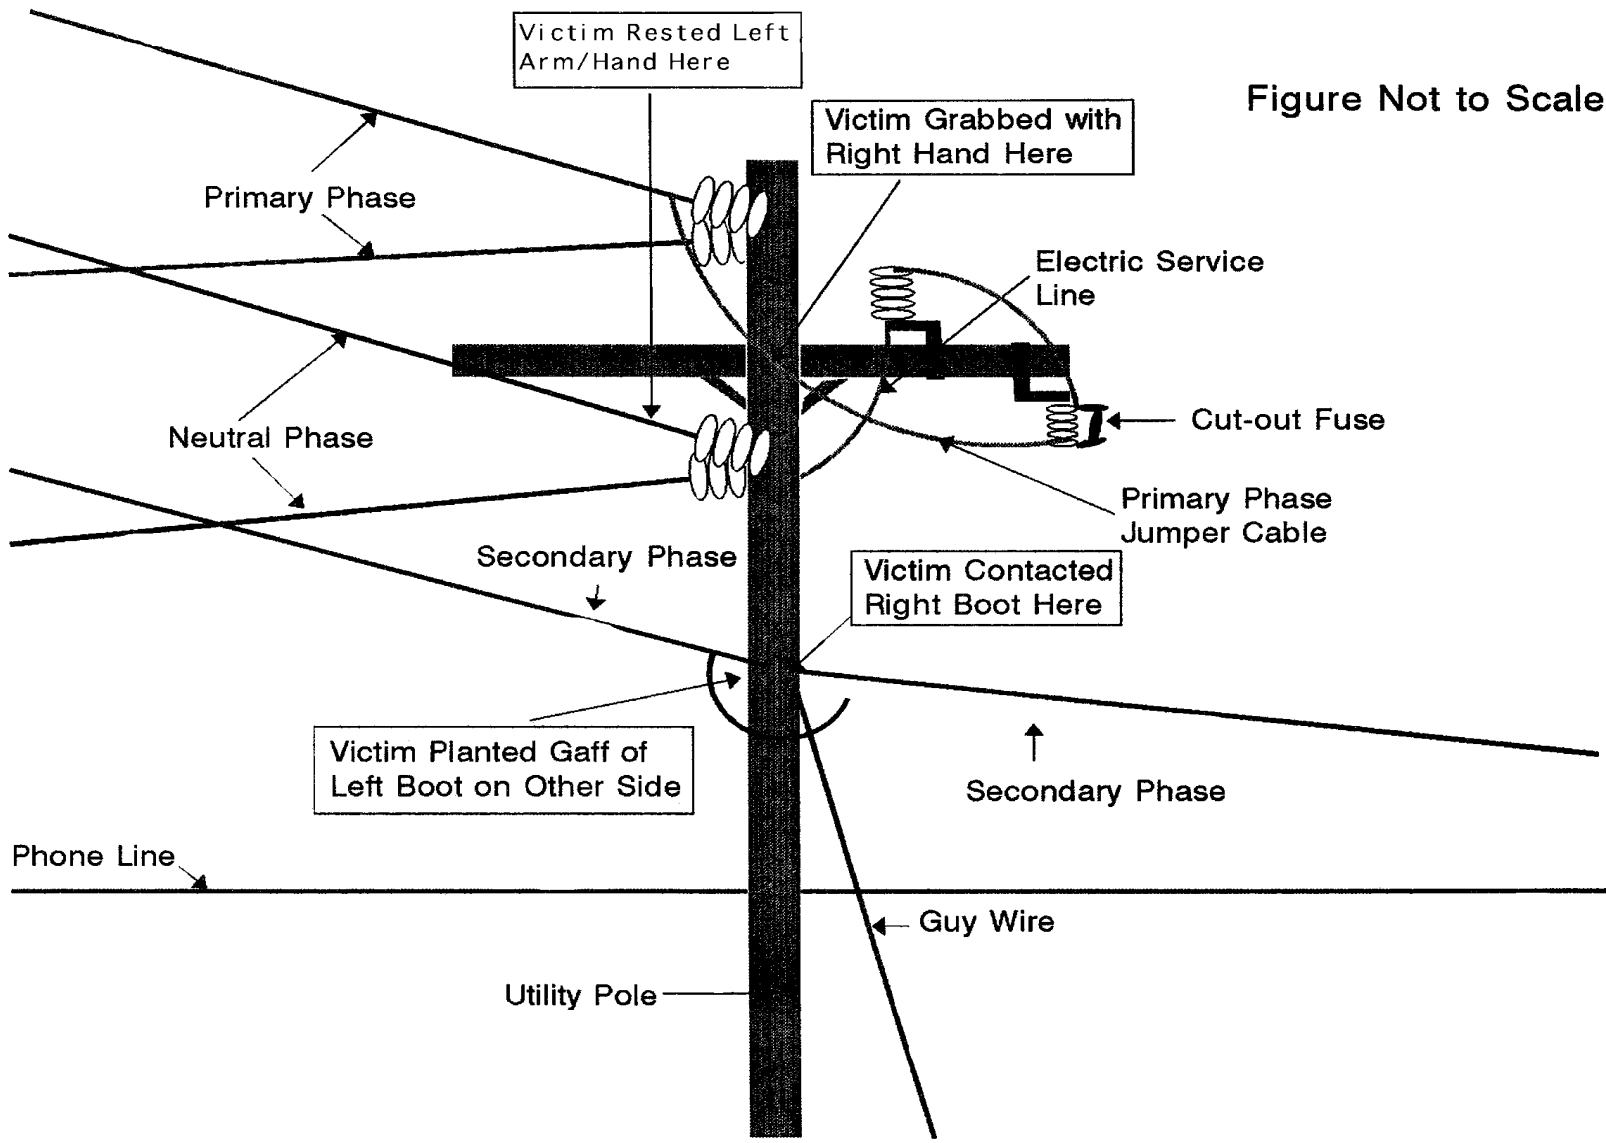
Figure. 7200-Volt Powerline

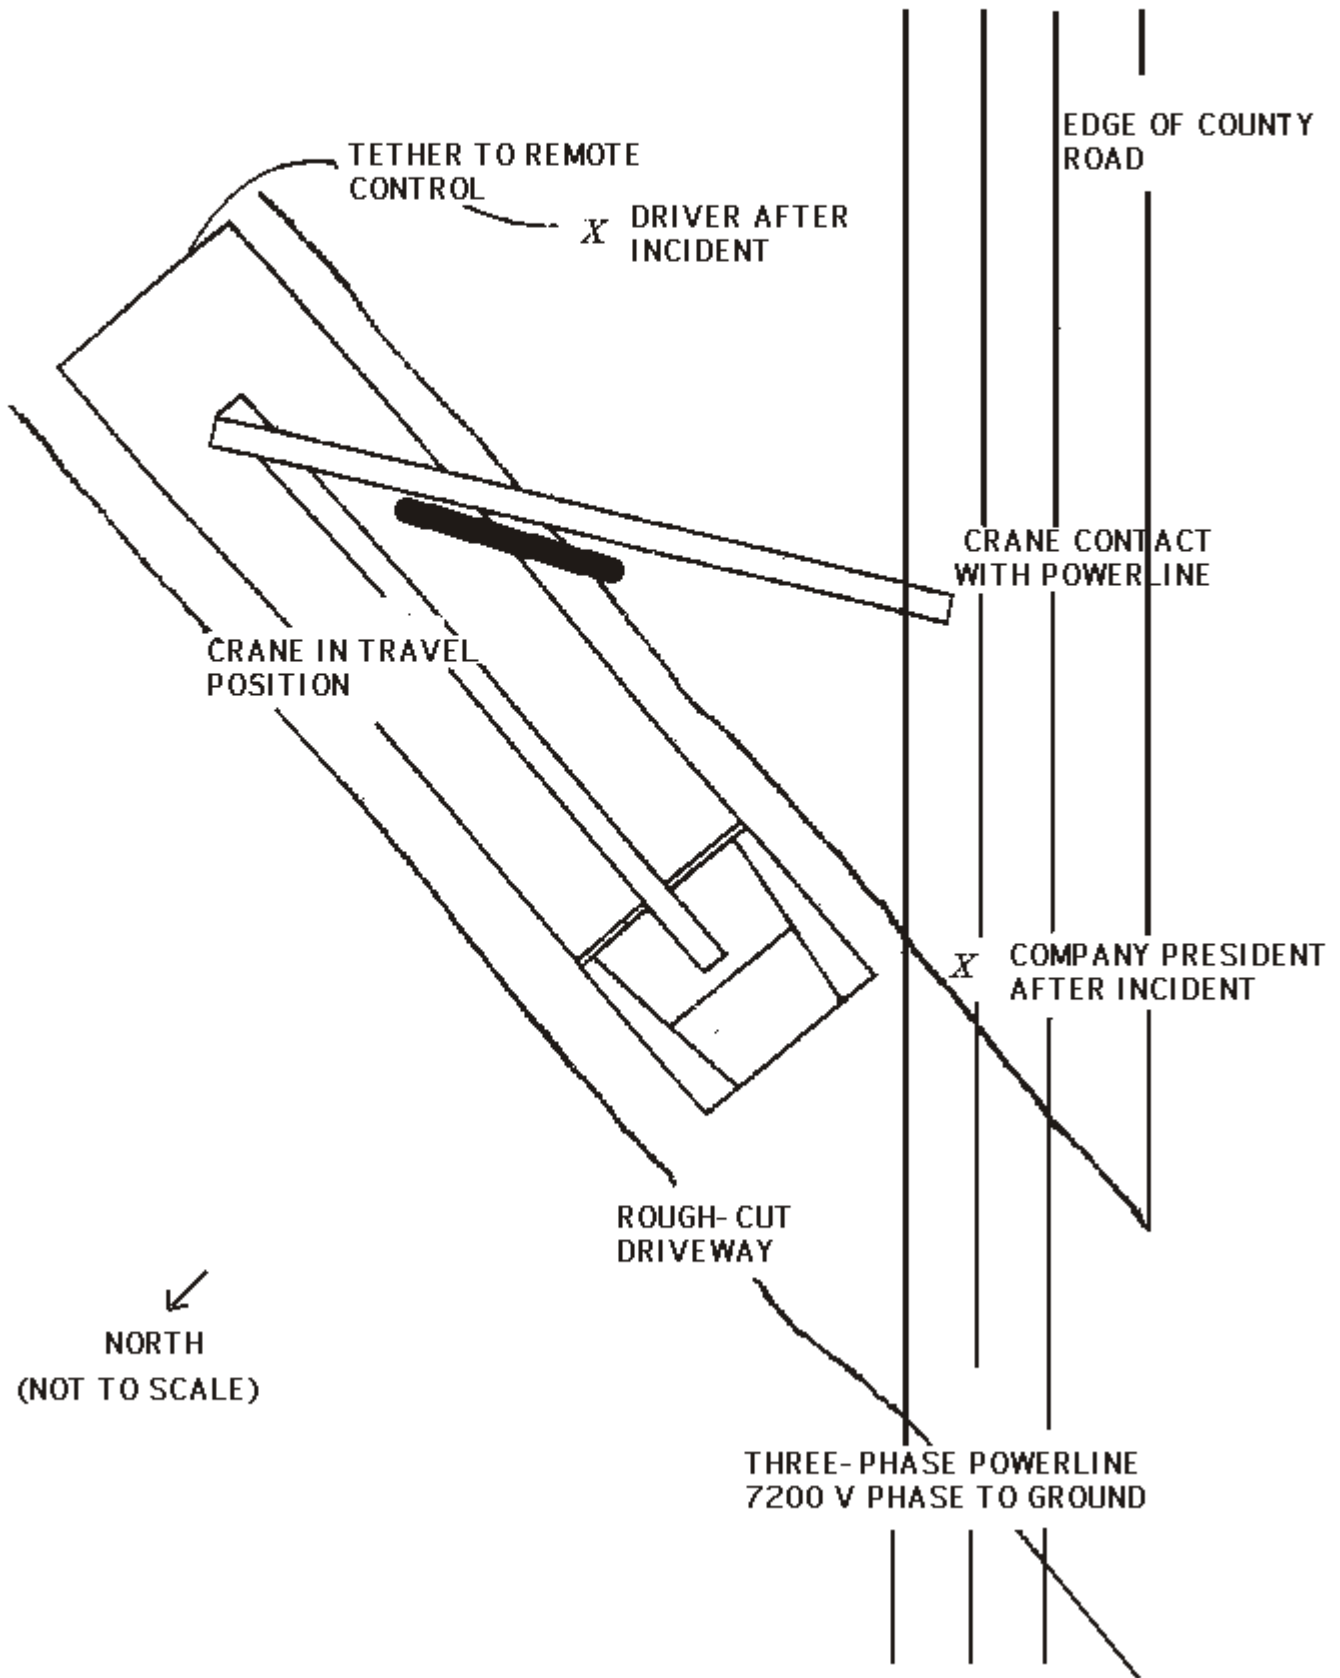
*Figure. Location of Truck Relative to Powerline*

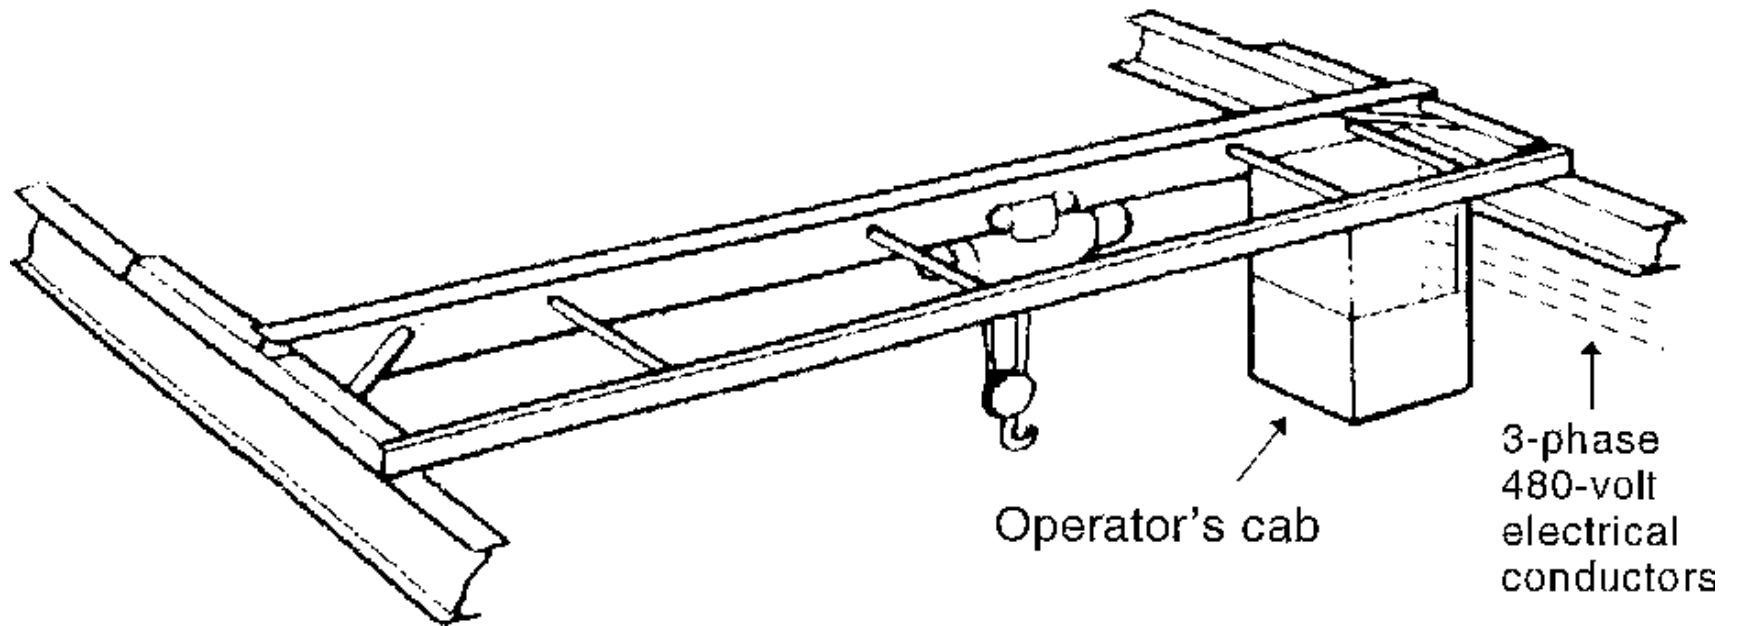
*Figure. Overhead Cab-operated Crane*
